**Corrosion of fasteners in furfurylated wood – final report after
9 years exposure outdoors**

Jöran Jermer*, Bo-Lennart Andersson**, Joanna Schalnat[#]

Paper prepared for the IRG48 Scientific Conference on Wood Protection
Ghent, Belgium
4-8 June 2017

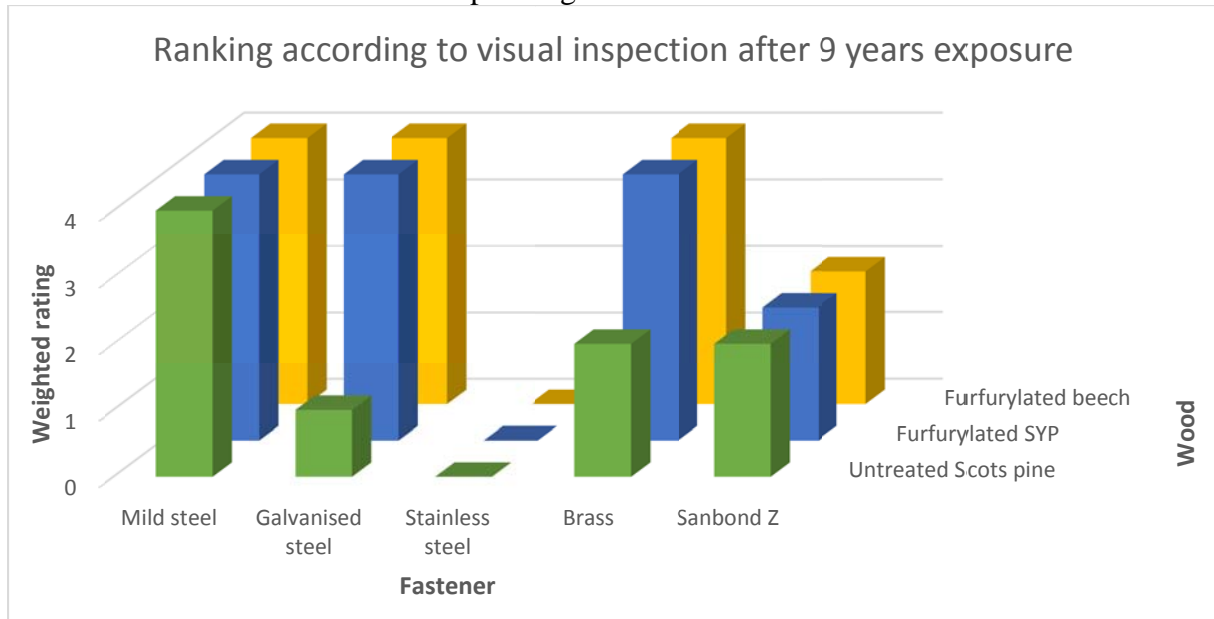
Figure 3. Results of visual inspection and rating of the corrosion of different fasteners in furfurylated and untreated wood after 9 years of exposure before pickling.

When comparing the visual assessment (Figure 3) against the calculated metal loss (Figure 4), it appeared that the actual corrosion in the untreated material for all materials but galvanised steel and stainless steel (no corrosion at all) was somewhat over-estimated. The corrosion of galvanised steel and brass in the two furfurylated materials was also over-estimated.

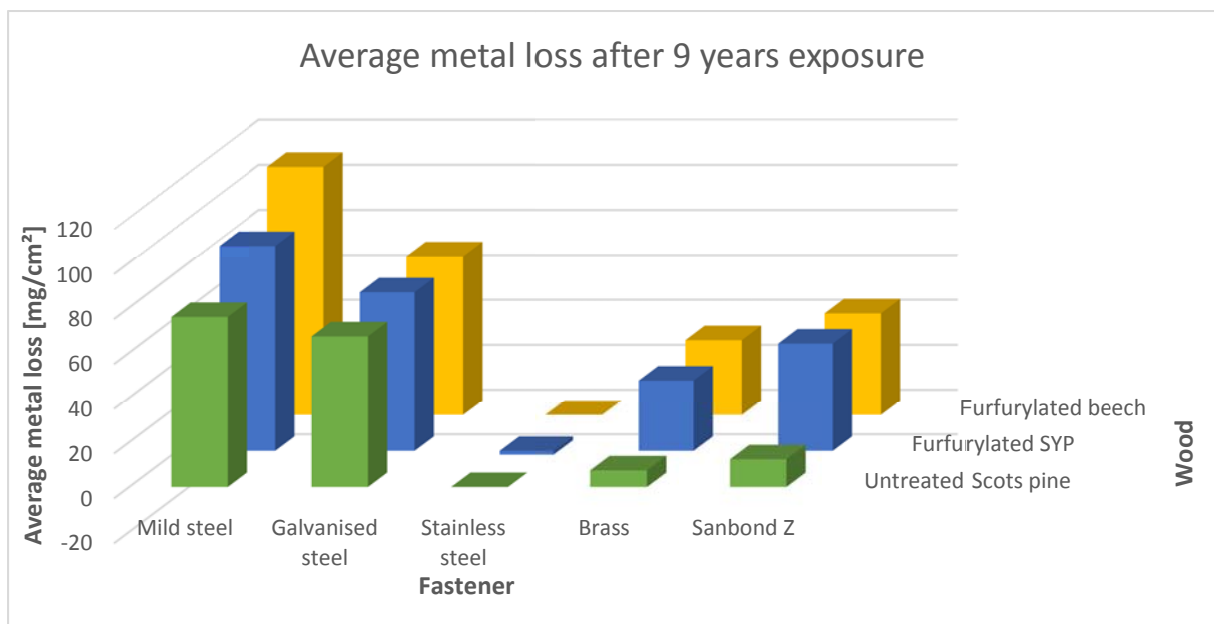
Figure 4. Average metal loss in mg/cm² after 9 years for the different fasteners tested in furfurylated and untreated wood after pickling.

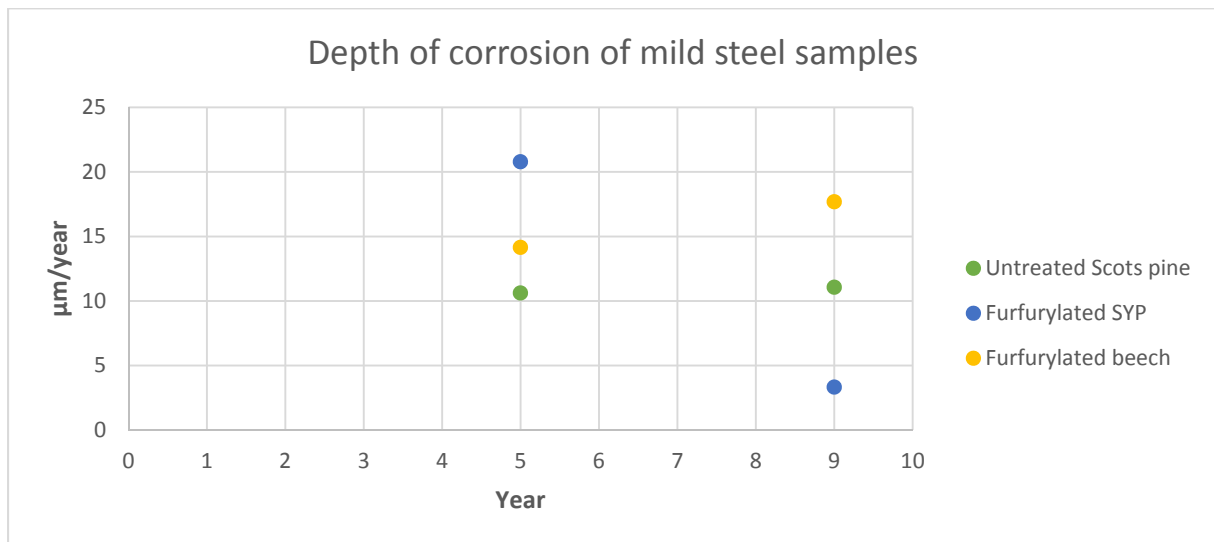
The corrosion of the mild steel nails was greater than the corrosion of the other materials in the test. Furfurylated beech showed the greatest corrosion rate. The corrosion rate expressed as $\mu\text{m}/\text{year}$ decreased over time for furfurylated SYP, increased somewhat for furfurylated beech and was constant for the untreated material, as can be seen in Figure 6.

Figure 6. Depth of corrosion in $\mu\text{m}/\text{year}$ in the first five years of exposure and the following four years.

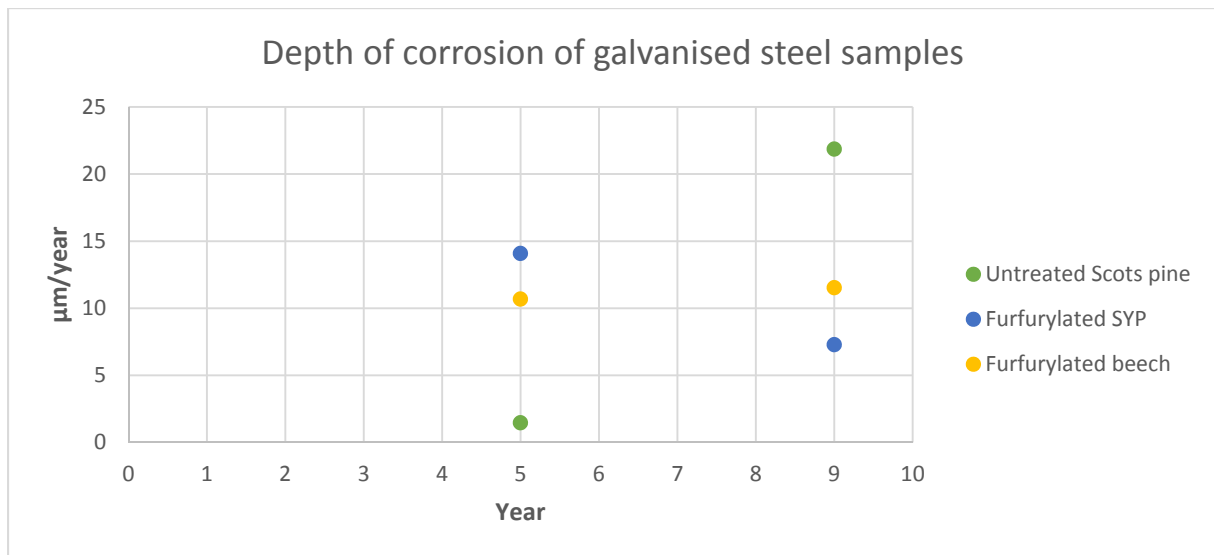
The original coating thickness for the hot-dip galvanised nails was just below 100 μm . Approximately 80 % zinc remained on the samples of the untreated Scots pine, whilst approximately 40 % zinc remained on the other samples. Some basic metal corrosion may have occurred on fastenings of the furfurylated samples. As was found with mild steel, the corrosion rate decreased over time for furfurylated SYP. For furfurylated beech it was nearly constant, but for the untreated wood there was a remarkable increase during the last 4 years, see Figure 8.

Figure 8. Depth of corrosion in $\mu\text{m}/\text{year}$ in the first five years of exposure and the following four years.
