MASH Test Nos. 3-11 and 3-10 on a Non-Proprietary Cable Median Barrier

*Midwest States Pooled Fund Research Program
Fiscal Years 2014 (Years 24)
Research Project Number TPF-5(193) Supplement #64
NDOR Sponsoring Agency Code RFPF-14-CABLE-1*

MASH TEST NOS. 3-11 AND 3-10 ON A NON-PROPRIETARY CABLE MEDIAN BARRIER

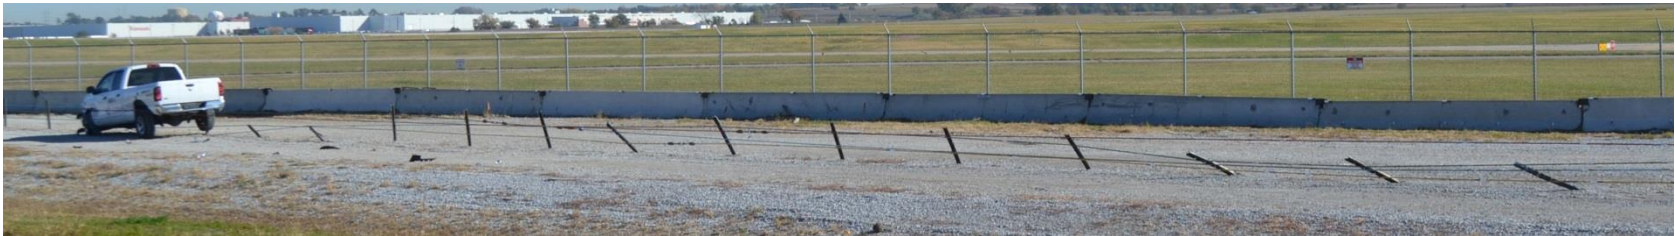
Figure 49. System Damage, Test No. MWP-4

Damage to the barrier was moderate, as shown in Figures 49 through 59. Barrier damage consisted of bent posts, disengaged cables, and deformed brackets. At its final resting position, the vehicle was still in contact with the cables. Cable nos. 1 and 2 were beneath the vehicle, cable no. 4 was on the impact side of the vehicle, and cable no. 3 was on the non-impact side of the vehicle.

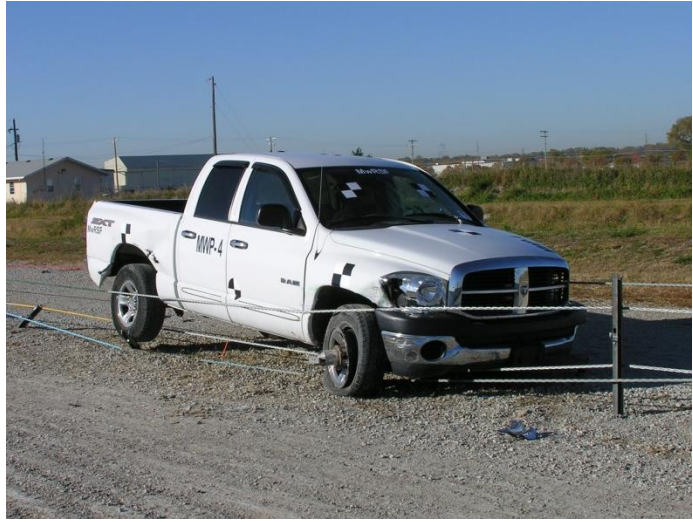
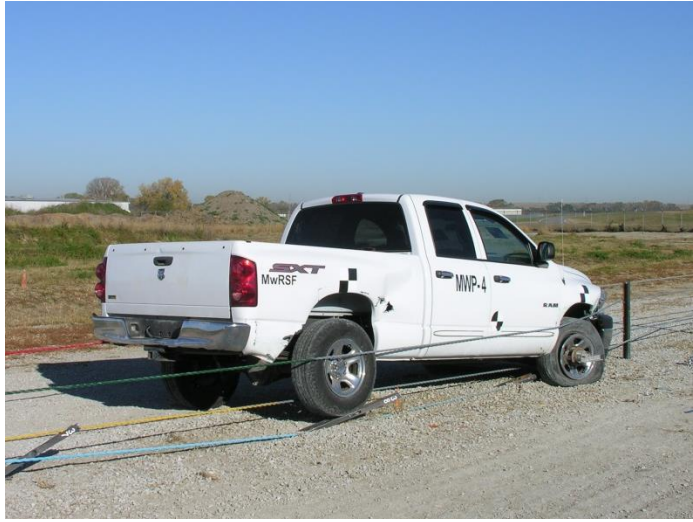
Figure 60. Vehicle Damage, Test No. MWP-4

The damage to the vehicle was moderate, as shown in Figures 60 and 61. The maximum occupant compartment deformations are listed in Table 6 along with the deformation limits established in MASH for various areas of the occupant compartment. Note that none of the MASH-established deformation limits were violated. Complete occupant compartment and vehicle deformations as well as the corresponding locations are provided in Appendix D.

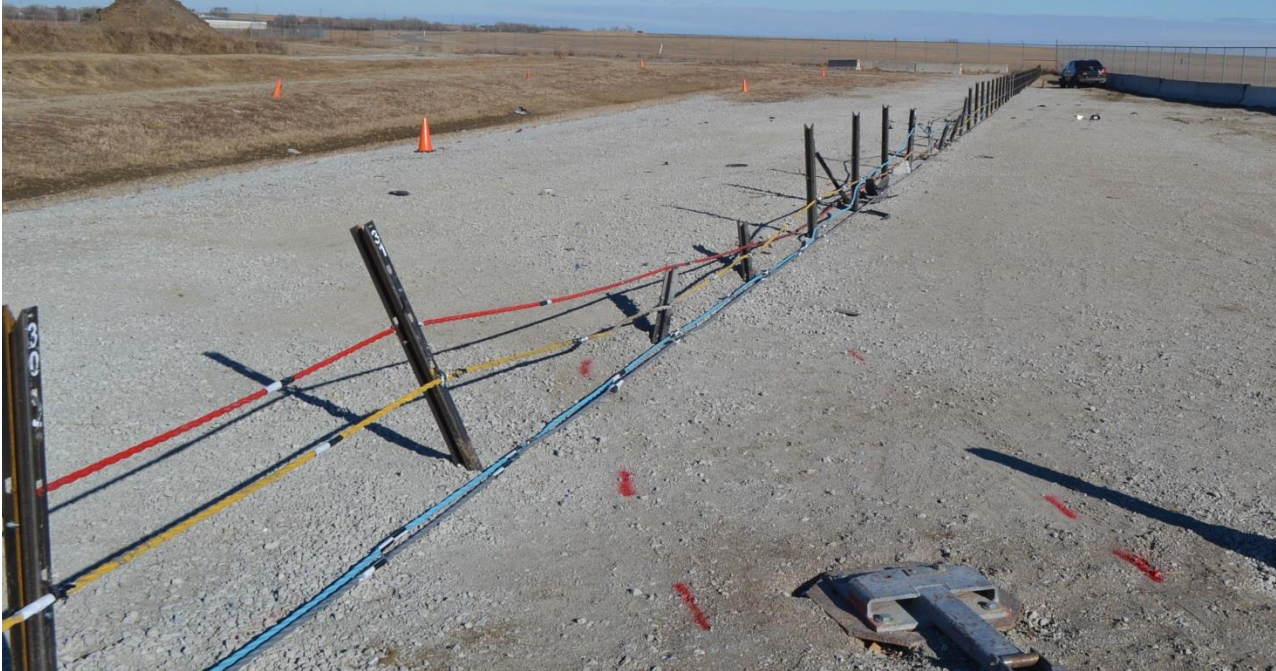
Figure 95. Vehicle Final Position and Trajectory Marks, Test No. MWP-6

Initial vehicle impact was to occur at a midspan location, or 4 ft (1.2 m) upstream from post no. 32, as shown in Figure 94, which was selected according to MASH guidelines. The actual point of impact was approximately 4.5 in. (114 mm) upstream from the target impact point. A sequential description of the impact events is contained in Table 10. The vehicle came to rest 234 ft - 6 in. (71.5 m) downstream from the point of impact. The vehicle trajectory and final position are shown in Figures 90 and 95.

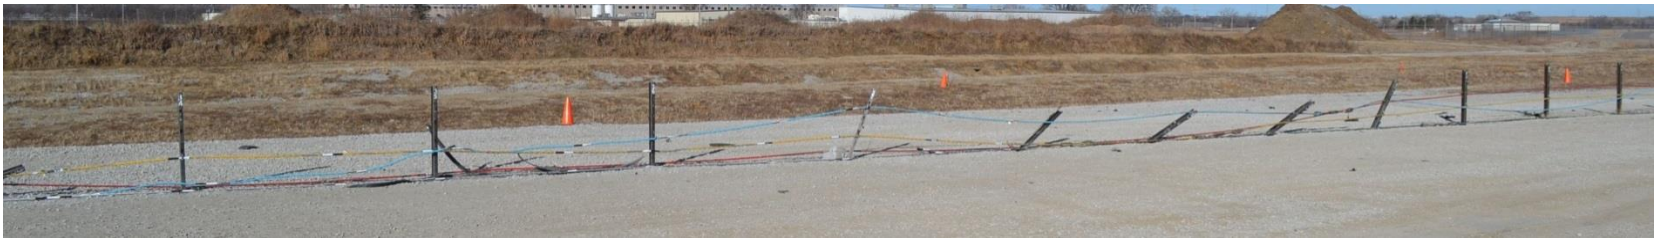
Figure 96. System Damage, Test No. MWP-6

Damage to the barrier was moderate, as shown in Figures 96 through 104. Barrier damage consisted of bent posts, disengaged cables, and bent and fractured brackets. At its final resting position, the vehicle was no longer in contact with the system.

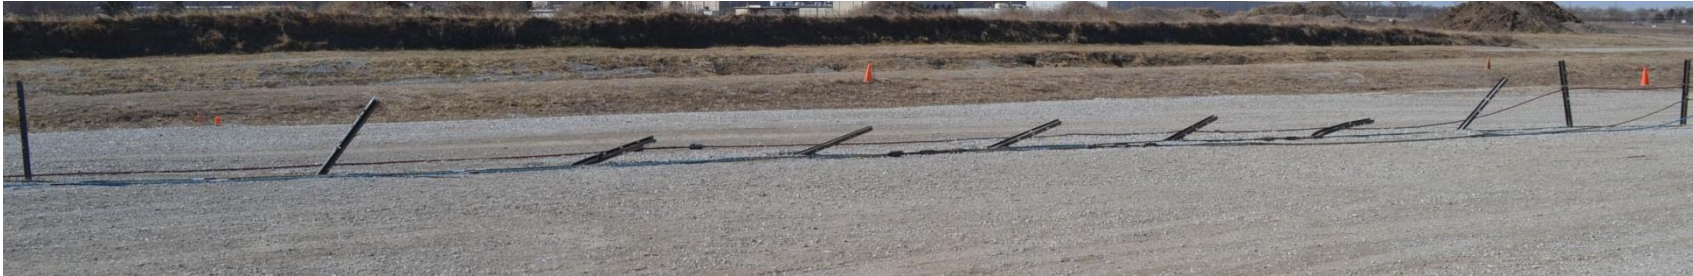
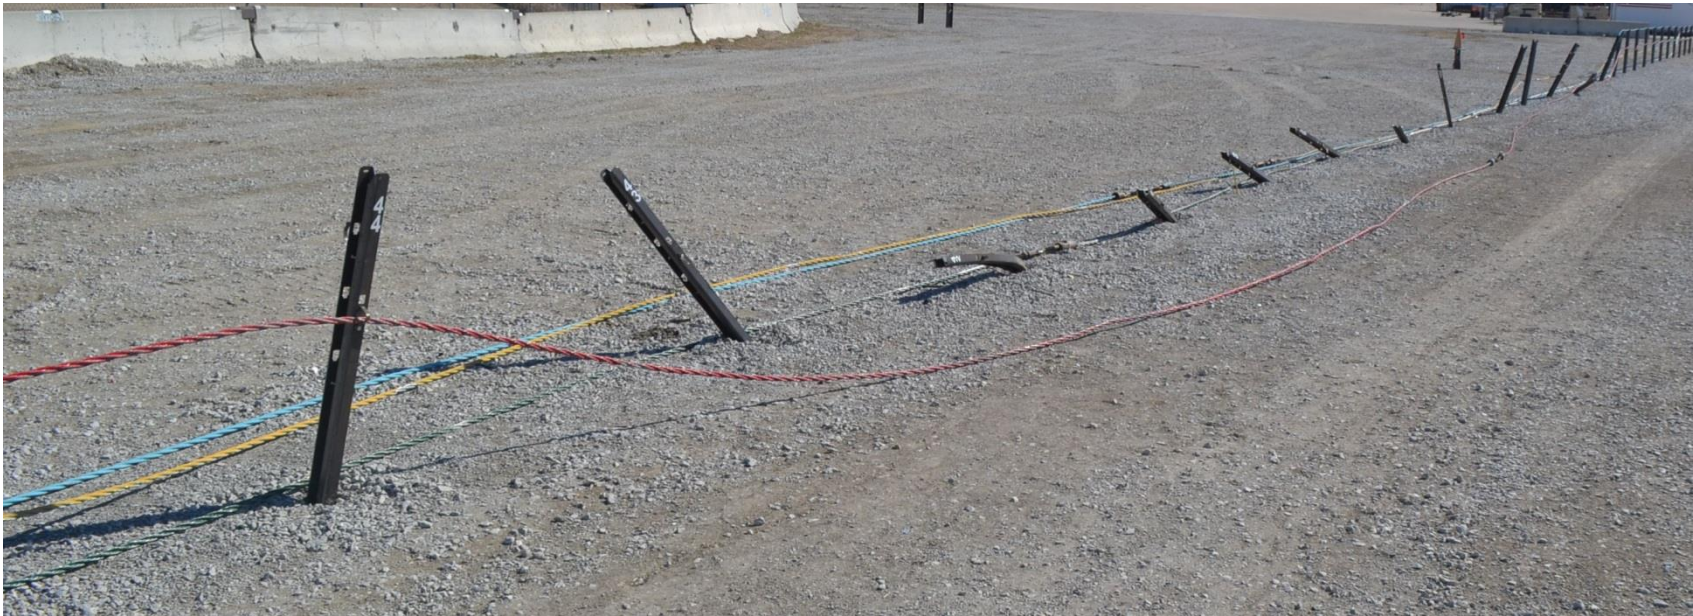
Figure 148. System Damage, Test No. MWP-7

Damage to the barrier was moderate, as shown in Figures 148 through 158. Barrier damage consisted of bent posts, disengaged cables, and bent and fractured brackets. At its final resting position, the vehicle was still in contact with the cables. Cable no. 3 was beneath the vehicle, cable no. 2 was on the impact side of the vehicle, and cable nos. 1 and 4 were on the non-impacting side of the vehicle.
