ASIA TURBOMACHINERY & PUMP SYMPOSIUM
SINGAPORE | 22 - 25 FEBRUARY 2016
M A R I N A B A Y S A N D S

Repair of Severely Damaged Rotor as an Emergency Spare

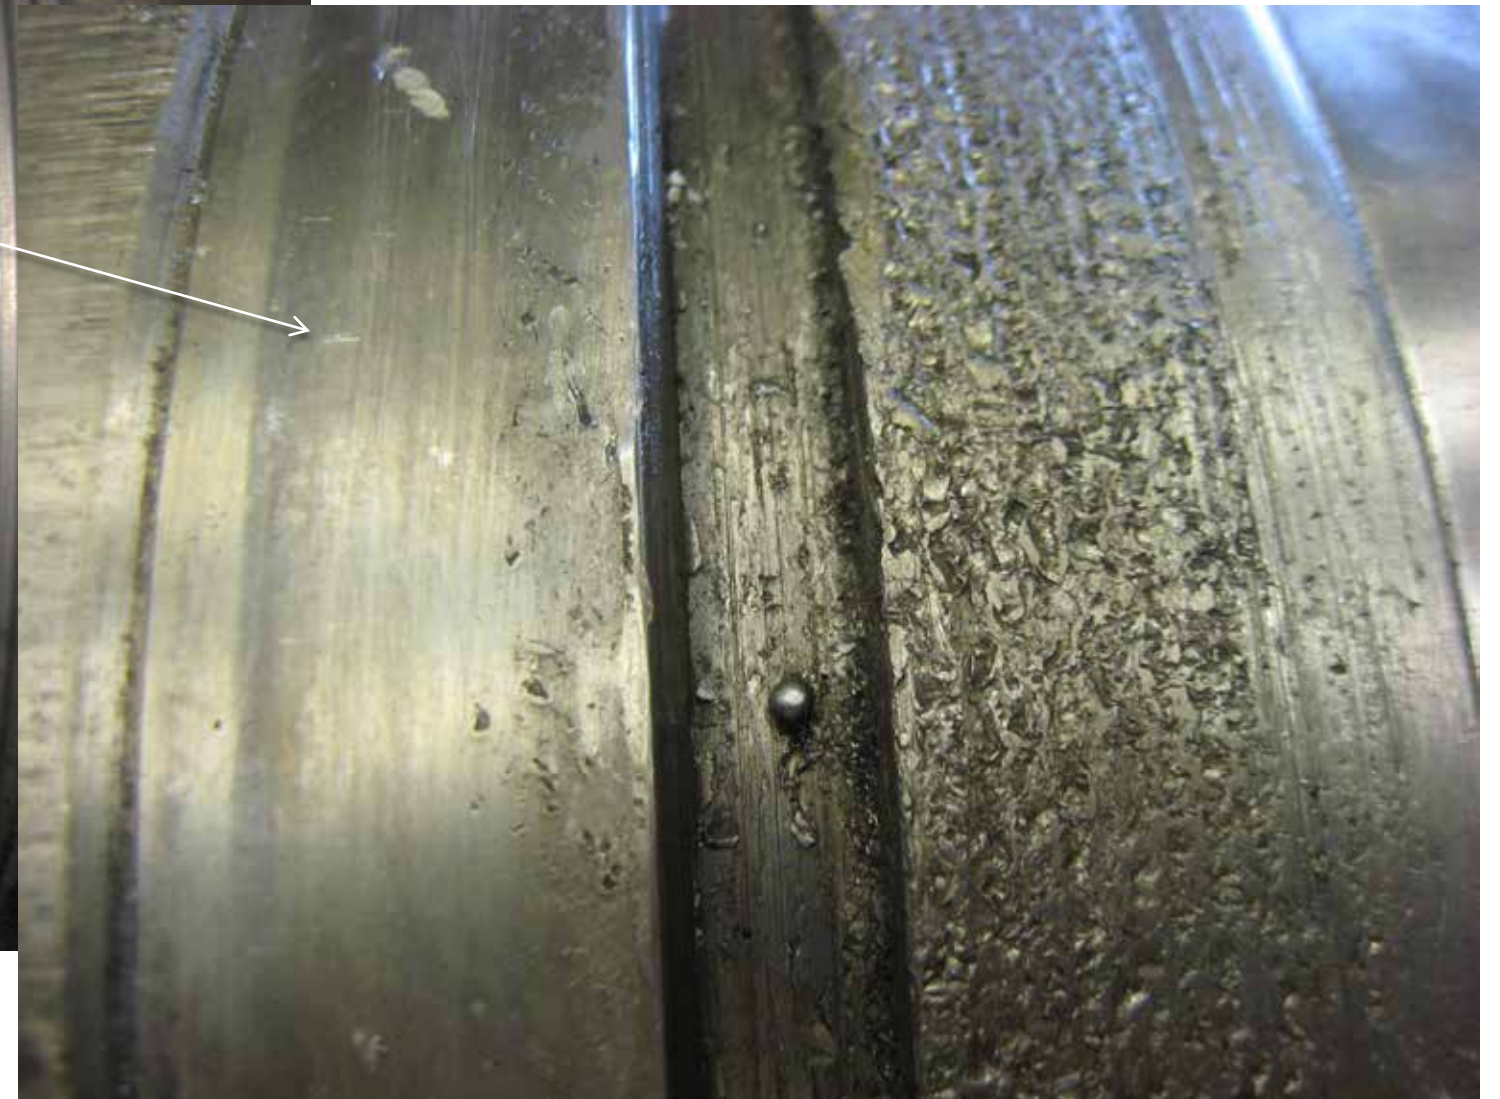
New Problem

- It was noticed that the first stage impeller had cracks in three blades
 - A large piece was missing from one of the cracks
 - There was a step change in the vibration early in the run, but no obvious indication that there was a problem
-
- As a result, the spare rotor was installed and the compressor restarted

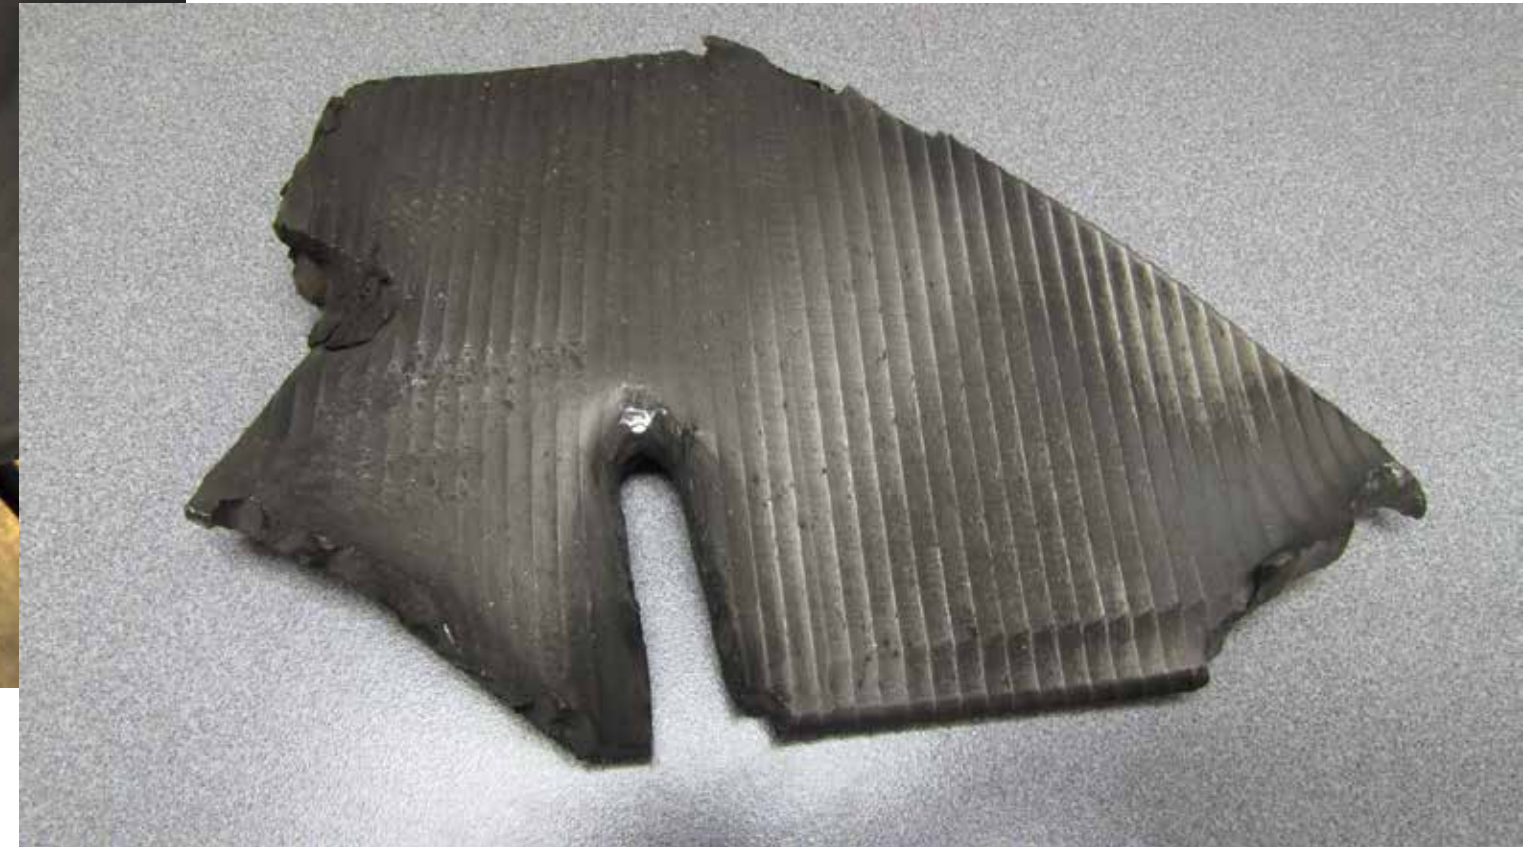
- A liberated piece struck the adjacent blade, initiating a crack
- There was much more of the piece missing than found

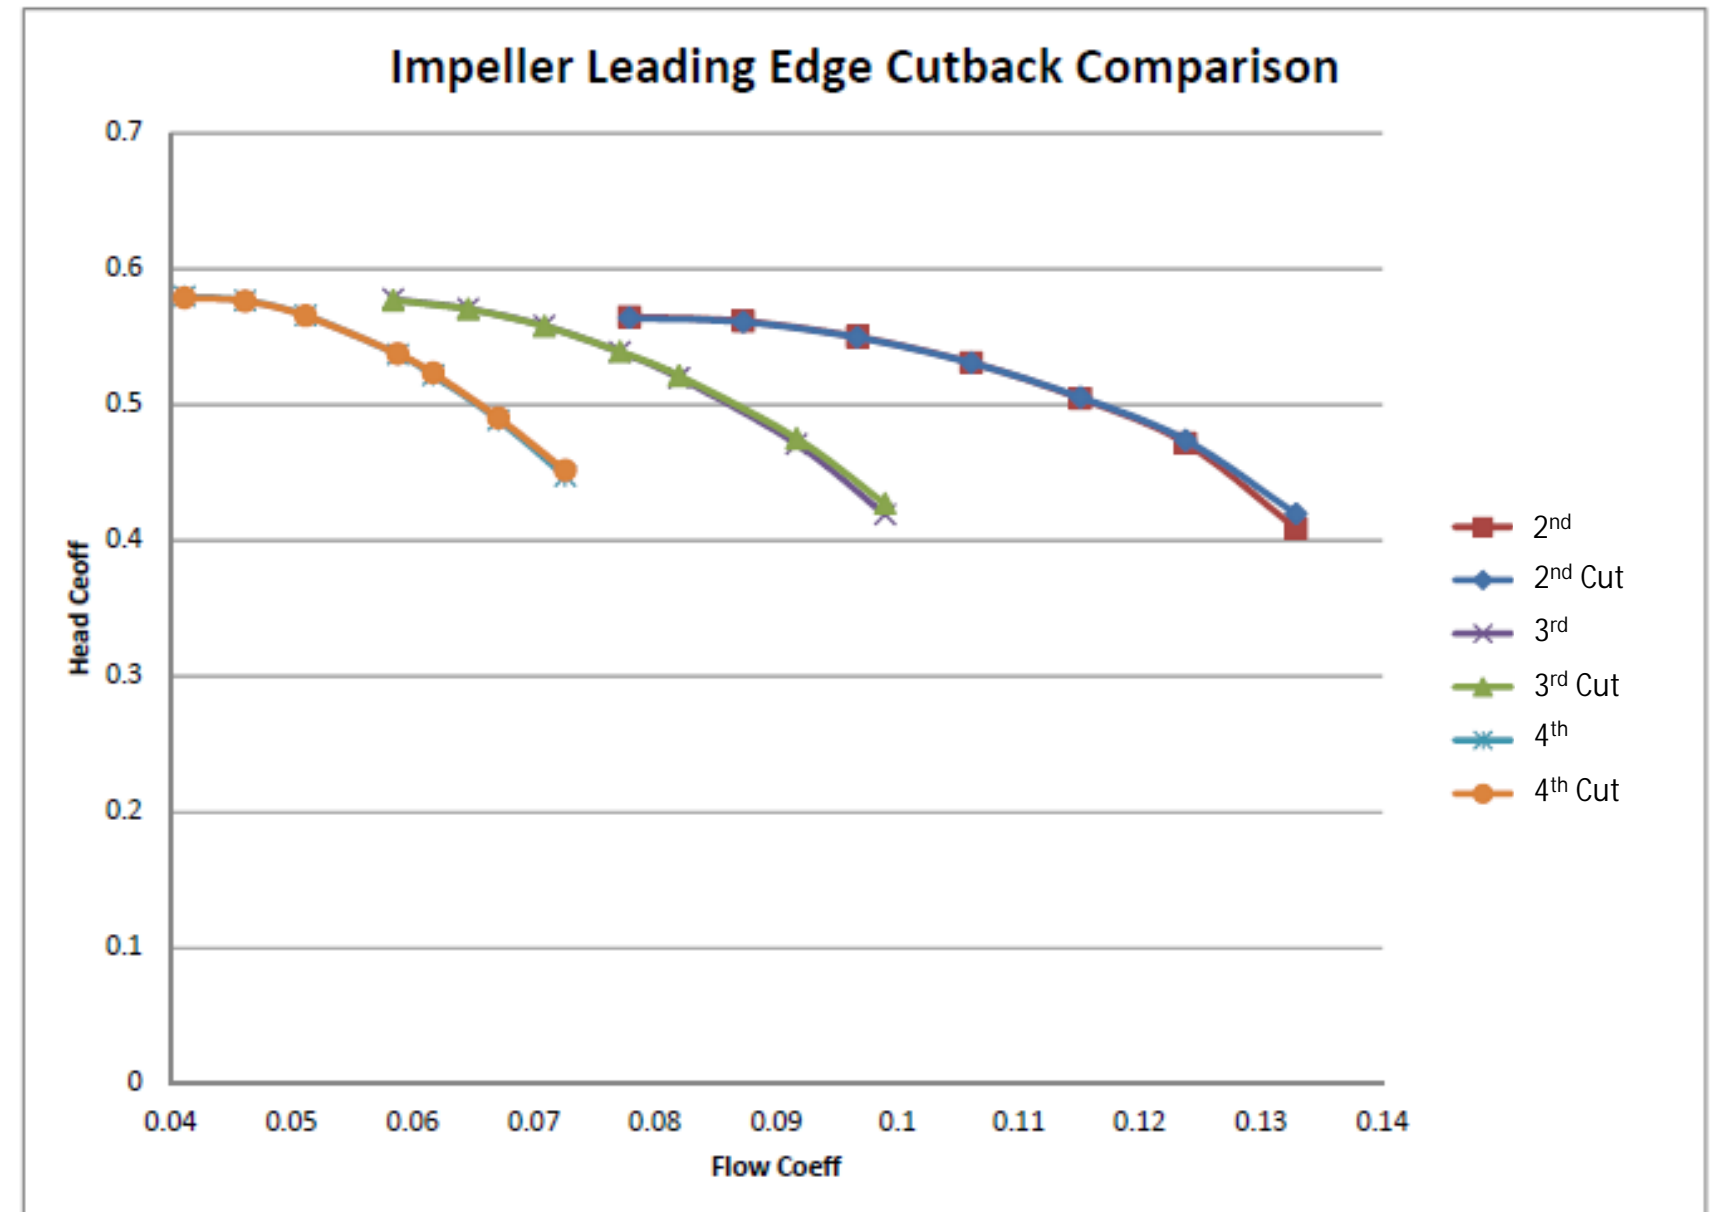
- Decided that the fastest, easiest, and most effective method to remove the damage is to machine back the leading edge of every blade by 6.35mm (0.25") and hand radiusing the new leading edge
- Structural and Aero impacts are minimal

Speed Held Constant	
	%diff
Pressure	0.31%
Head	0.22%
Power	0.34%

Discharge Pressure Held Constant	
	%diff
Speed	-0.06%
