# Emergency Damage Restoration Experience of 25MW Heavy-Duty Gas Turbine: Bearing Retrofit Design and Test Run

An Sung Lee, Byung Ok Kim, and Kyung Ho Sun  
Korea Institute of Machinery and Materials (KIMM)  
Daejeon, South Korea

Byeong Kyu Park, and Young-Soon Bae  
LG Chem, Ltd., Yeosu, South Korea

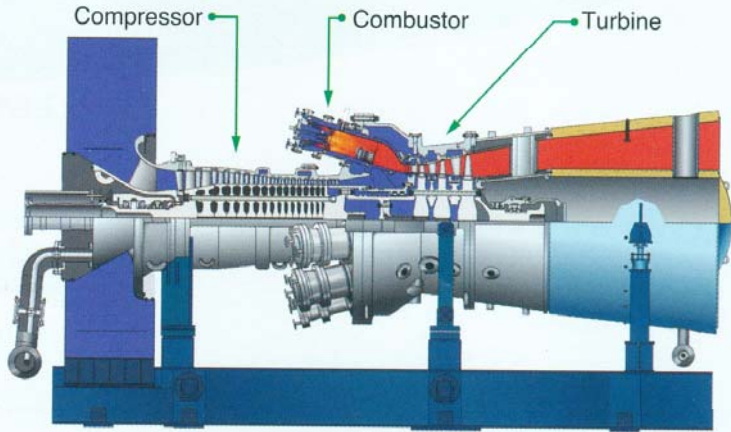
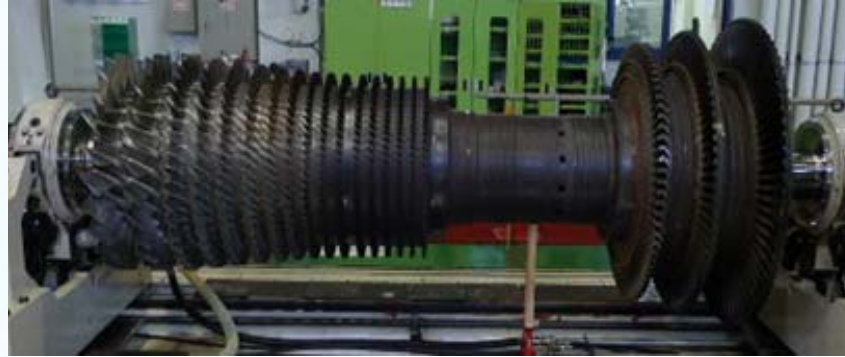
- H25 GT: 25 MW (1st unit ever exported overseas out-of Japan)
- Rated speed: 7,280 rpm

- Due to the loss of lubrication oil supply, the GT suffered extensive damages, particularly, at its bearings and journals.

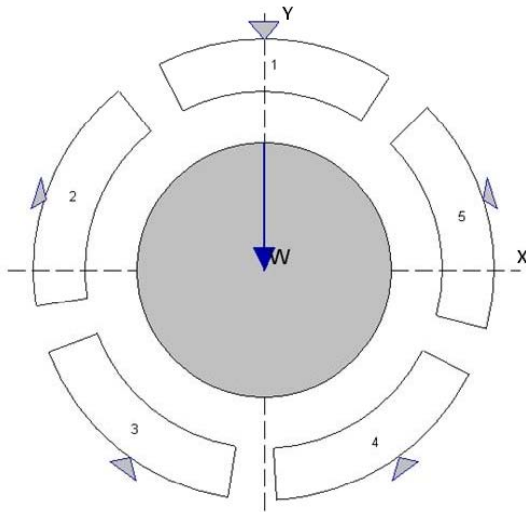
5-Pad LBP Geometry

Compressor Side	Turbine Side
Bearing Type	Tilting pad, LBP	Tilting pad, LBP
Number of Pads	5	5
Journal Dia. (mm)	184	184
Bearing Length (mm)	90	110
Bearing Diametral Clearance (mm)	0.290	0.290
Bearing Load (N)	28545	32586
Rated Speed (rpm)	7280	
Lubricant	ISO VG32	
Supply Oil Temp. (°C)	52	52
Oil Flow Rate (l/m)	78	85

- Consider 3 bearings retrofit design analysis cases, depending on the journal diameter reductions (%):**
  - 0% less,
  - 2% less,
  - 5% less

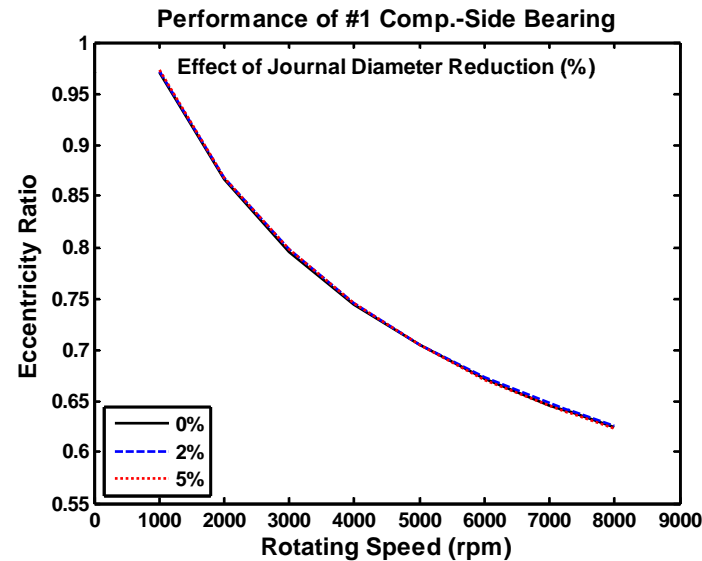
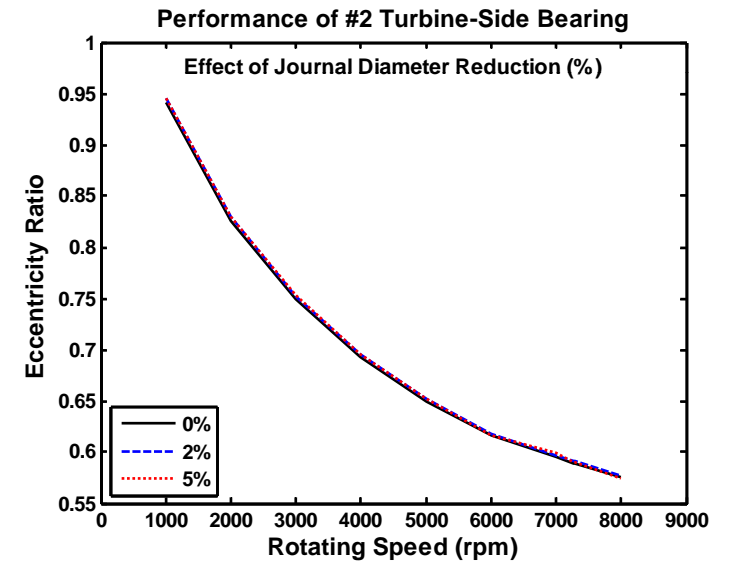
Eccentricity Ratio Analysis

- Regardless of the journal diameter reduction rates (%), the eccentricity ratios are analyzed as almost identical to the original ones for the compressor and turbine-side bearings, respectively.
- Therefore, it is confirmed that the bearing design control variables have been selected satisfactorily.

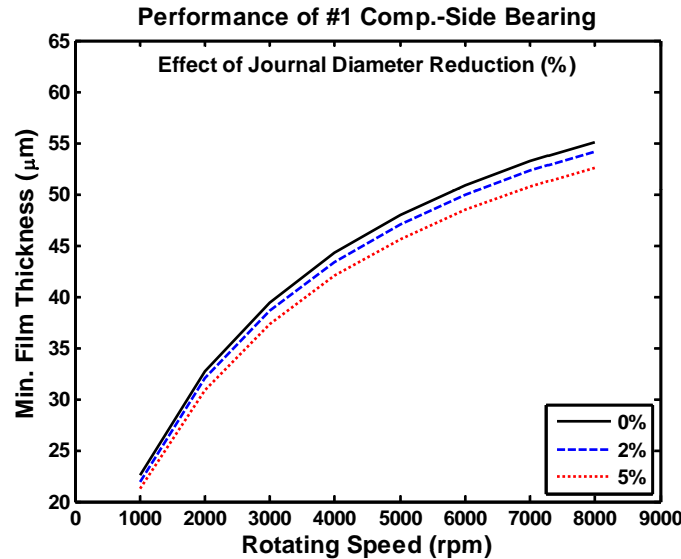
Minimum Film Thickness Analysis

- As the journal diameters decrease 2%, the starting lift-off speeds increase 1 ~ 2 rpm. **No detrimental effect on pad babbitt wear at starting is expected.**
- At the rated speed the minimum film thickness of compressor-side bearing decreases about 1 µm from 53.75 to 52.80 µm.
- The power loss of compressor-side bearing improves about 3.5% from 21,659 to 20,910 W.

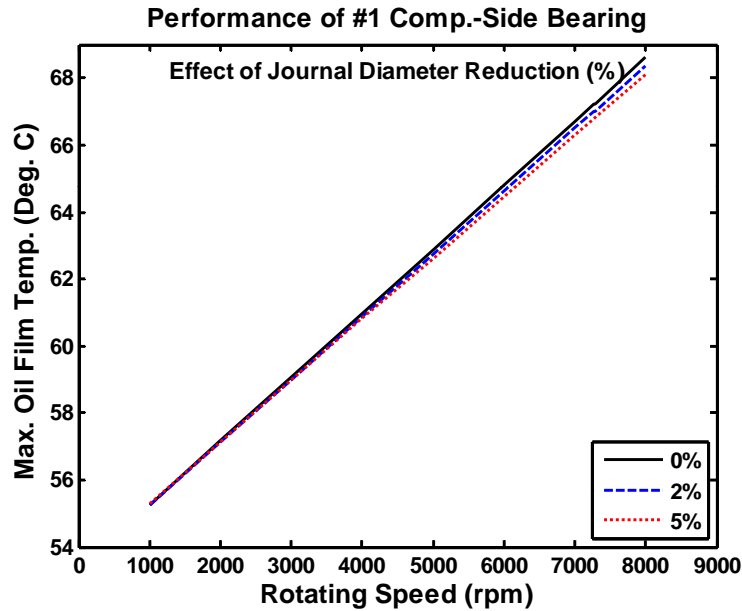
Maximum Oil Film Temperature Analysis

- As the journal diameter decreases 2%, at the rated speed the max. oil film temperature of compressor-side bearing decreases 0.2°C from 67.2 to 67.0°C.
- The outlet oil temperature of compressor-side bearing decreases 0.4°C from 61.4 to 61.0°C.

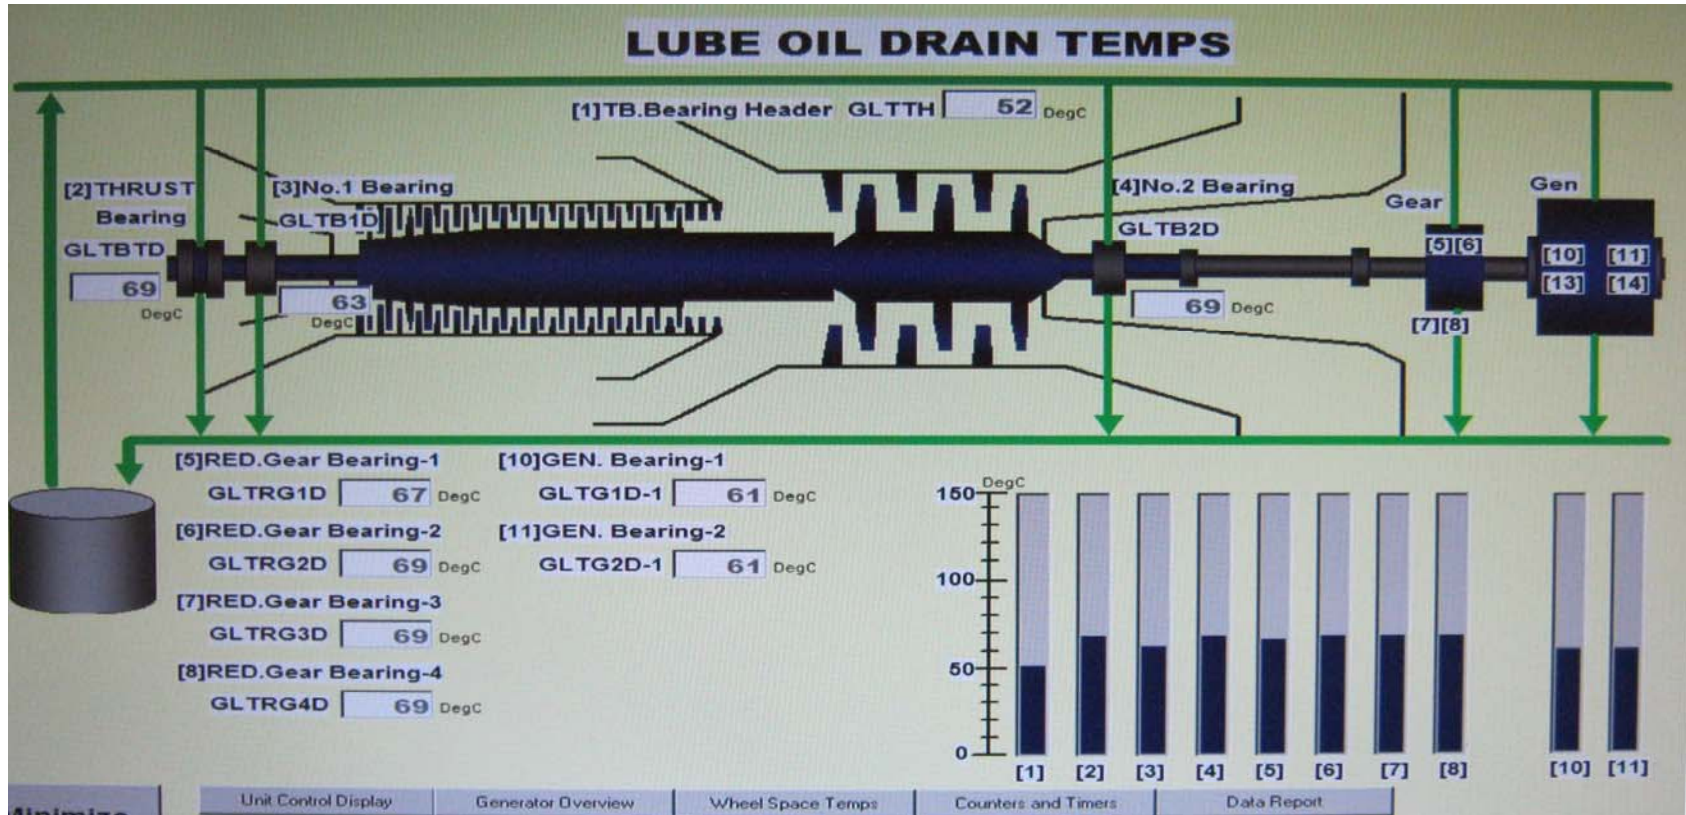
## Past Measured Outlet Oil Temp. For #2 GTG During Normal Operation (Verification Reference)

- With a supply oil temp. of 52.0°C, the outlet oil temps. of compressor and turbine-side bearings were 63°C and 69°C, respectively.
- Considering a heat transfer effect from the rotor shaft, the 63°C measured at the compressor-side bearing agrees very well with the 61.4°C predicted by the analysis.

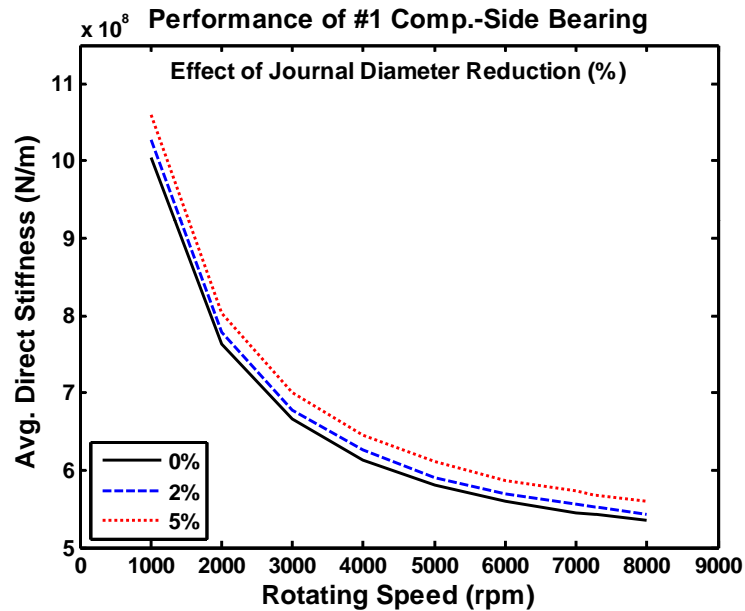
**Bearing Stiffness Analysis**

- As the journal diameter decreases 2%, at the rated speed the average direct stiffness of compressor-side bearing increases about 1.84% from  $5.421 \times 10^8$  N/m to  $5.521 \times 10^8$  N/m.
- The average direct damping of compressor-side bearing increases about 2.03% from  $5.415 \times 10^5$  N-s/m to  $5.525 \times 10^5$  N-s/m.
- Therefore, not much differences are expected, concerning the bearing stiffness and damping.
