# Case Studies in Construction Materials

# A study on the cement-based decorative materials in the San Fedele Church in Milan

Cement-based materials have been used since the 19th century for different decorative purposes, and a high levels of expertise has often reached in reproducing or restoring even quite elaborated stoneworks. An important example is the application of cement-based decorative materials on the façades of the San Fedele church in Milan. The church, built in the 16th century and characterized by the presence of pinkish-yellowish Angera stone on the façades, was subjected, especially in the 20th century, to several restoration works. Damaged decorative elements of the façades as well as portions of its structural elements were replaced or covered in the last century by “stone imitating render”, made with cementitious materials which imitate the original Angera stone. In this study, several samples of cement-based decorative materials, collected from different elements of the external façades of the Church, were characterized by several analytic techniques (thermogravimetric analysis, X-ray diffraction, scanning electron microscopy and IR analysis), in order to in

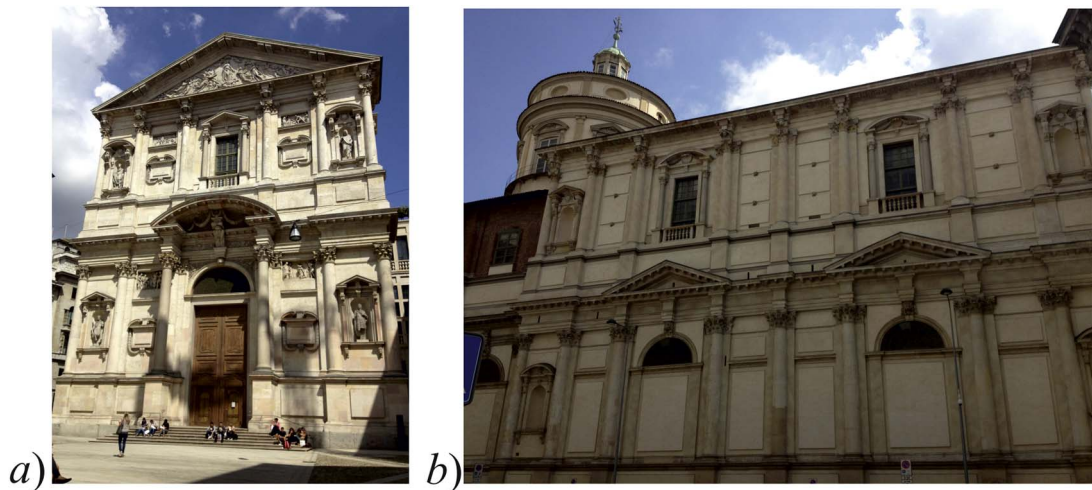
Fig. 1. Main (a) and left (b) façade (b) of San Fedele Church.

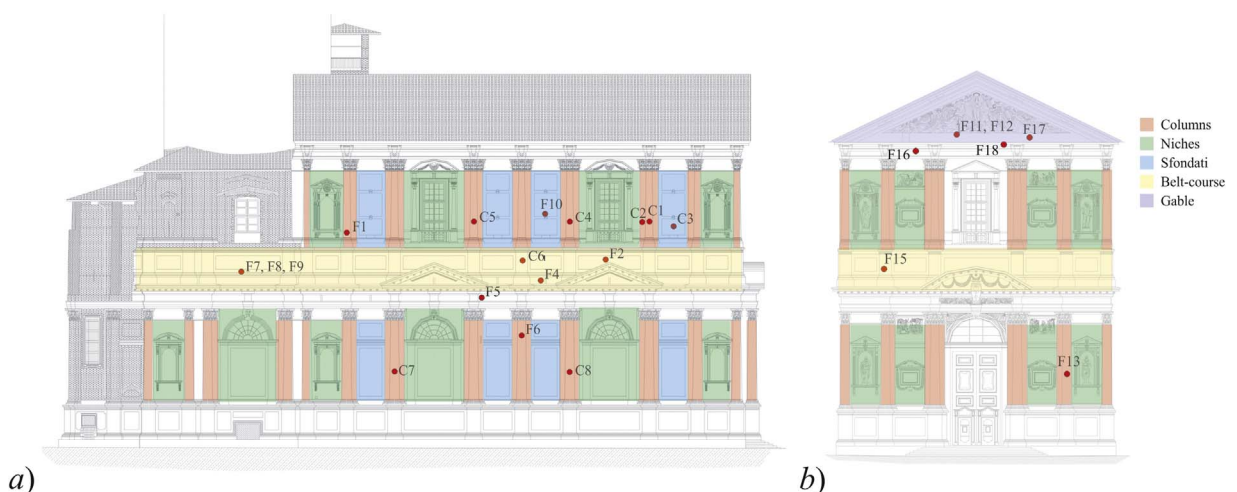
Fig. 2. Indication of the main elements and sampling: left side (a) and main façade (b) of San Fedele Church.

To characterize the different types of materials and evaluate their state of conservation a sampling was carried out. Fragments were taken manually, especially in those areas where materials appeared to be damaged, while other samples were cored to define the different layers of materials. Fig. 2 shows the position of the specimens: letter *F* identifies the fragments taken manually and letter *C* identifies the cores. On the left side, 10 fragments and 8 cores were taken (Fig. 2a), whilst on the main façade 7 fragments (Fig. 2b). Finally, for comparison also a sample of Angera stone was collected (*F3*); this sample was already detached from the substrate and hence the exact location is unknown.
