44TH TURBOMACHINERY & 31ST PUMP SYMPOSIA
HOUSTON, TEXAS | SEPTEMBER 14 – 17 2015
GEORGE R. BROWN CONVENTION CENTER

Analysis and On-Stream Countermeasures of High Thrust Bearing Temperature of Centrifugal Compressor

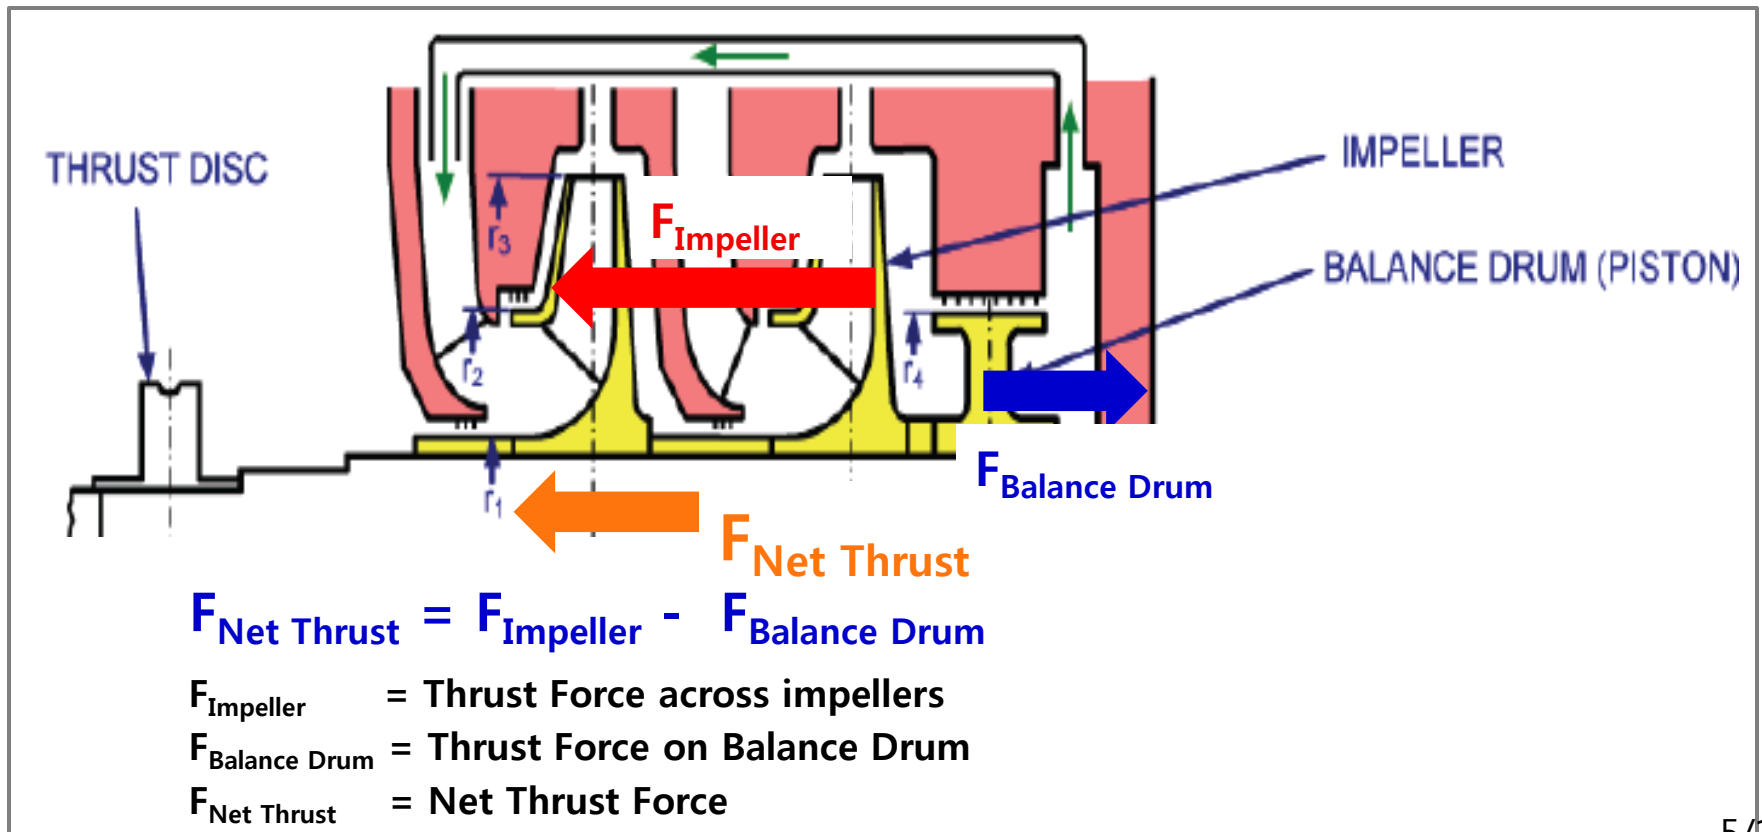
Excessive differential pressure and insufficient balance force could cause an increase of thrust force that could affect adversely bearing temperature.

① (F_{Impeller}) Excessive
Differential Pressure

② ($F_{\text{Balance Force}}$) Insufficient
Balance Force

Excessive
Thrust Load

Thrust Bearing
Temperature Increase

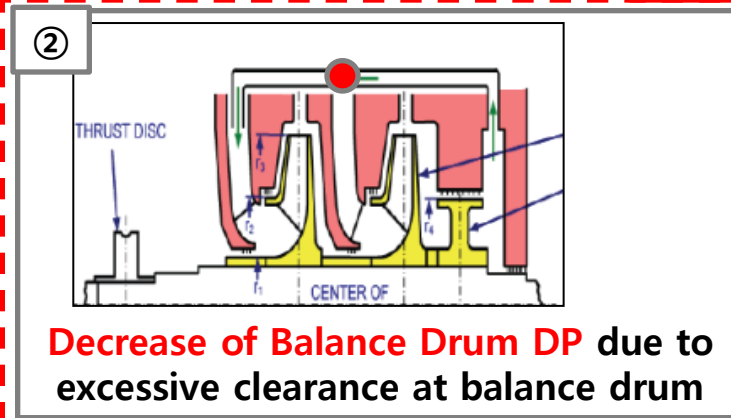
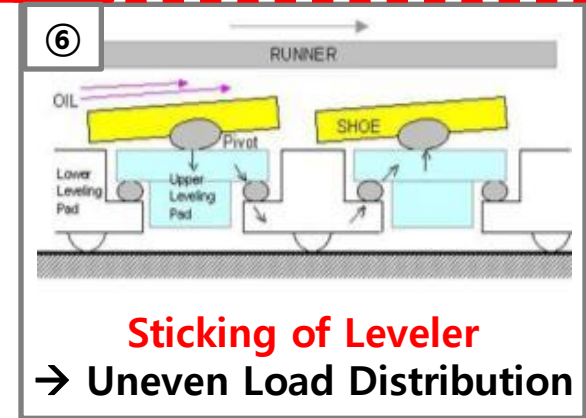
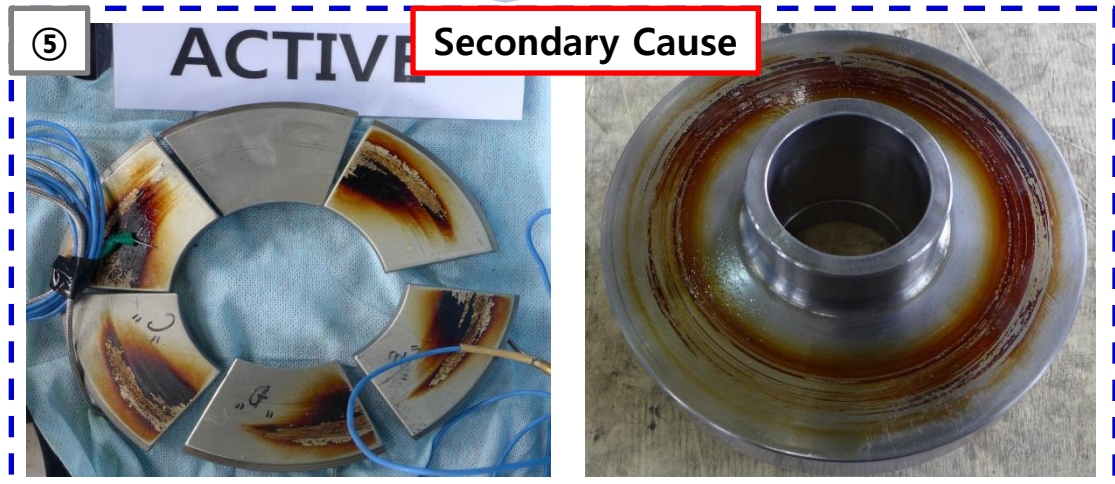
Primary Causes

High initial bearing temperature accelerate **Varnish Formation** and has a negative influence on bearing temperature increase

Possible Causes	Solution Provided	Aspect
④ High Temperature of Lube Oil Supply	▪ Adjust Oil Supply Temperature & Pressure	Operation
① Insufficient Balance Force	▪ Balance Drum Pressure Decrease ▪ Replace Balance Drum Labyrinth	Maintenance
⑤ Varnish on bearing Pad	▪ Install Varnish Purifier to improve the oil quality and remove varnish	Operation
⑥ Thrust bearing leveling plate malfunction	▪ Thrust Bearing Up-grade - Rounded Leveling Plate - Cu-Cr Back Metal	Design
