**43<sup>rd</sup> Turbomachinery & 30<sup>th</sup> Pump Users Symposia (Pump & Turbo 2014)**  
**September 23-25, 2014 | Houston, TX | [pumpturbo.tamu.edu](http://pumpturbo.tamu.edu)**

**REPETITIVE SHAFT CRACK FAILURE ANALYSIS  
 ON A MULTISTAGE CENTRIFUGAL PUMP IN REACTOR CHARGE SERVICE  
 IN A NUCLEAR POWER PLANT - BASED ON ODS AND FEA**

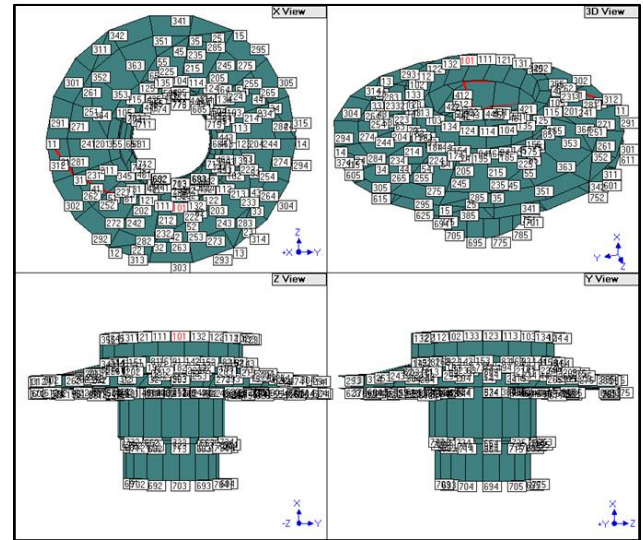
Figure 8. Computer Model of the Impeller. Each Label Represents a Measurement Location

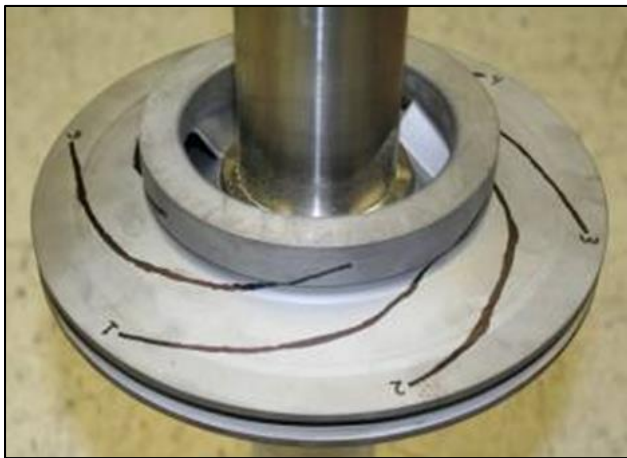
Figure 6. 11<sup>th</sup> Stage Impeller Mounted on a Mandrel

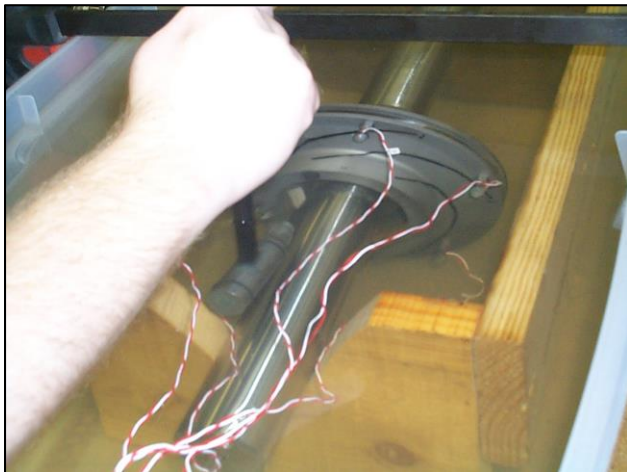
Figure 7. Experimental Modal Analysis Test of the 11<sup>th</sup> Stage Impeller Wet Conditions

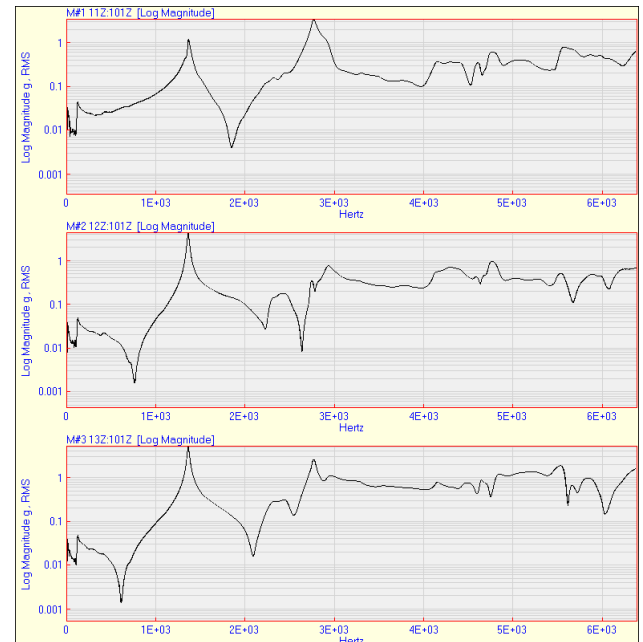
Figure 9. Typical Frequency Response Function (FRF) Spectra Under Wet Conditions

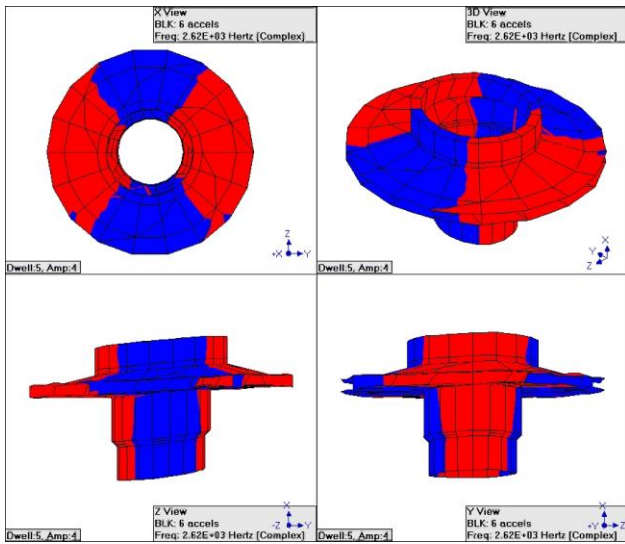
Based on this test, it was concluded that the construction of the impeller was robust enough that its natural frequencies or disk modes were well above potential excitation sources in regards to the number of rotating vanes (6 vanes) and diffuser vanes (8 vanes). In this case the main excitation shape would be at 2 Nodal-Diameter (2ND), which is the difference between the number of diffuser vanes and the impeller vanes.

Figure 10. Mode Shape at 2620 Hz (2ND Mode)

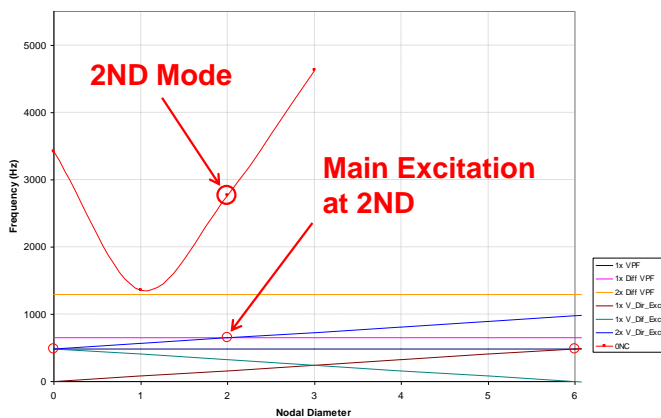
Figure 11. Interference Diagram under Dry Conditions

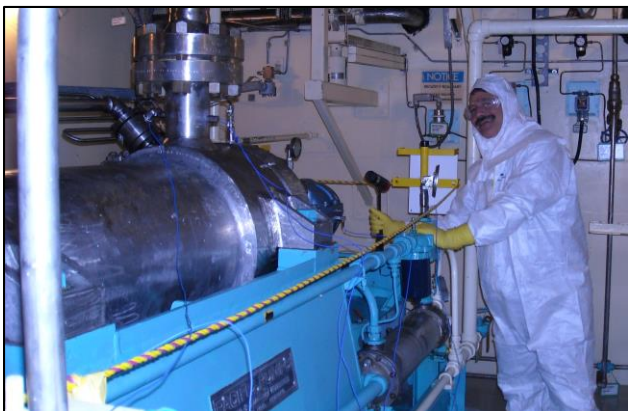
The outboard bearing (OBB) housing was impacted in the axial direction and the frequency response was recorded using an axial proximity probe installed in the same direction as shown in Figure 12.

Figure 12. EMA Test at the OBB in the Axial Direction Using a 3 lbm Hammer

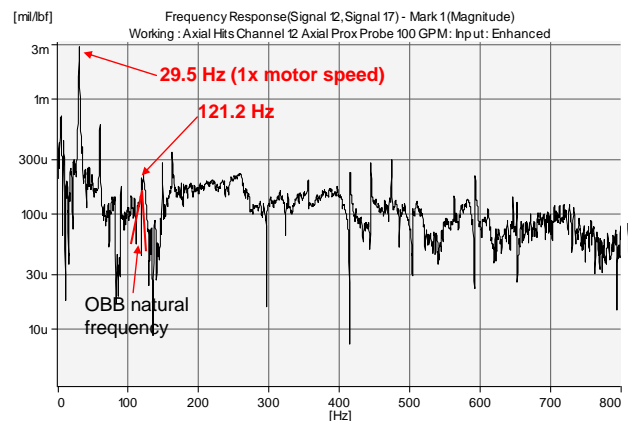
The Time Averaged Pulse (TAP™) technique was used to take into account the operating fluid film stiffness for the thrust bearing. This test was performed with the pump operating at 145 gpm (32.9 m<sup>3</sup>/h) to determine if there are any potentially relevant axial natural frequencies of the pump shaft. After several hundred impacts, the final FRF plot (Figure 13) did not indicate any natural frequency in the vicinity of the running speed of the pump (81 Hz). In contrary, a strong excitation at the motor running speed was observed (29.5 Hz). The only natural frequency identified was at approximately 121 Hz. However, this natural frequency is difficult to be excited. The 4x rpm of the motor is the closest harmonic and it is considered a weak excitation source, especially in the axial direction. The same test was performed while the pump was operating at 160 gpm (36.3 m<sup>3</sup>/h) of capacity indicating a similar frequency response.

Figure 13. 1B NV Pump EMA Test - FRF Plot from the Axial Proximity Probe at the OBB (mil/lbf versus Frequency in Hz)

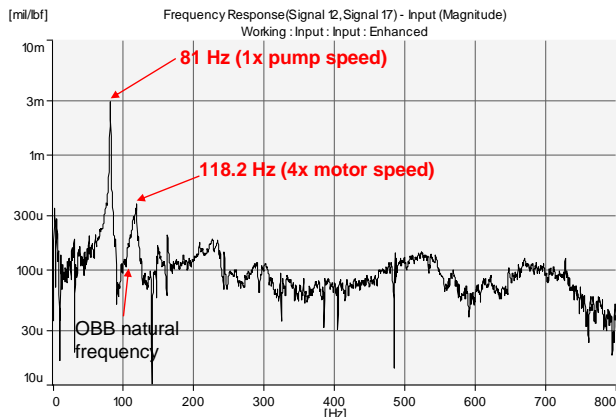
Modal impact testing performed on the counterpart pump from Unit 2 was conducted while it was operating at 160 gpm of capacity to determine if any potential axial natural frequencies of the shaft could be detected by reading the frequency response from the permanently installed axial proximity probe. After several hundred impacts, the final FRF plot, shown in Figure 14, did not indicate any natural frequency in the vicinity of the running speed of the pump. In this particular pump, the strongest excitation was detected at the running speed of the pump, which was expected. The motor speed excitation was not present. In addition, the same structural natural frequency was detected at 118 Hz. Similarly, this mode can be excited by the 4<sup>th</sup> harmonic of the motor running speed, which was considered weak and unlikely.

Figure 14. 2B NV Pump EMA Test - FRF Plot from the Axial Proximity Probe at the OBB (mil/lbf versus Frequency in Hz)

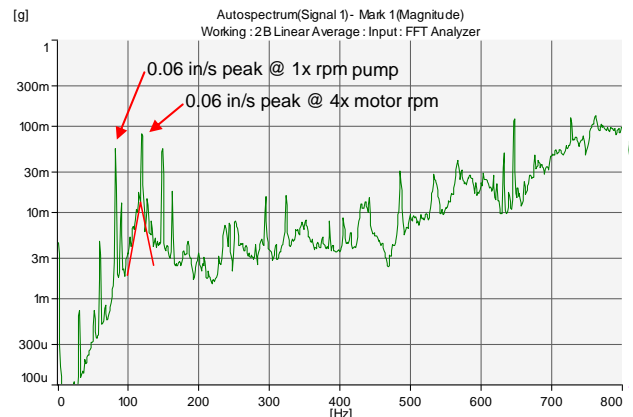
In contrast to the 1B NV pump, vibration readings taken from the 2B NV pump indicated different behavior from a dynamic stand point. This pump was tested only at 160 gpm (100 gpm [22.7 m<sup>3</sup>/h] + 60 gpm min-flow [13.6 m<sup>3</sup>/h]). The maximum discrete vibration at steady-state conditions at the running speed frequency was measured at the OB bearing housing in the same vertical direction (0.06 in/s or 0.15 mm/s) pk, which was considered low (Figure 16). A similar natural frequency was observed near 120 Hz.

Figure 16. 2B NV Pump Vibration Spectrum at the OBB in the Vertical Direction (g's versus Frequency in Hz)

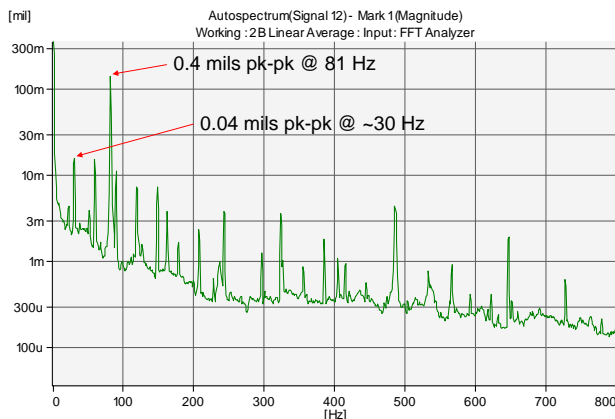
Vibration reading from the axial proximity probe installed at the OBB of the 2B NV pump indicated 12 times smaller amplitude (0.04 mils or 1.0 micron) pk-pk at approximately 30 Hz, when compared with the 1B NV pump. The highest amplitude was measured to be only 0.4 mils (10.2 micron) pk-pk at the running speed of the pump, which was expected, but mostly due to axial run-out of the target surface. Figures 19 and 20 depict the FFT and the time waveform plots from this axial probe, respectively, indicating the amplitude and the frequency of this axial motion of the 2B NV pump shaft.

Figure 19. 2B NV Pump Axial Proximity Probe Vibration Spectrum (mils rms versus Frequency in Hz)

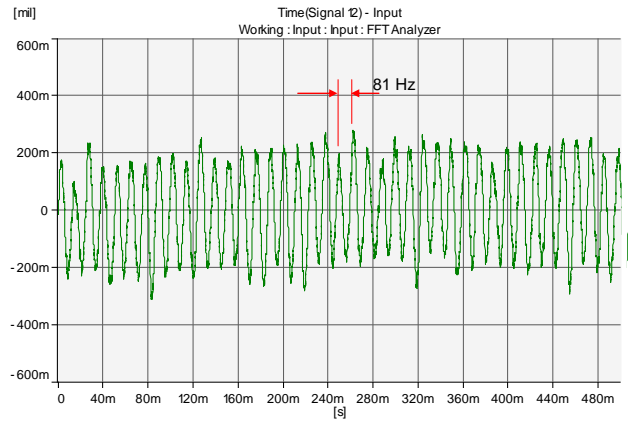
Figure 20. 2B NV Pump Axial Proximity Probe Vibration Waveform (mils versus Time in Seconds)

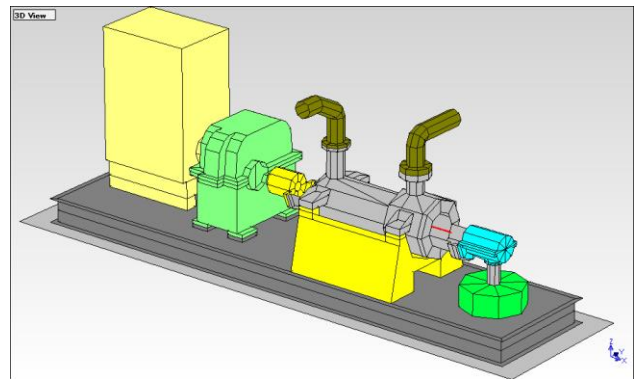
Detailed ODS testing was conducted on both pumps for comparison purposes. Figure 21 shows a 3D CAD computer model used to create animations of the pump structure at its main excitation sources (i.e. 1x rpm of the motor, 1x rpm of the pump, etc.).

Figure 21. Charge Pump CAD Computer 3D Model for ODS Testing

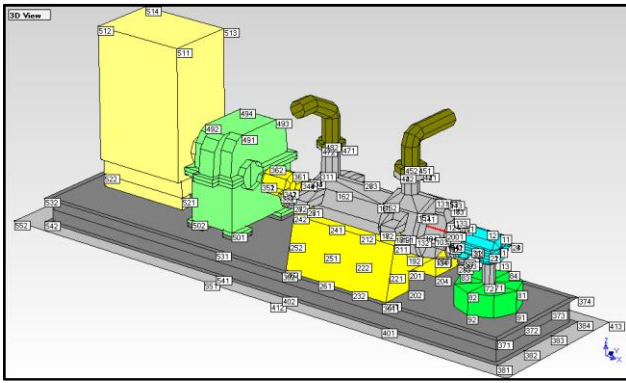
Figure 22 shows the same CAD computer model of the pump system assigning motion to each individual vibration data point. Each label represents the location where a tri-axial accelerometer was placed (roving accelerometers) in order to characterize the overall global relative motion of the pump at a given frequency. Over 700 vibration locations / directions were recorded to create a data base of amplitude versus frequency and phase angle.

Figure 22. Charge Pump CAD Computer 3D Model for ODS Testing Tri-axial Accelerometer Locations

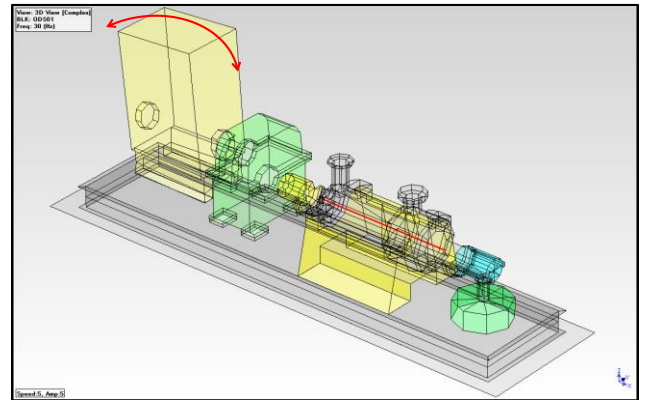
Figure 25. 1B NV Pump ODS at 1x rpm of the Motor (30 Hz)

The ODS animation at 1x rpm of the motor is shown in Figure 25. In contrast to the offending pump, at this frequency the motor indicated rocking motion in the axial direction. The rest of the unit remained basically stationary (without axial motion of the pump shaft). The ODS animation at the running speed of the pump, shown in Figure 26, described typical orbiting motion of the pump shaft.

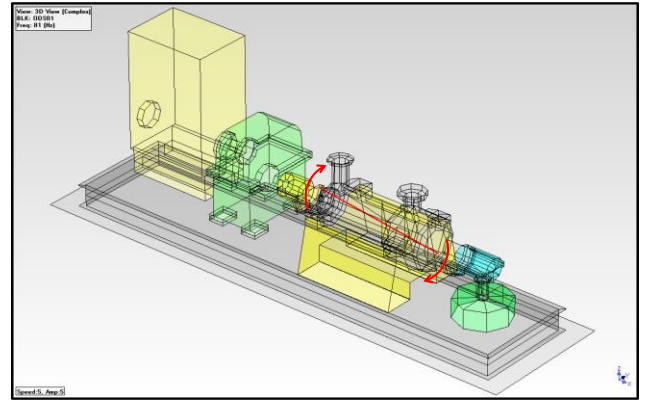
Figure 26. 1B NV Pump ODS at 1x rpm of the Pump (81 Hz)

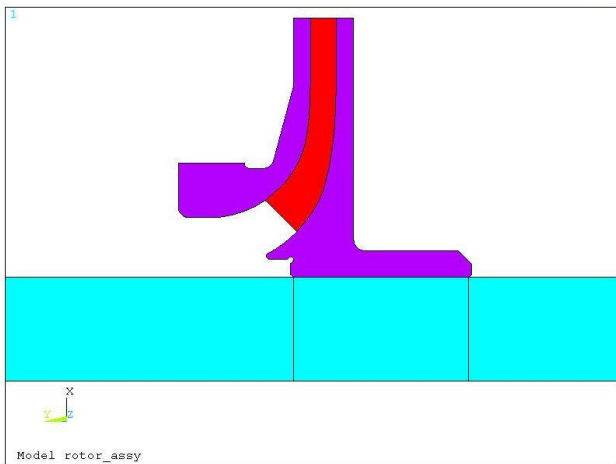
An axi-symmetric model of the pump rotor assembly was idealized to include the shaft and the last stage impeller of the pump (11th stage) as shown in Figure 27. Plane type elements were used resulting in roughly 28,000 degrees of freedom FEA break-up (Figure 28). The model was run using transient dynamic solution techniques.

Figure 27. Axi-Symmetric Model of the 11<sup>th</sup> Stage Impeller and Shaft Assembly

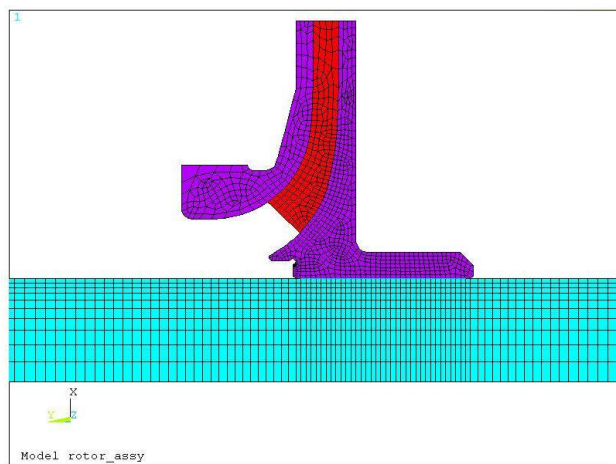
Figure 28. Axi-Symmetric Break-Up Model of the 11<sup>th</sup> Stage Impeller and Shaft Assembly

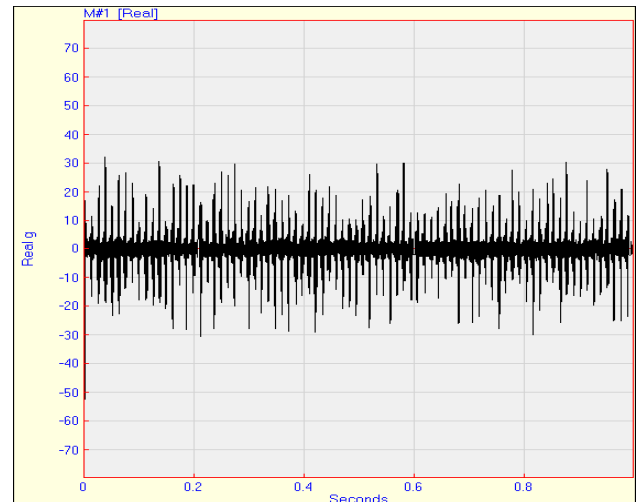
A 75 psi (5.2 bar) pressure saw-tooth impulse of 0.2msec duration was applied to the inboard end of the shaft. This impulse was determined to result in 30 g (294.2 m/s<sup>2</sup>) acceleration at the outboard end, which correlated with the axial proximity probe readings. Figures 17 and 18 show the vibration spectrum and wave form from the axial proximity probe mounted at the outboard bearing of the pump. Figure 29 depicts the acceleration differentiated two times from the proximity probe displacement data.

Figure 29 Acceleration Signal Derived From Axial Proximity Probe Readings (g's versus Time in Seconds)

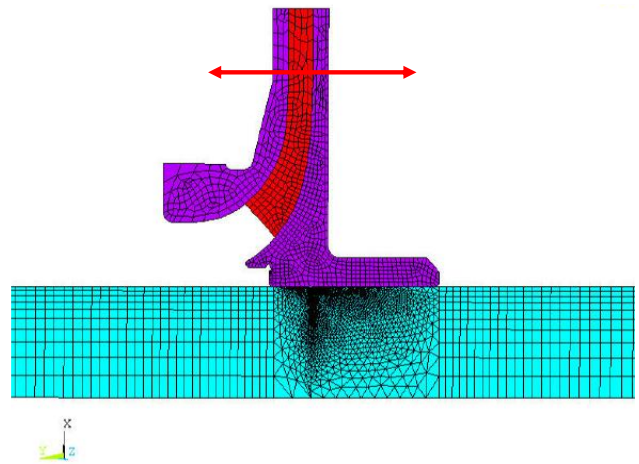
Figure 31 Impact Acceleration of 30 g's pk (294.2 m/s<sup>2</sup>) at 30 Hz

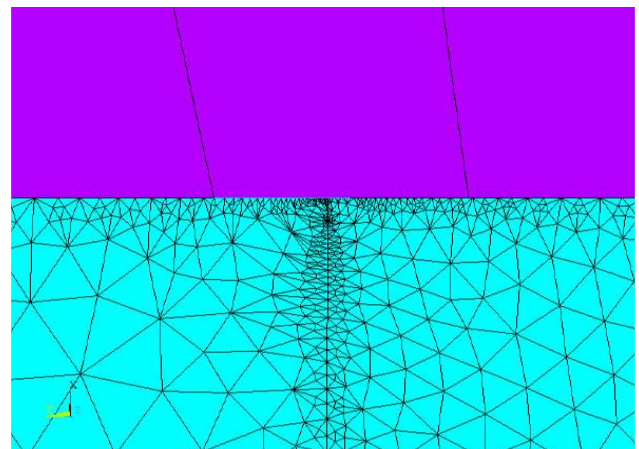
Figure 31 shows the same axi-symmetric model with a finer break-up around the initial crack (5.0 mils or 127 microns) included into the model. Figure 32 shows a zoomed view of the explicitly modeled crack on the shaft.

Figure 32 Explicitly Modeled 0.005 inch (127 microns) Crack on the Shaft

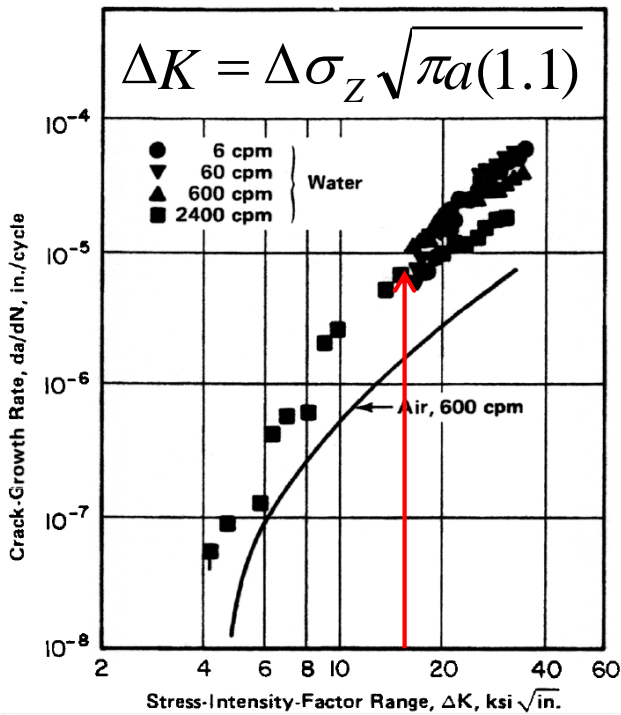
The stress-intensity factor ( $\Delta K_I$ ) was calculated to be 16.3 ksi $\sqrt{\text{in}}$  (17.9 MPa $\sqrt{\text{m}}$ ). Based on the experimental crack-growth rate graph of a similar material (Figure 35) in water at 2400 cpm, the calculated stress-intensity-factor intersected the curve beyond the threshold point. Therefore, crack propagation was expected to occur.

Figure 35. Crack-Growth Rate versus Stress-Intensity-Factor Range for 403SS. (Source: Aerospace Structural Metals Handbook).  $\Delta K$  is the stress intensity factor,  $\Delta\sigma_z$  is the stress range perpendicular to the to the crack or flaw, and  $a$  is the length of the crack or initial flaw.
