**43rd Turbomachinery
30th Pump SYMPOSIA**

**DRIVE SHAFT FAILURE ANALYSIS ON A MULTISTAGE VERTICAL TURBINE
PUMP IN RIVER WATER SUPPLY SERVICE IN A NICKEL AND COBALT MINE IN
MADAGASCAR - BASED ON ODS AND FEA**

Juan Gamarra
Mechanical Solutions, Inc.

Paul Behnke
ITT Industries, Industrial Process

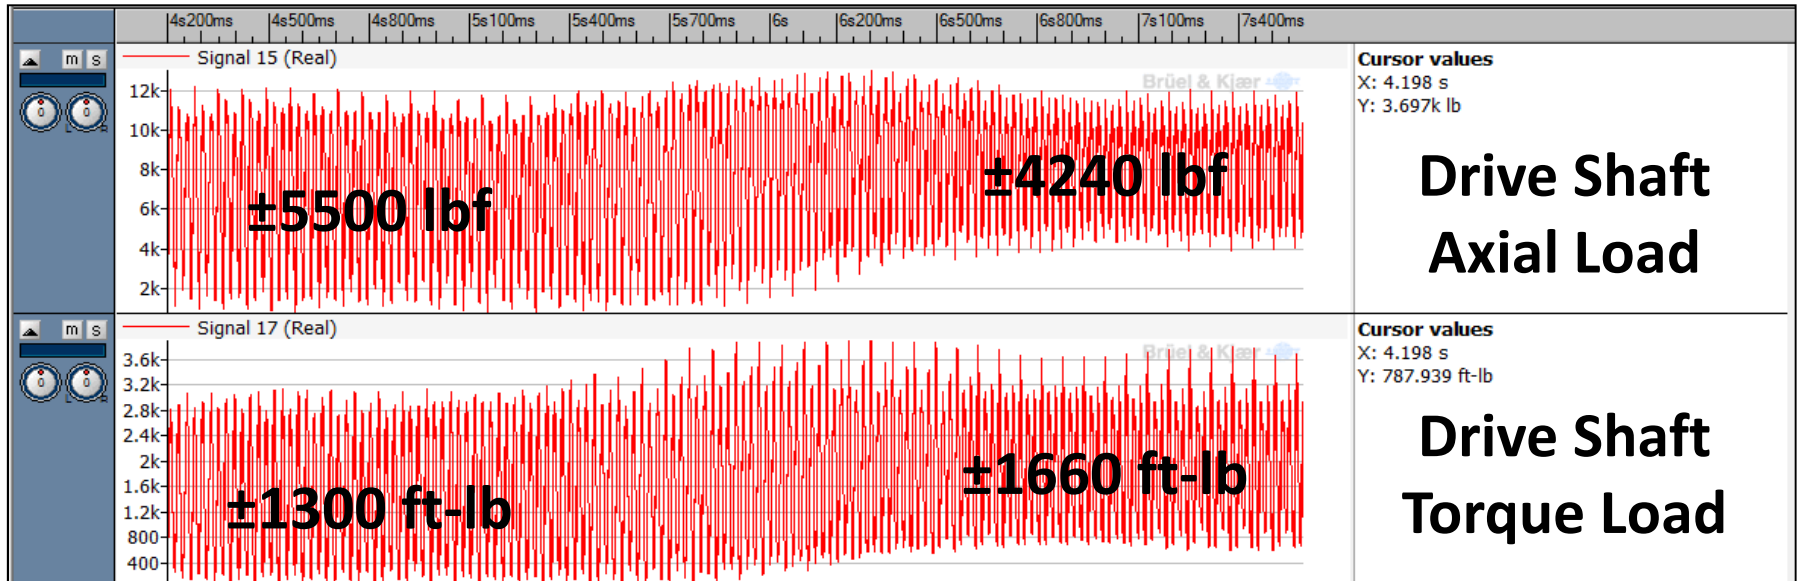
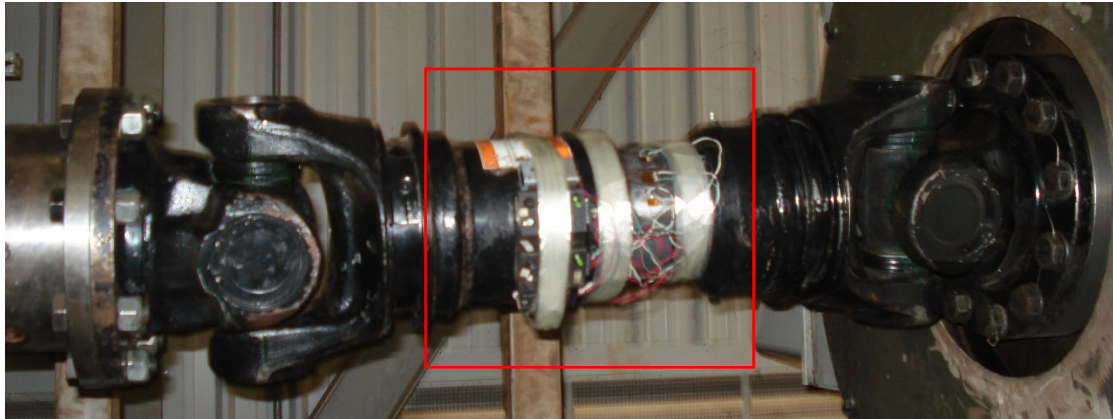
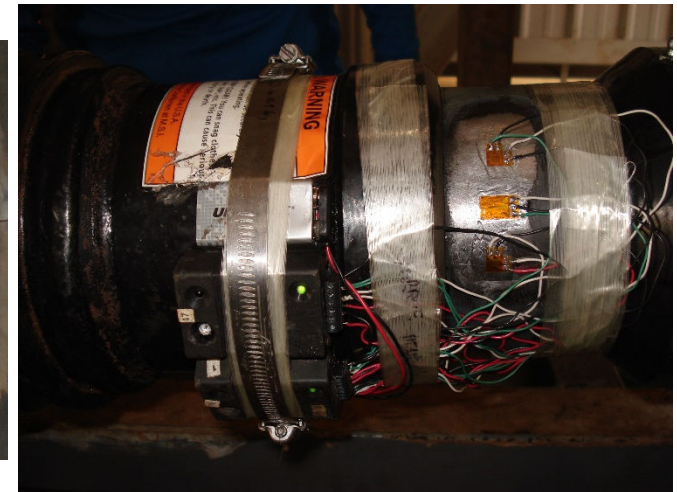
Time Domain Plots/ Drive Shaft 1,650 - 1,820 rpm

- Radio Frequency (RF) telemetry strain gauges measuring axial bending and torque were installed on the driveshaft of one pump.
- Time-transient vibration testing results on the pump, gearbox, drive shaft, and engine were collected using accelerometers and shaft sticks.
- An Operating Deflection Shape (ODS) test was performed to reveal dynamic behavior of the entire pump system.
- Experimental Modal Analysis (EMA) data was collected to find natural frequencies of the different system components.
- A test-calibrated Finite Element Analysis (FEA) based fracture mechanics analysis approach was used to predict the ability of detected stresses in the drive shaft to encourage initiation and propagation of the crack.

The ODS animation at 41 Hz on Pump A (1.5x RPM) indicated a strong motion of the gearbox head towards the engine. According to the strain gauge data, it was evident that the drive shaft axial splines were binding in the axial direction when under torque load, allowing this mode to enable driveshaft failure.

1. The failure mechanism of the drive shaft was caused by the elevated axial and torsional oscillation loads in combination with the jammed driveshaft spline.
2. The situation became severe because an axial (horizontal parallel to the crankshaft) pump natural frequency and torsional shaft assembly natural frequency were simultaneously in resonance with an unexpectedly high 1.5x running speed harmonic, which appeared due to a poorly tuned engine (resulting in a 1/2x rpm fundamental and its harmonics).
3. The 2nd torsional natural frequency of the drive shaft was determined to be at 42.0 Hz (Pump C). The separation margin from 1.5x running speed is within 5% from both the pump and engine speed.
4. The torsional oscillation was observed to be as high as 94% zero-to-peak of the mean torque value.

5. The measured axial force oscillation imposed on the drive shaft peaked at 11,000 lbf pk-pk.
6. Since the weld on the driveshaft did not penetrate to the inner diameter of the material the region near the weld, this created effectively a crack around the circumference of the shaft. This resulted in a high stress concentration at the edge of the weld. The peak oscillating membrane plus bending stress amplitude located at the region near the “crack” was calculated from the FEA model to be 3118 psi due to the observed alternating torque and axial loading.
7. For carbon steels, exceeding a critical stress intensity factor of 8,000-10,000 indicates the effective initiated crack length “a” has the ability to propagate under alternating load. This analysis calculated a stress intensity factor value of 11,040 which explained the failure from fatigue loading on the weld bead.

1. The engine was re-tuned due to the observed mis-firing, since it was providing unusually strong torque impulses or "shocks" at the rate of $1/2x$ RPM, which caused strong frequency harmonics. This left no place to "park" the system natural frequencies to avoid resonance.
2. A torque shock absorbing coupling between the engine and the drive shaft was implemented. The entire drive shaft and coupling assembly was replaced including the u-joints at each end.
3. The highest vibration level dropped from 24 mm/s pk at the gearbox horizontal measurement location near the input shaft to 7.8 mm/s pk after change to a flexible coupling. Failures ceased.
