# The Effect of Foundation Piers on the Natural Frequencies of a Vertically Mounted Sewage Pump in Resonance with Vane Pass Excitations

27<sup>th</sup> International Pump Users Symposium

**Paul A. Boyadjis**

*Mechanical Solutions, Inc.*

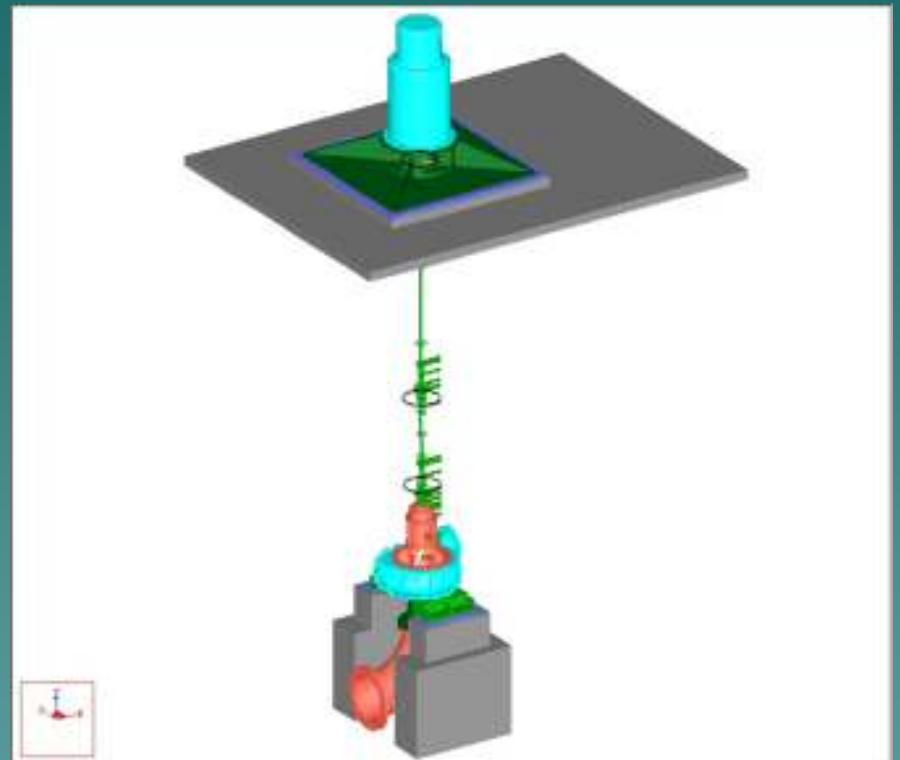
- ◆ A VFD driven sewage pump with a long drive-shaft mounted on large vertical concrete piers was originally analyzed for natural frequency prediction using FEA techniques as required by the specification.
