Diagnosing and Correcting a Damaging Below-Ground Column Natural Frequency in a Vertical Pump Using Field Testing and FEA

28th International Pump Users Symposium
September 24 - 27, 2012

Case Study

Paul A. Boyadjis & Maki M. Onari
Mechanical Solutions, Inc. – Whippany, NJ

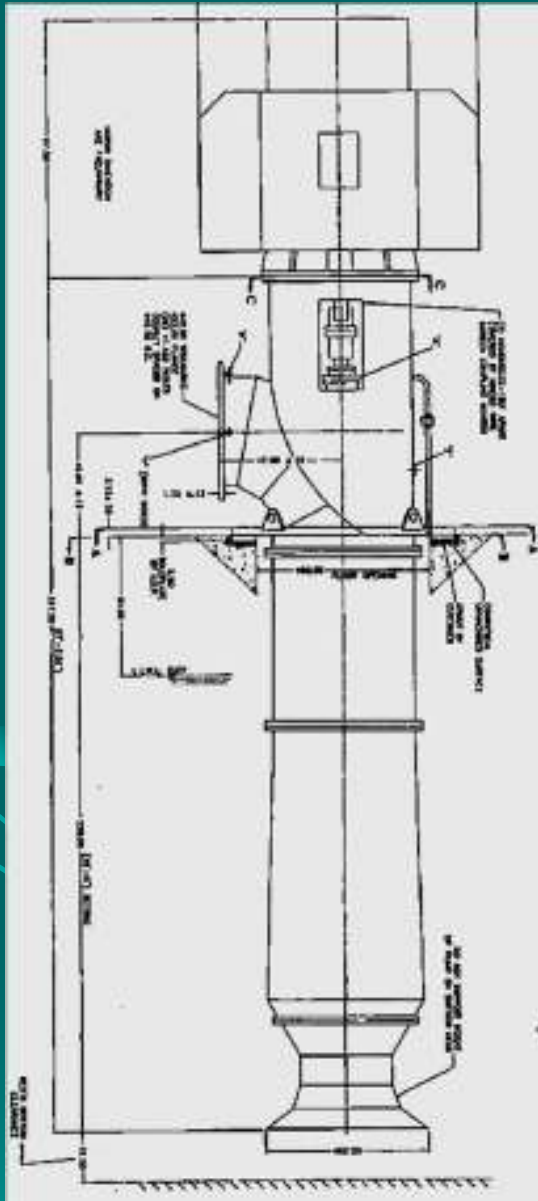
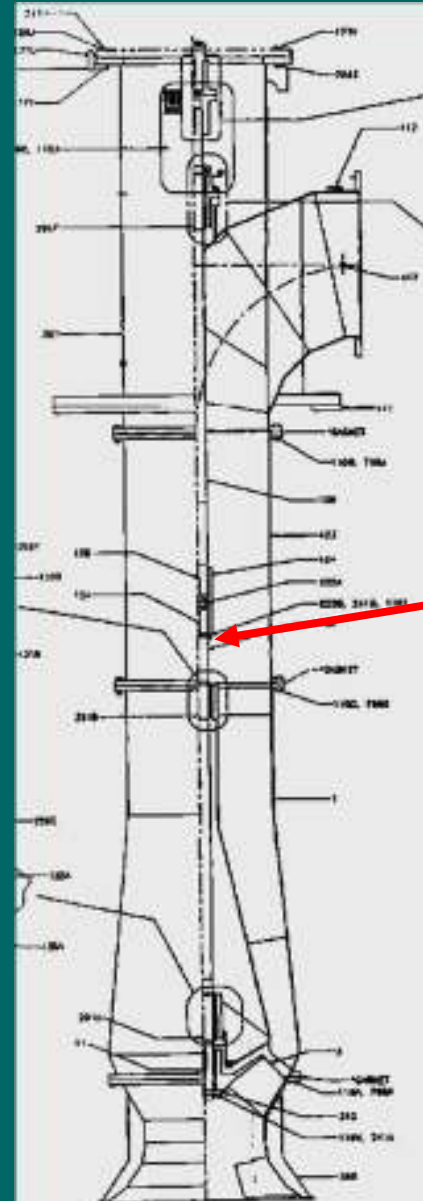
Shaft Failure

- In 2008, acceptable vibration (0.10 in/s pk) in two orthogonal directions was measured at the top of the motor. The amplitude increased gradually over the next 2.5 years. Within this period, the pump shaft failed in December 2009 (5.5 inch diameter at the upper end of the pump shaft coupling). Before the failure, the vibration was approximately 0.20 in/s pk. In addition, there were only a few of the upper column flange bolts remaining in place, and there was minor rubbing detected at the tip of the impeller vanes. During this period, when the pump was sent out for repair, the soleplate was replaced.
- After the pump was re-installed in March 2010, the vibration was around 0.20 in/s pk, then it started to increase quickly reaching the alarm level of 0.40 in/s pk in the mid-2010.

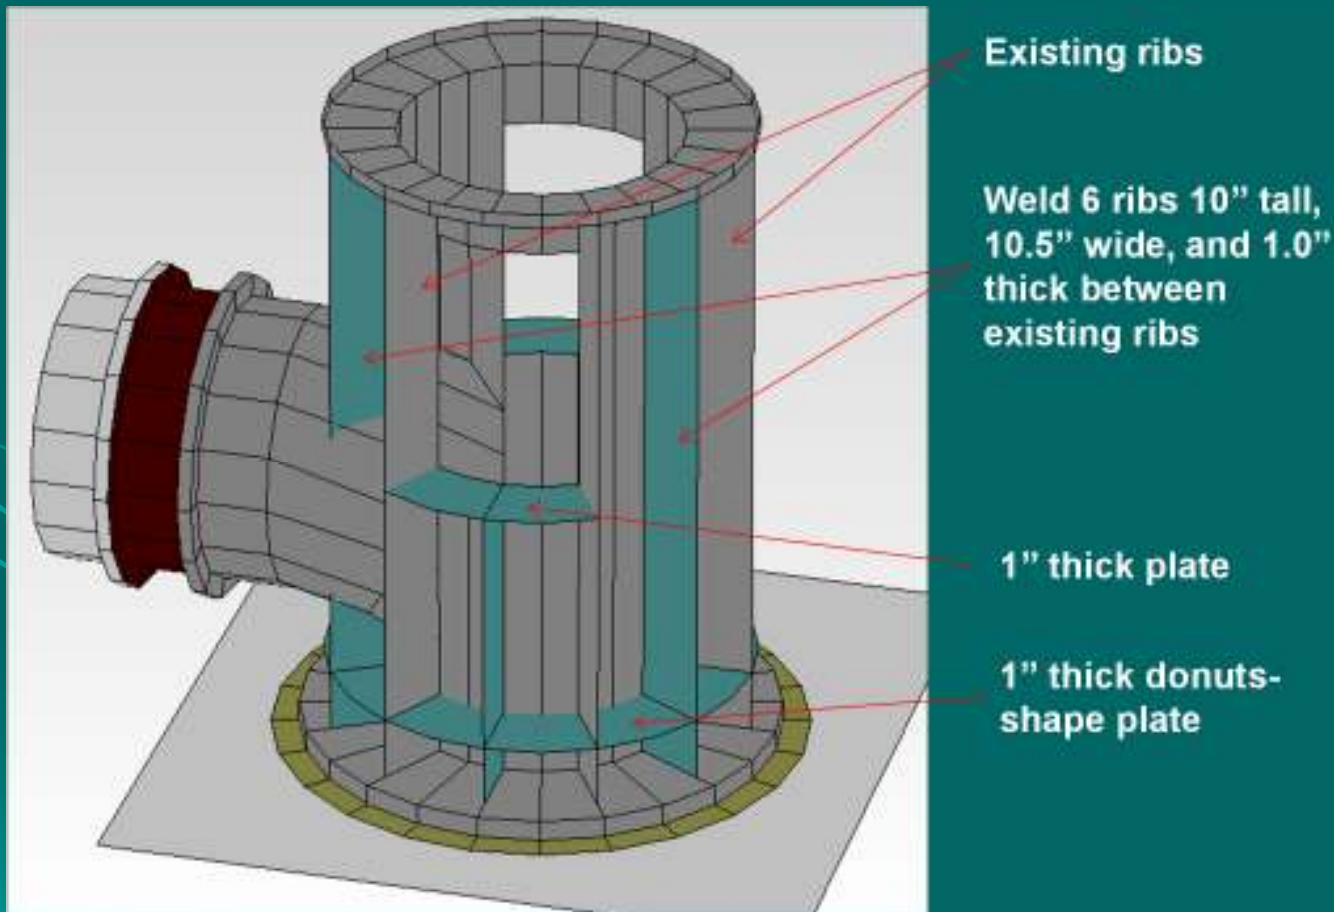
- 50% reduction in vibration amplitude at the top of the motor, but still high (0.50 in/s pk).
- The increase in the above-ground stiffness did not shift the offending mode of the system as expected.

- Increase the stiffness of the discharge head
- Eliminate the looseness of the soleplate with respect to the concrete floor
