PERFORMANCE LOSS INVESTIGATION USING THERMAL IMAGING

SCOTT MCPHERSON

LEAD FIELD ENGINEER – SULZER PUMPS (US) INC

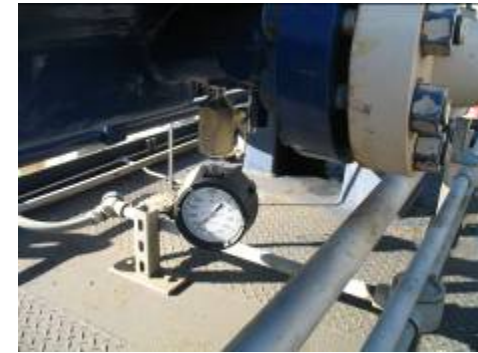
- No improvement was observed!!
- Pressure gauge added to pump discharge nozzle. Reading compared well to gauge on discharge line
- Pressure gauge was added to a vent on the long cross over with interesting results!!!!
- Suction side of pump found to be performing as expected
- All losses isolated to the discharge side of pump
- Pump run down at 3600rpm to allow comparison to factory performance test results. Pump still 20% low at factory test speed!!!
- Further investigation was required

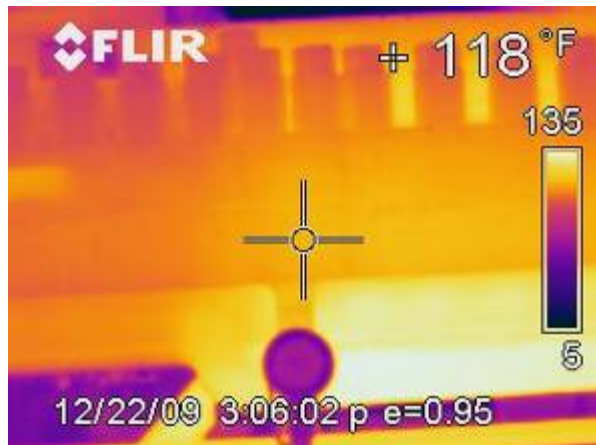
Zoning in

No exceptionally high localized hot spots apparent, however, left of thermowell boss appears cooler

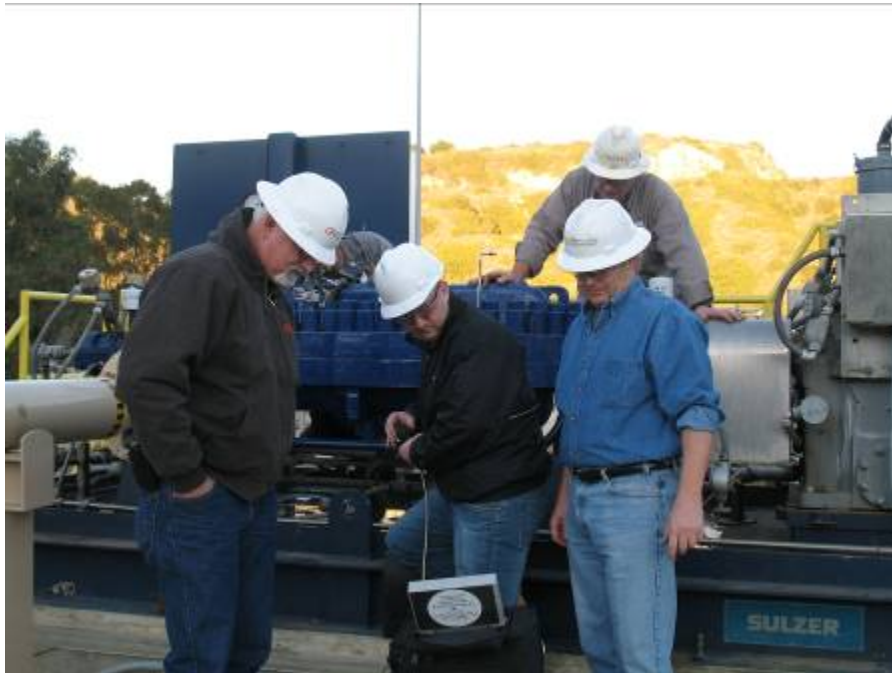
- Borescope with articulating head was utilized to perform internal pump inspection in the field.
- Camera fed through drain point on bottom half long crossover

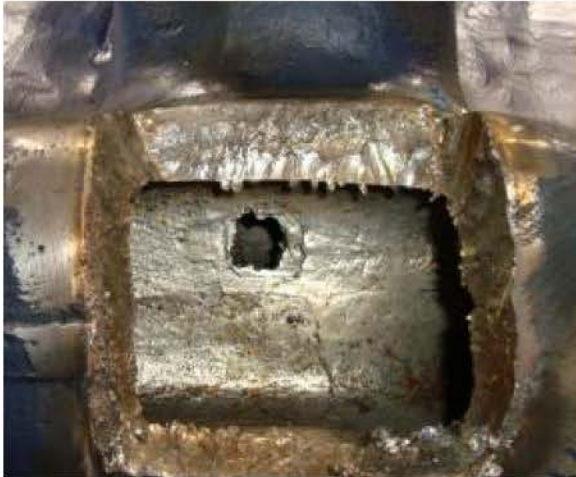
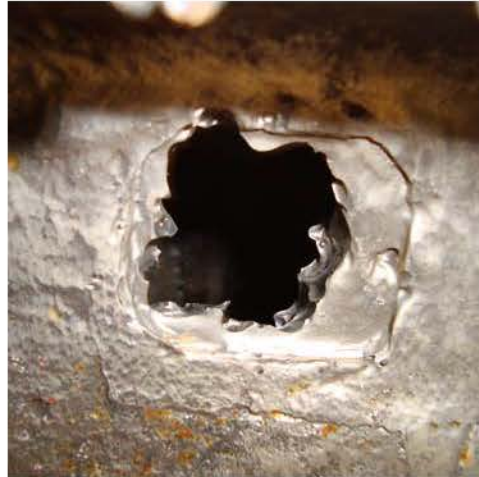
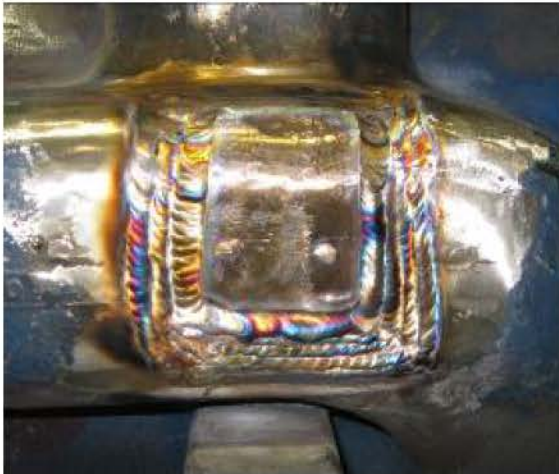
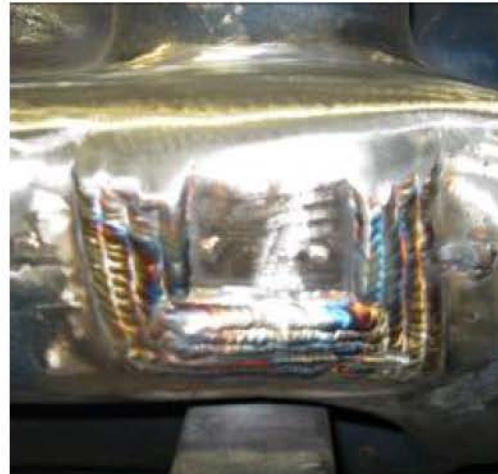
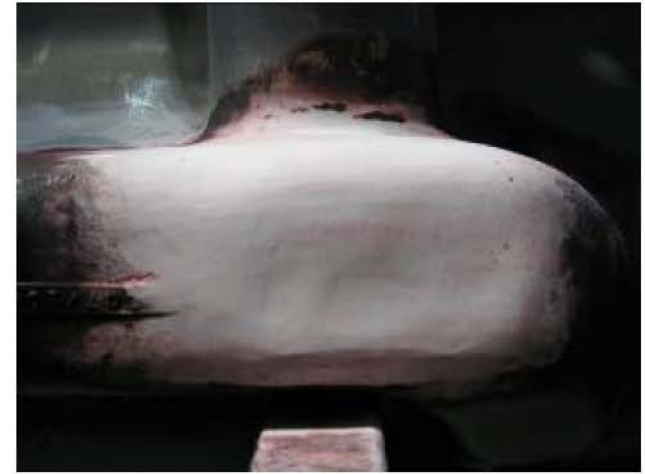
REPAIR PROCESS

- CHAPLETS (SHOWN BELOW) ARE USED TO POSITION SAND CORE BOXES DURING THE CASE CASTING PROCESS.
- THE CHAPLETS SHOULD BE MADE OF THE SAME MATERIAL AS THE CASTING AND IS INTENDED TO FUSE INTO THE CASTING AND BECOME A PART OF THE FINISHED COMPONENT
- IN THIS CASE IT APPEARS THAT THE CHAPLET MAY HAVE NOT FUSED, OR POSSIBLY BEEN MADE OF THE WRONG MATERIAL
- NOTICE THE SQUARE RECESS AROUND THE HOLE FOUND IN THE CROSS OVER
