**43rd Turbomachinery
30th Pump SYMPOSIA**

DRY GAS SEAL FAILURES IN A RECYCLE GAS CENTRIFUGAL COMPRESSOR, CAUSES & REMEDIAL ACTIONS

VASANTH BHAT, SINGAPORE REFINING CO. PTE. LTD.

JIM DEMETRIOU, CHEVRON ENERGY TECHNOLOGY CO.

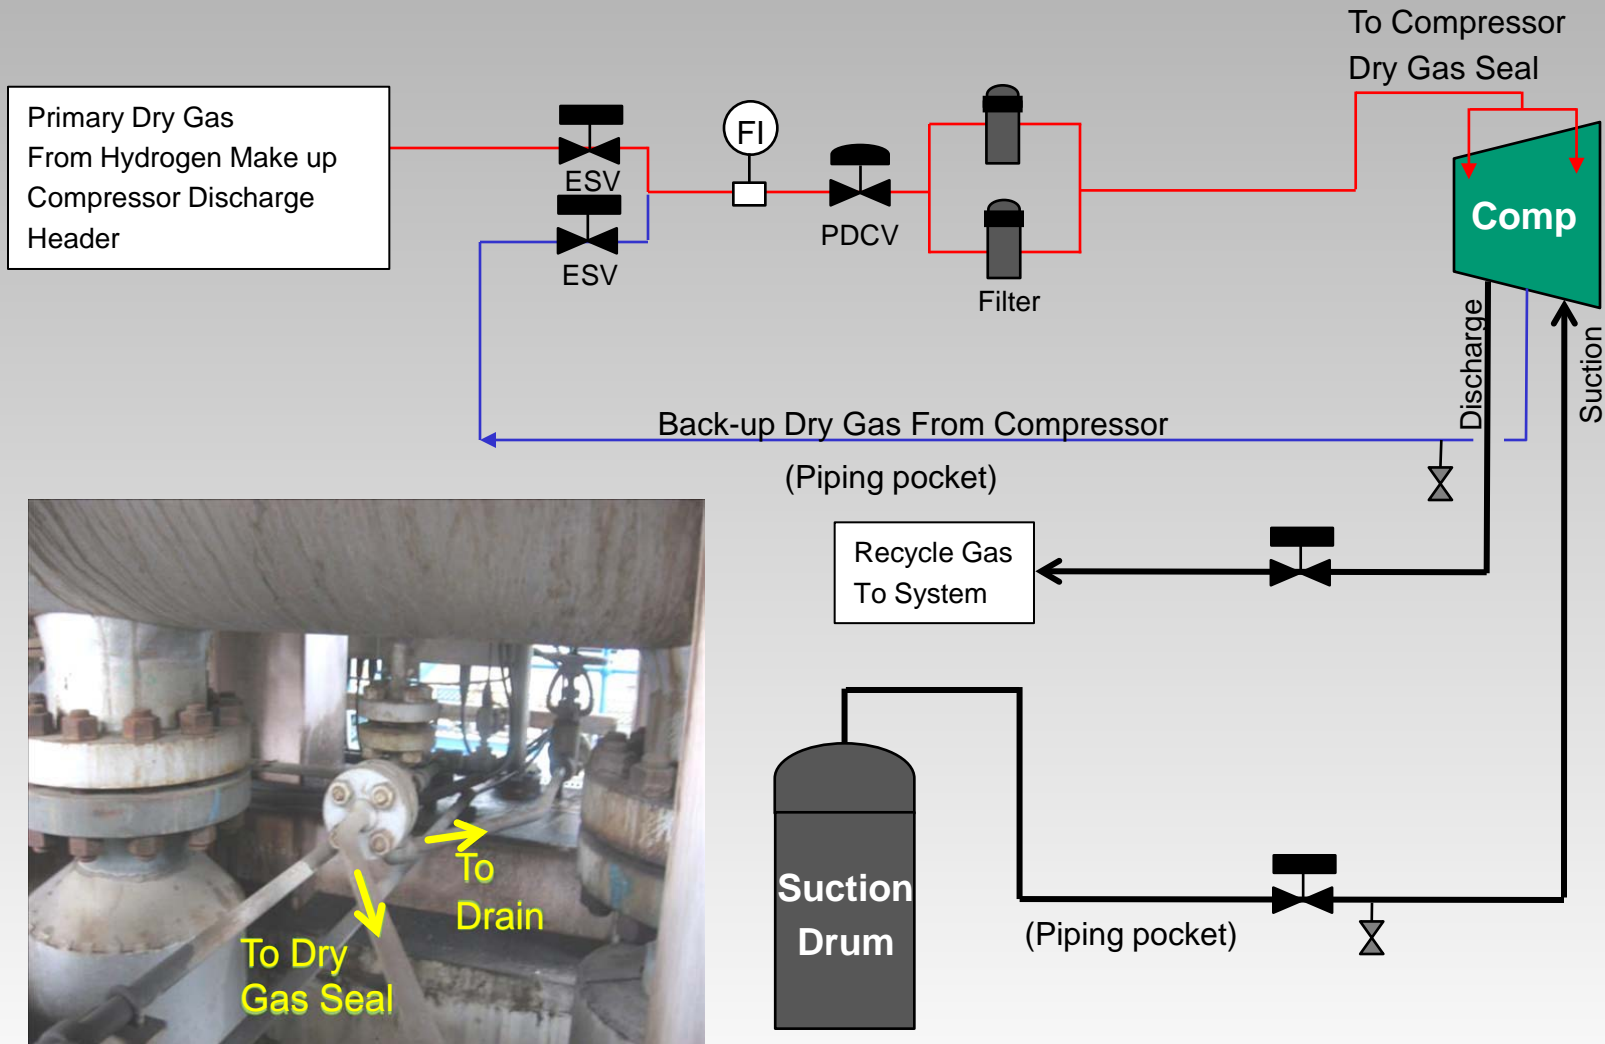
Compressor Flow Scheme

- Seal system found heavily contaminated with water-like liquid.
- Suction drum steaming for vessel entry during turnaround done with compressor suction and discharge ESVs left open resulting in condensate building up in the compressor and seal gas system.
- Seal gas take-off from casing bottom allowed for additional condensate to reach the dry gas seal, shattering the faces.
