FIELD INVESTIGATION OF GEARBOX VIBRATION DUE TO CRACKED MOTOR ROTOR BARS

BY ROSS PINNER
AND TROY FEESE

42nd Turbomachinery
29th Pump SYMPOSIA

Problem Statement

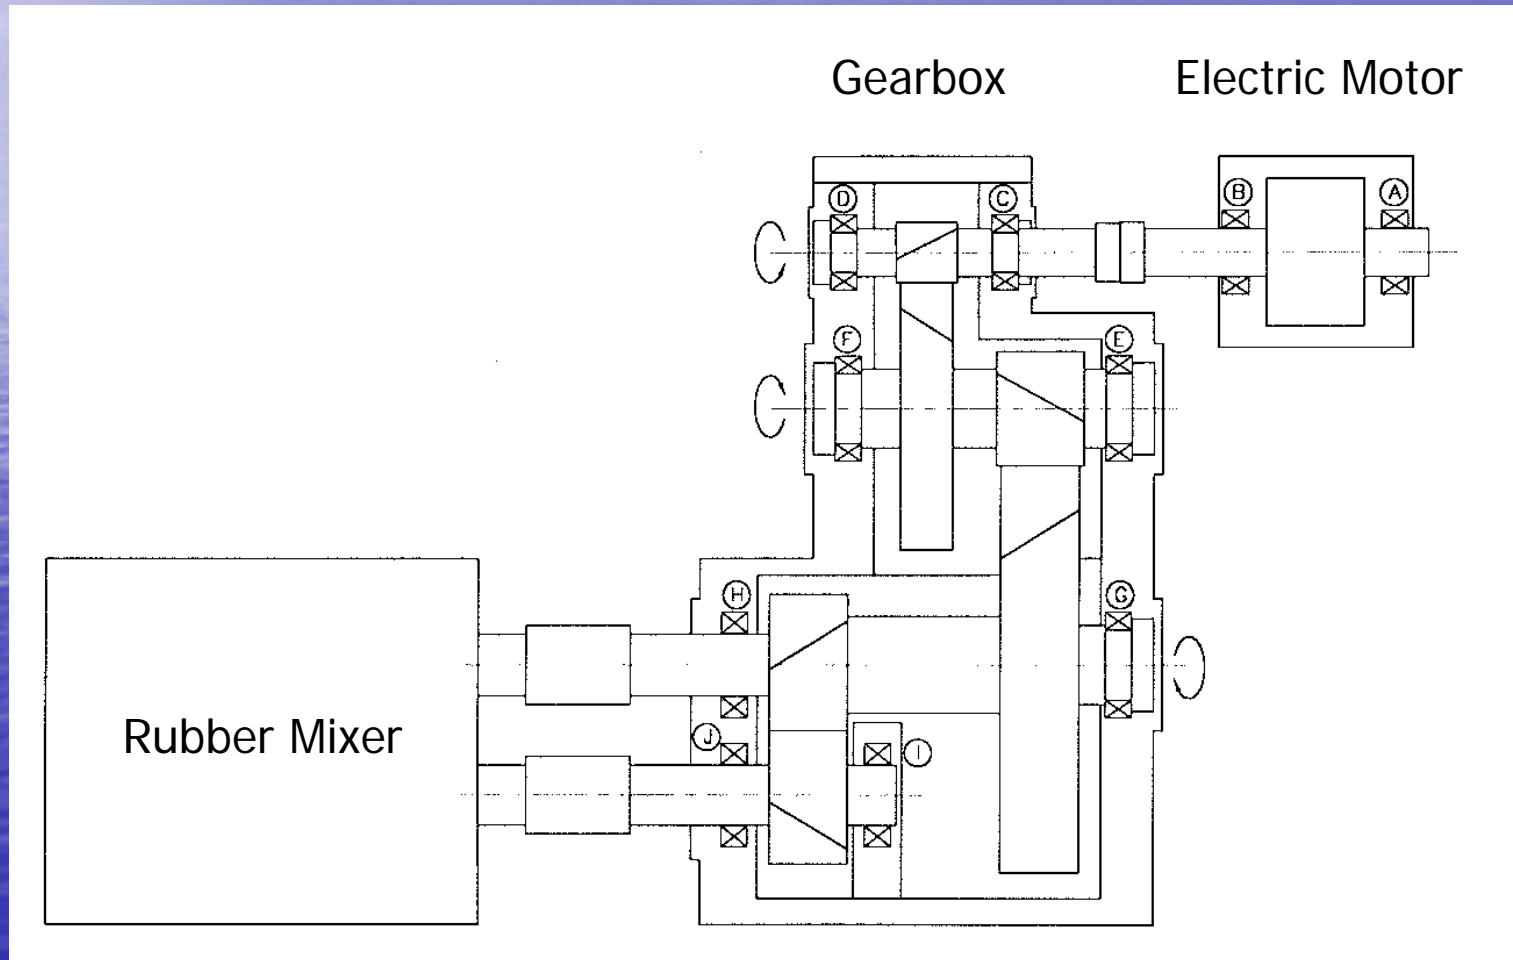
Motor – Gearbox – Mixer Unit For Tire Production

Approximately one year after installing a new gearbox, vibration levels were gradually increasing. The tire plant requested that the gearbox manufacturer investigate under warranty. A field study was performed by an independent engineering company to measure the vibration of the motor, gearbox, and rubber mixer unit at the plant.

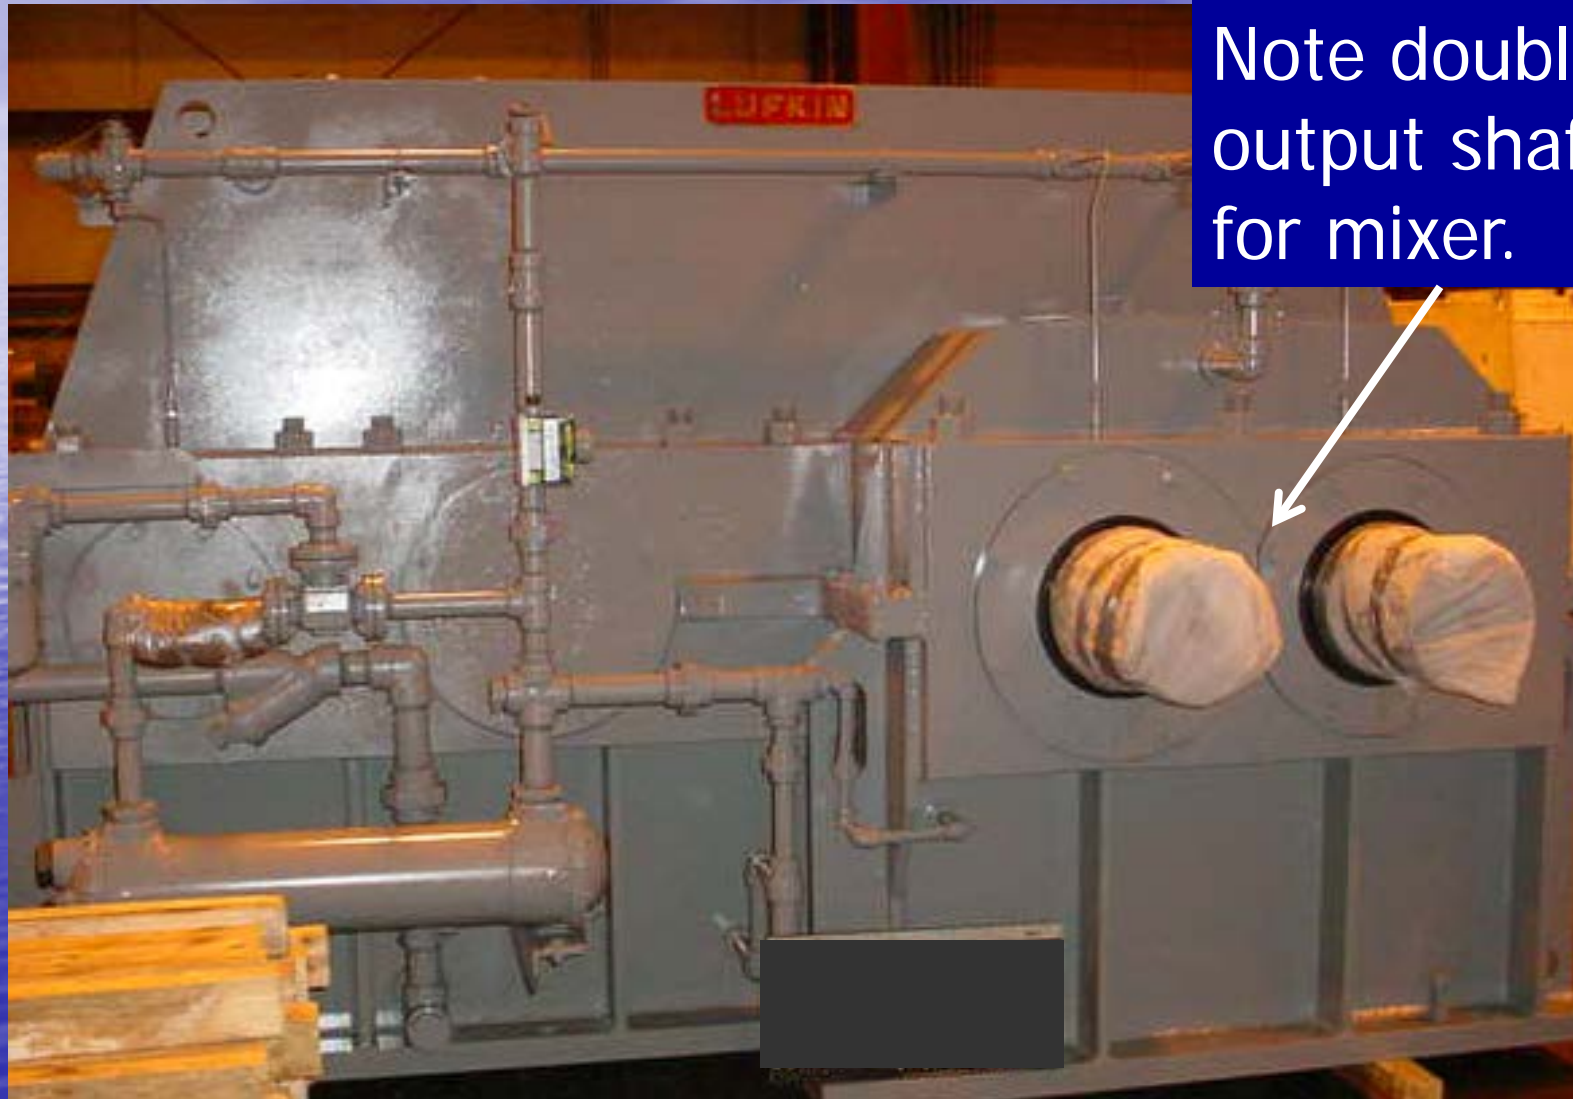
New Gearbox at Shop

Note double output shafts for mixer.

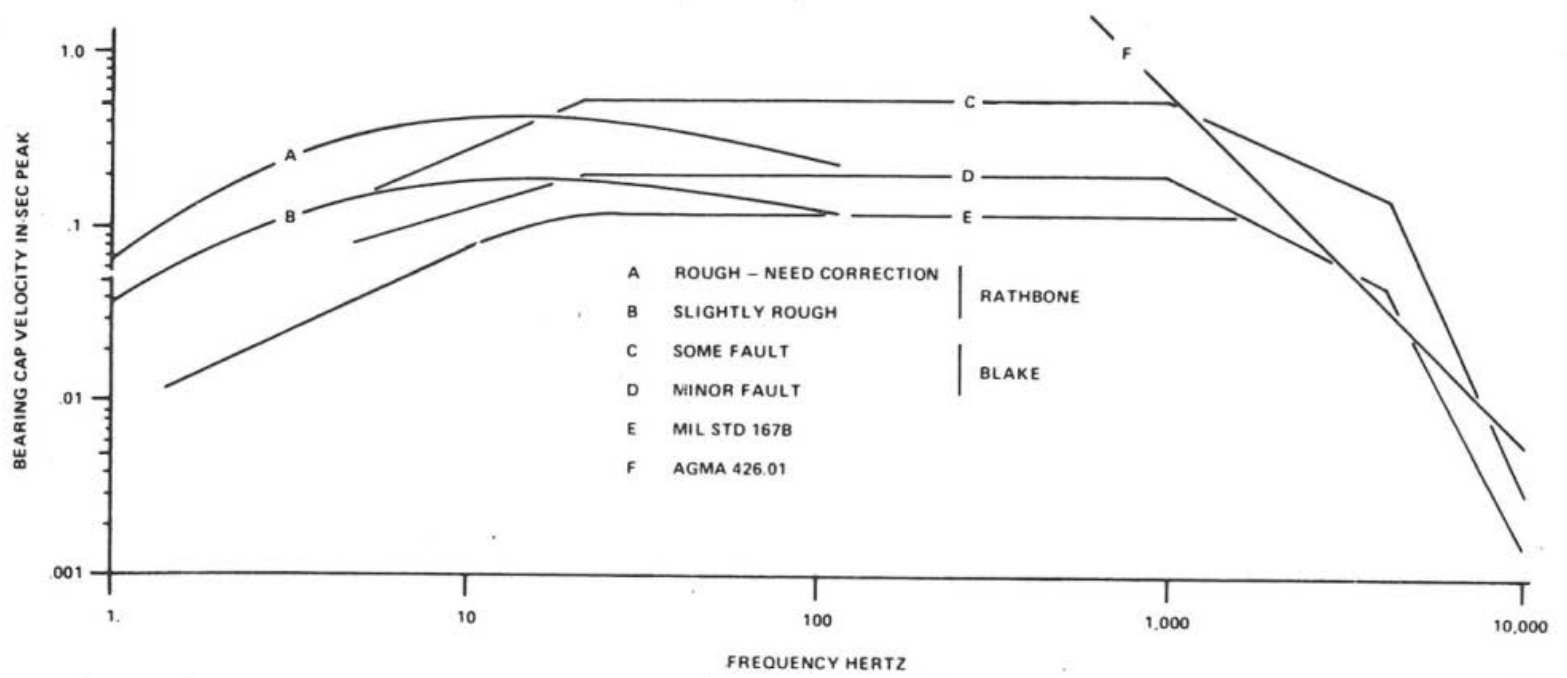
Figure 10-4 Comparison of Casing Vibration Limits

Above 600 Hz, AGMA allows gearbox case vibration up to 10 g's

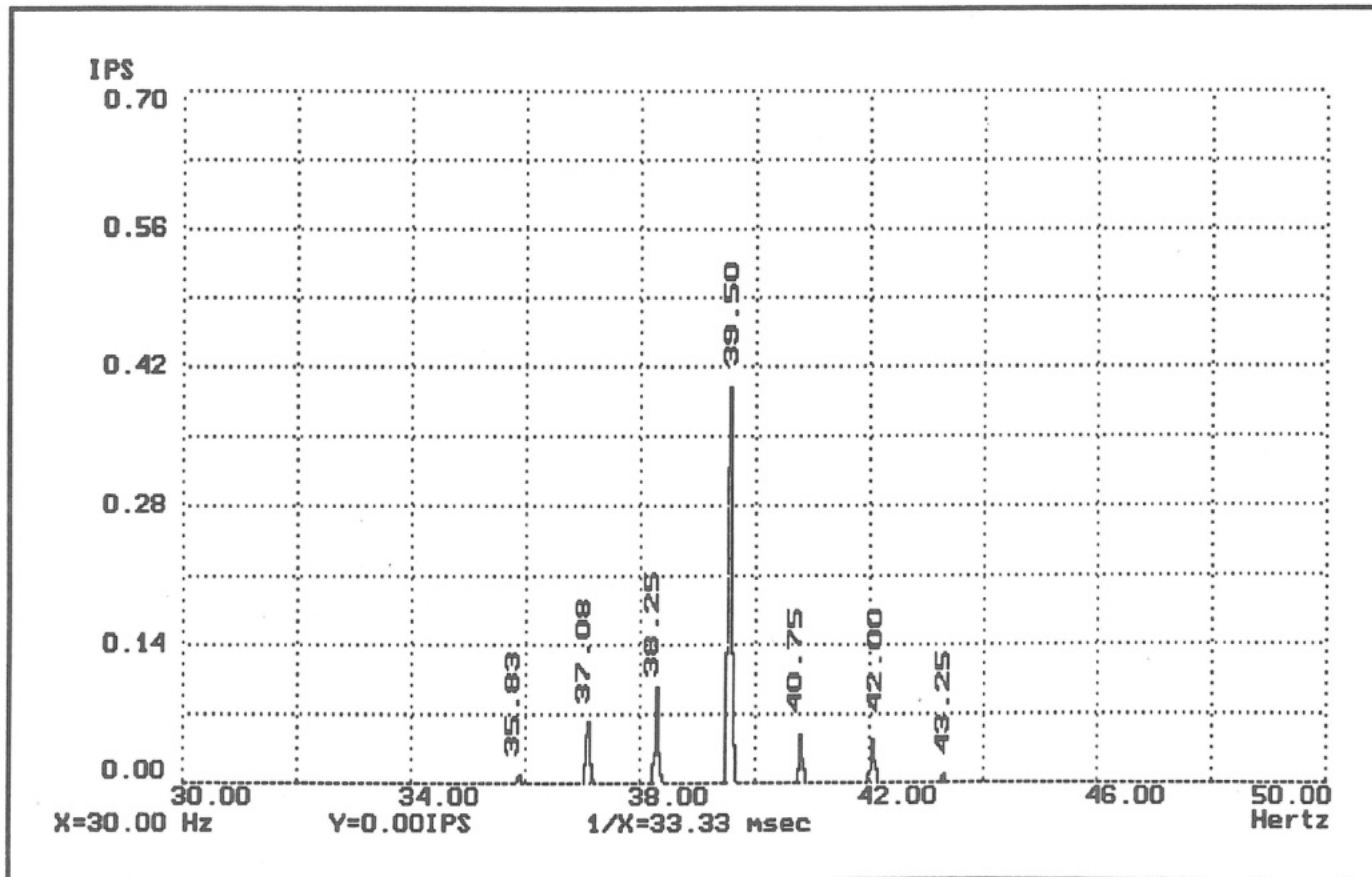
Fig. 4-28. Frequency Spectrum of 20 Hz Window around the Second Harmonic of Motor Speed.

Compare to "Text Book" Example of Broken Rotor Bars [Taylor]
