**INNOVATIVE DESIGN IN EXPANDER WHEEL-SHAFT  
ATTACHMENT REPLACES HIRTH COUPLING  
FOR  
HIGH SPEED, HIGH TEMPERATURE AND HIGH POWER  
APPLICATIONS**

**HOUMAN SHOKRANEH, PH.D.  
DIRECTOR OF ENGINEERING  
L.A. TURBINE**

**42<sup>nd</sup> Turbomachinery  
29<sup>th</sup> Pump SYMPOSIA**

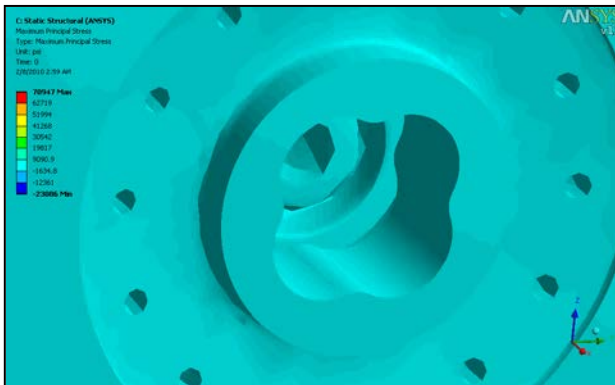
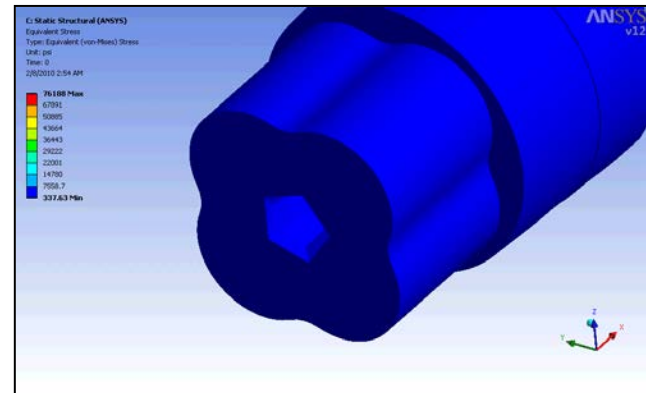
- A unique four-lobe polygon attachment was designed.
- To reduce the centrifugal stress further, the hub diameter was increased by one inch.
- With this new design, stress at the hub at no point exceeds more than 60% of expander wheel's material yield stress.
- To increase the effective contact area, advanced lobe geometry with very tight tolerances were used. CNC machining advancement allowed for machining shaft and hub assembly to a tight tolerance of less than 0.0002” inch.

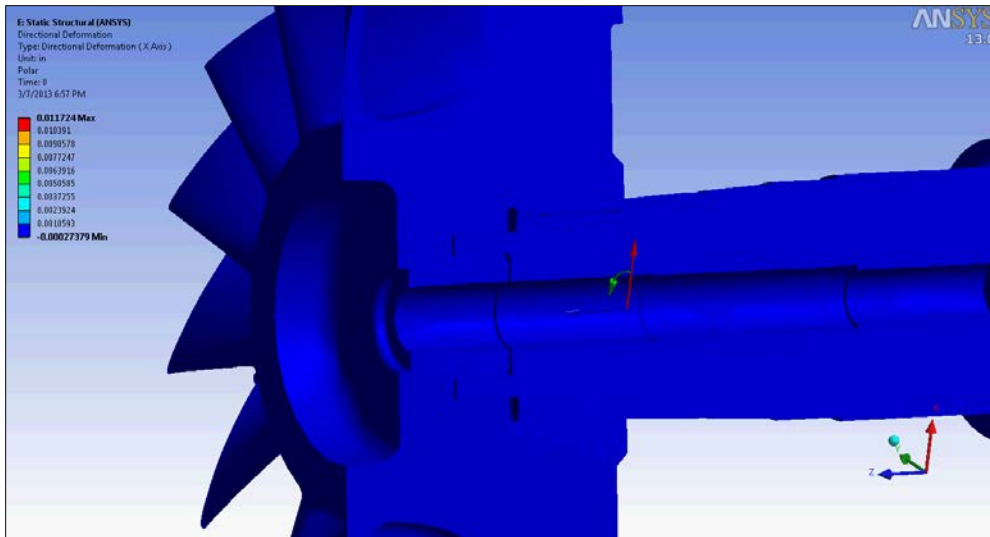
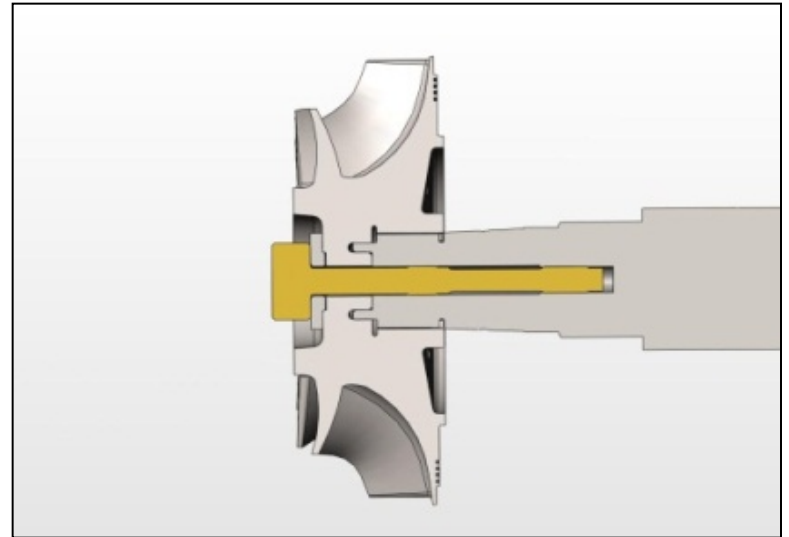
- To be able to repeat balancing procedure by keeping the wheel centric to the shaft, a tightly-machined locator was added to the end of the shaft design.

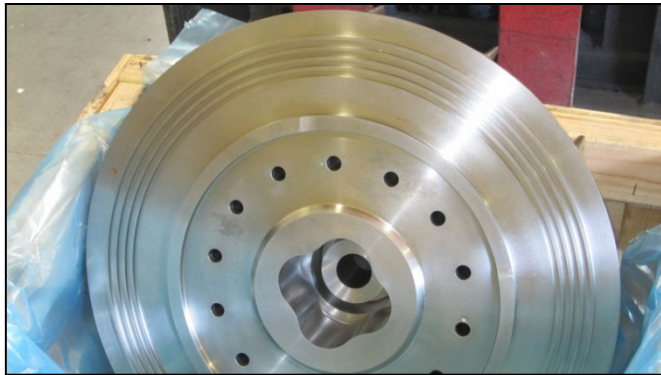
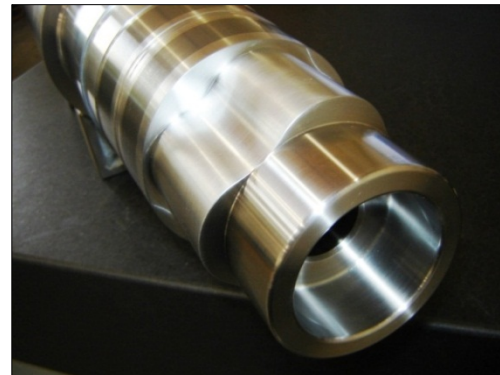
- New machining design applied to the shaft and wheel.

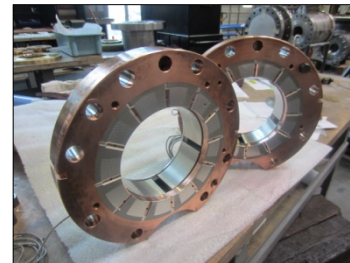
- Increased bearing size by one inch to increase stiffness and increase the shoulder area between shaft and expander wheel.
- Changed the number of pads from four to five, and the pivot-pin to half-sphere pivot (4140 Rc52), for better strength and stability.
