RCFA for Recurring Impeller Failures in a 4.7 Mtpa LNG Train Propane Compressor

ABSTRACT

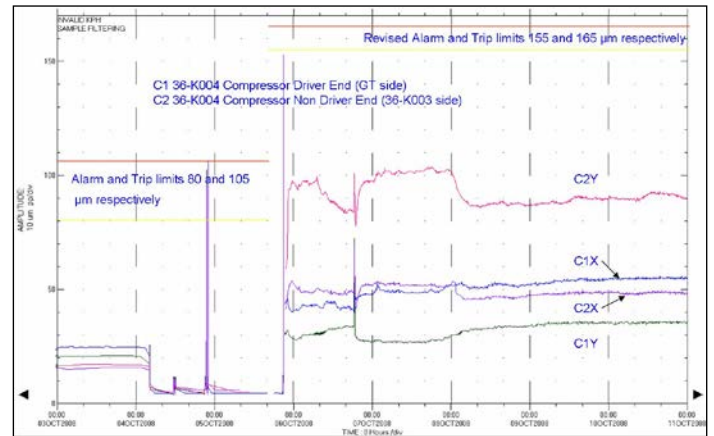
Figure 7. Bearing X and Y probe measured vibration amplitudes 3 – 11 October 2008

approximately 30 degrees indicating a change in the rotor unbalance. The measured 1X vibrations on the non-drive end bearing before the trip were deemed too low to be reliable data. The overall and filtered 1X frequency vibrations, measured during the successful start up on 5th October 2008, indicated that the step change in the vibration amplitude was dominated by increases in the 1X running frequency component. No significant changes in the other frequency components were noted.

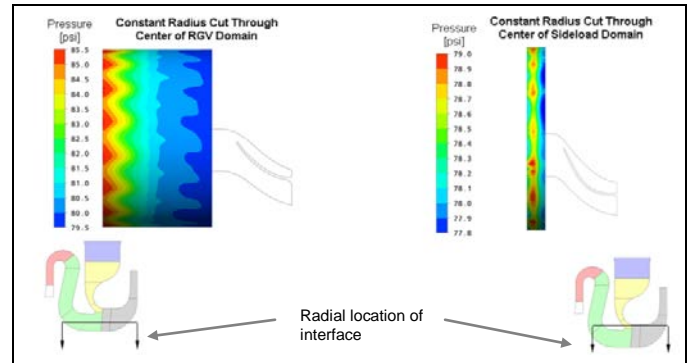
Figure 13. Fourth Impeller CFD results for vane wake impeller interface

Figure 13 shows the predicted pressure wake distributions for the 16X return channel vane and 14X side load vane wake frequencies. The applied operating boundary conditions were close to the compressor rated point although other cases close to surge and choke were also run. The results indicate that no large wakes in either domain are present and the maximum

pressure gradient is less than 2 psi (0.14 bar), which is about 2 percent of the fourth impeller inlet pressure.

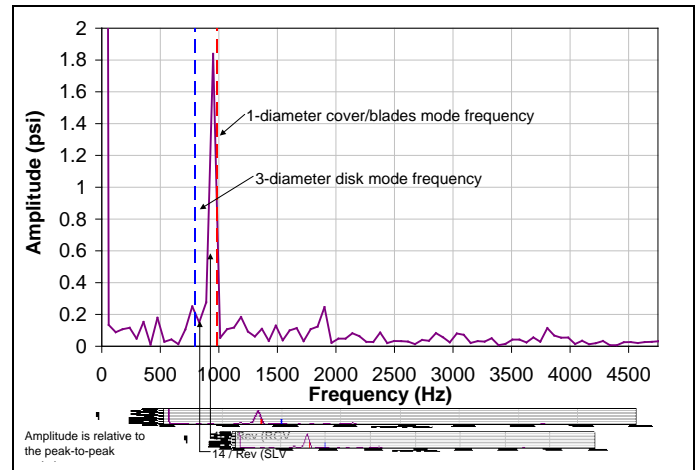
Figure 14. Fourth Impeller FFT for 16X and 14X combined signals

A particular area of concern was how both 16X return channel and 14X side load wakes would interact at the impeller inlet. In order to assess this, the predicted static pressure distribution at the interface between the return channel and side load domains was analyzed using the Fast Fourier Transform (FFT) method. Results are shown in Figure 14 where no higher harmonics causing resonance were discovered. The mixing signal on the graph is the pressure at the interface between the return channel and side load flows. It is approximately equal to the sum of the pressure variations from the two individual streams.

The measured 1-diameter cover/blades mode (984 Hz) is plotted as the red dashed line. This frequency is only slightly above the 16X return vane wake frequency and without phase cancellation would be considered resonant. A peak static pressure of just 1.8 psi (0.12 bar) was predicted and it was considered doubtful whether a significant alternating blade stress could result during resonance. For the 14X side load signal, the maximum peak to peak variation was only 3.2 psi (0.22 bar) during choke. Again, this was considered to be too low to be able to cause significant blade stress. The conclusion leading from the steady state CFD and FEA work was that the 16X, 14X and higher vane wake frequencies seemed unlikely to

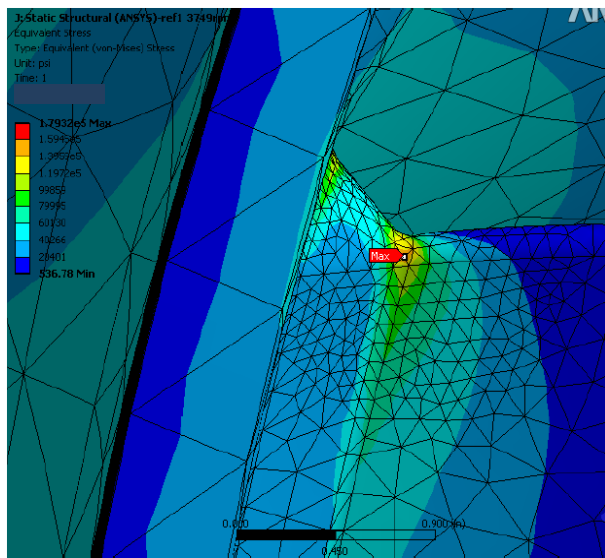
Figure 15. Fourth Impeller FEA result for maximum mean stress

The FEA identified the maximum equivalent mean (von Mises) stress, due to impeller rotation, to be located at the leading edge cover weld fillet. A value of 179 ksi (1234.2 MPa) was predicted, see Figure 15. Since the yield strength is 90 ksi (758.4 MPa), this high local stress would result in local yielding. Therefore, 90 ksi was applied in the Goodman diagram for the mean stress. An elastic-plastic analysis would be needed to obtain a more accurate mean stress prediction.

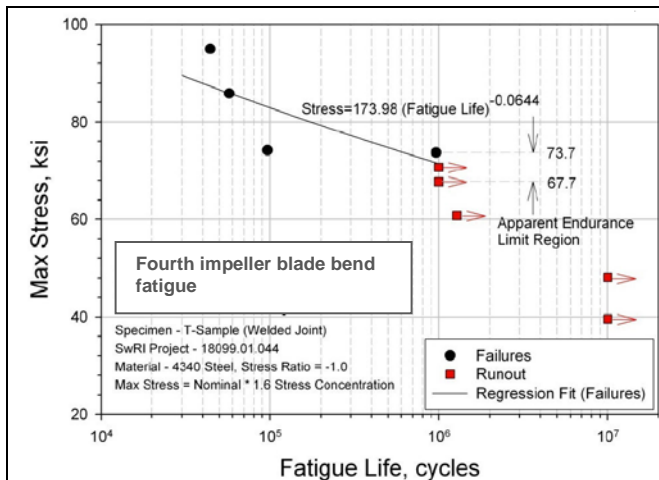
Figure 16. Fourth Impeller T-sample bend fatigue test results

As previously discussed, the alternating stress limit is defined under the condition of zero mean equivalent stress. Due to the fact that the failures occurred at the toe of a weld and the properties in welds can be variable, it was difficult to determine what and if published fatigue data would be applicable. It was suggested that testing of the actual weldment would provide the most satisfying results. The testing consisted of T-sample fatigue testing of twelve samples taken from four individual blades of the 2007 failed fourth impeller. Each sample was taken across the weld region near the leading edge of the blade. The applied alternating stresses ranged from 95.1 ksi (655.4 MPa) to 39.6 ksi (273.2 MPa) and resulted in lives of 44 thousand cycles and 10 million cycles respectively. Failure was achieved at 73.7 ksi (508.1 MPa) stress and 965 thousand cycles for one sample but two other samples achieved run-out at 10 million cycles at slightly less stress, see Figure 16. The failure stress that was applied within Goodman diagram was taken in between these three points at 70 ksi (482.6 MPa). Despite the fact that the samples were taken from the actual failed impeller, which, in theory, would remove effects due to geometry and surface variations, the analysis included the assumption that the T-sample test did not represent the worst case. For example, it was observed that the surface at the leading edge had slightly more extensive damage due to erosion than the location the samples were taken from. Therefore, a reduction of the endurance stress was included to account for the effects of material surface flaws and deviation from averaged endurance results (reliability). These “K factors” were 0.7 and 0.81 respectively. The source for the values was taken from (ANSI/ASME B106.1M, 1985). The product of the K factors reduced the effective endurance limit for the

alternating stress to 39.7 ksi (273.7 MPa). It is noted that the use of these values is conservative. In particular, the K factor related to the surface is the value used if the sample tested had a mirror finish. The reliability K factor is essentially a statistical factor to account for the inherent variation in fatigue data. The value of 0.81 assumes that 99 percent of all samples tested at 70 ksi (482.6 MPa) do not fail after 10^6 cycles. This is a reasonable reduction given the number of samples available for testing.

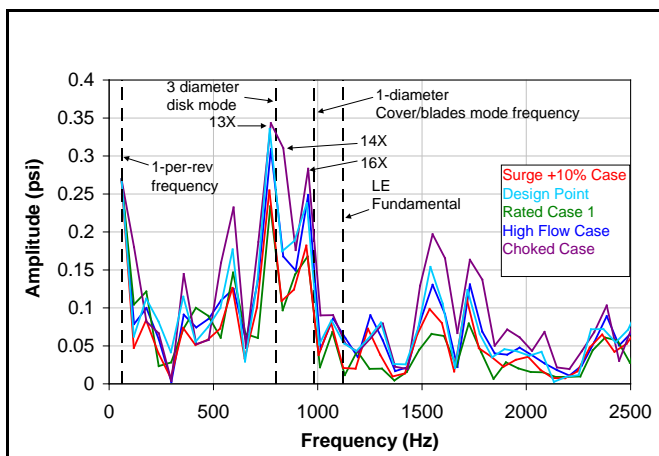
Figure 18. Fourth Impeller FFT plot of steady state CFD signals at impeller inlet

Similar to the 1-diameter cover/blades mode, mistuning is a category of vane wake resonance. It was however, graded with a higher confidence factor; 3 (likely) based upon the evidence uncovered from steady state CFD at near choke conditions. Figure 18 shows how the 14X harmonic becomes stronger as choked conditions are approached. Other harmonics would undoubtedly become greatly amplified during deep choke so that total excitation over the entire spectrum, in addition to 13X and 16X, were the most likely sources for crack initiation.

The strong 13X signal from the 14-vane side load is apparently caused by the nonuniform flow from the side entry. Flow entering from the side load nozzle is not turned completely to the radial direction by the vanes. This causes the strong wakes

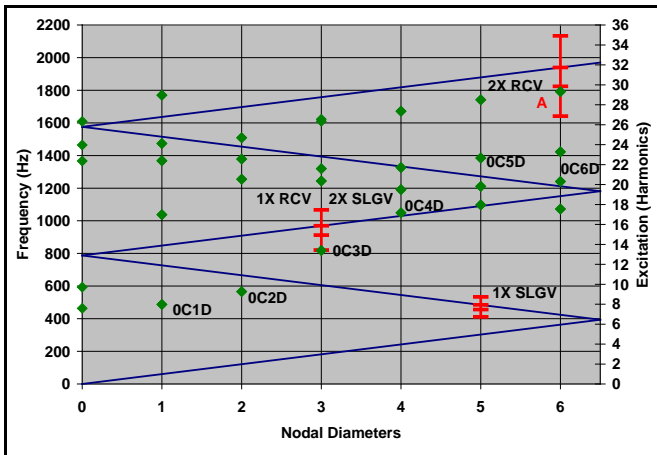
Figure 20. Fourth Impeller Interference Diagram change

This is a 6 nodal diameter pattern of the leading edge second mode at 1792 Hz. It would be resonant with 2 times the return channel vanes (32X) at 3360 RPM (slightly below minimum continuous speed). This mode would not be responsive as it is a second blade mode with a nodal line through the blade.

The interference diagram in Figure 20 shows even greater design margins compared to Figure 12, including the 1-diameter cover/blades mode that will be near 1100 Hz instead of 1000 Hz. In addition, changing the sideload inlet from 14 inlet guide vanes to 7 inlet guide vanes with spacing equivalent to 8 eliminates the 1 nodal diameter excitation potential. A potential resonance point is shown as point A.

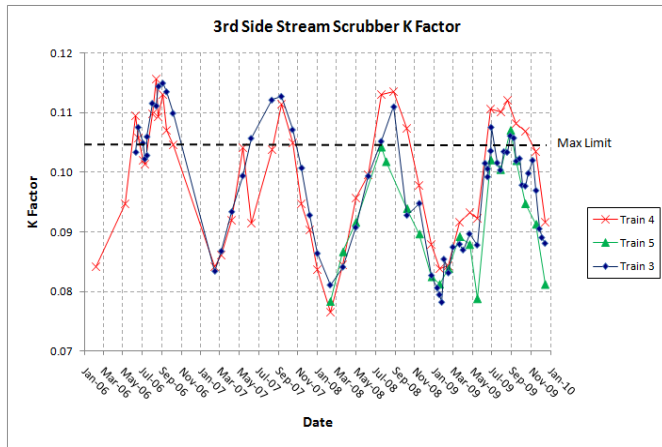
Figure 25. K factor for Trains 3, 4 & 5 - third side load

The analysis confirmed that the first and third side load scrubber mist eliminators had consistently exceeded their limits. Focus was however, given to the third side load because it was the worst case and is located immediately upstream of the fourth impeller. The results are plotted in Figure 25 for Trains 3, 4 & 5. The horizontal dashed line denotes the maximum limit. The plotted points were selected with the greatest measured flow rates to show the general trend throughout the year. A clear periodic swing is shown for each train as the volumetric flow rate varies between high during summer and low during winter. This is caused by the increased refrigeration duty as a result of the higher sea water cooling temperature in the hotter months. During the summer, Trains 3 and 4 exceeded the K-factor limit by as much as 10 percent. Train 4 was marginally worse in the latter two years. Data for Train 5, which began operating in early 2006, was unavailable before February 2008. This train only exceeded the limit by 2 percent in 2009.

The objective was to remove the possibility of mist carry over from the third side load scrubber. The obvious solution was to upgrade the mist eliminator to handle the required amount volumetric flow rate during the summer months. Consultation with the vessel OEM confirmed that a replacement would be possible to accommodate an extra 19 percent of flow. Considering the results in Figure 25, this would still leave a positive margin of approximately 10 percent. Site work could be easily incorporated within the next available scheduled train shutdown. It was decided to apply the same upgrade to Trains 3, 4 & 5.

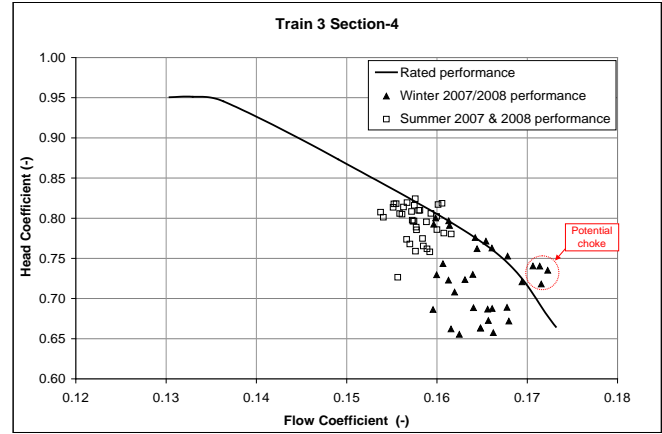
Figure 28. Fourth Section head versus flow coefficient – Train 3

The results are plotted in Figure 28 in the form of head coefficient versus flow coefficient for the fourth section. The rated performance curve determined by the OEM factory acceptance test is also included for comparison. In general the

points match the curve well although there is a larger scatter towards the end of curve. The winter points were located at the highest flow rates because of the greater gas turbine power available during that time of year. Based on the Flexware prediction, none of the points were found to be located beyond the end of the curve (in choke) however, four points during December 2007 were in the end of curve region as indicated by a ring in the plot.

In reality an error band of at least 3 percent is applicable to all the points shown, based on the calculation and measurement uncertainties discussed above. It is possible that the four marked points could have been operating in choke. Furthermore, the other programs indicated up to twelve points near the end of curve region with some points potentially in choke, or certainly in choke if considering a 3 percent uncertainty. Another observation is that the weekly flow trends, from which each point was selected, did not tend to fluctuate a great deal. This confirms that these adverse operating conditions would have persisted for hours or even days.
