# Reliability Improvement for Reciprocating Compressor Valve in CCR Reformer (Case study)

Lee Sang Suk (SK Innovation, Korea)

40<sup>th</sup> Turbomachinery Symposium

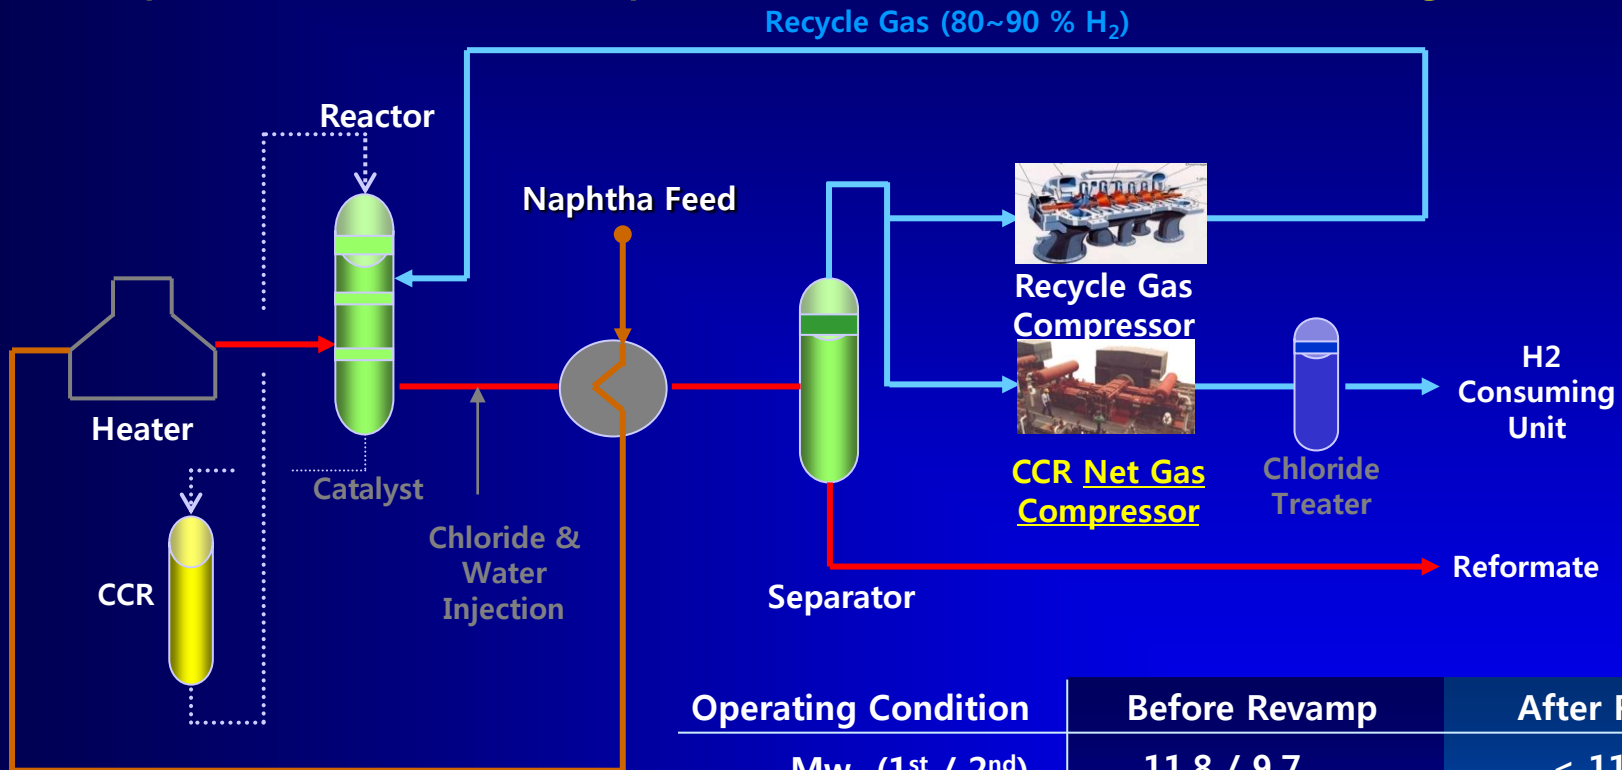
Reformer process was revamped where **all three net gas compressor run and process condition are changed**

Operating Condition	Before Revamp	After Revamp
Mw (1 <sup>st</sup> / 2 <sup>nd</sup> )	11.8 / 9.7	< 11.6 / 8.5
Suction Temp. (1 <sup>st</sup> / 2 <sup>nd</sup> )	40 / 38	49~52 / 38
Pressure Ratio (1 <sup>st</sup> / 2 <sup>nd</sup> )	2.38 / 2.78	3.14 / 2.83
Net Gas Compressor at Operating	2 out of 3	3 run out of 3

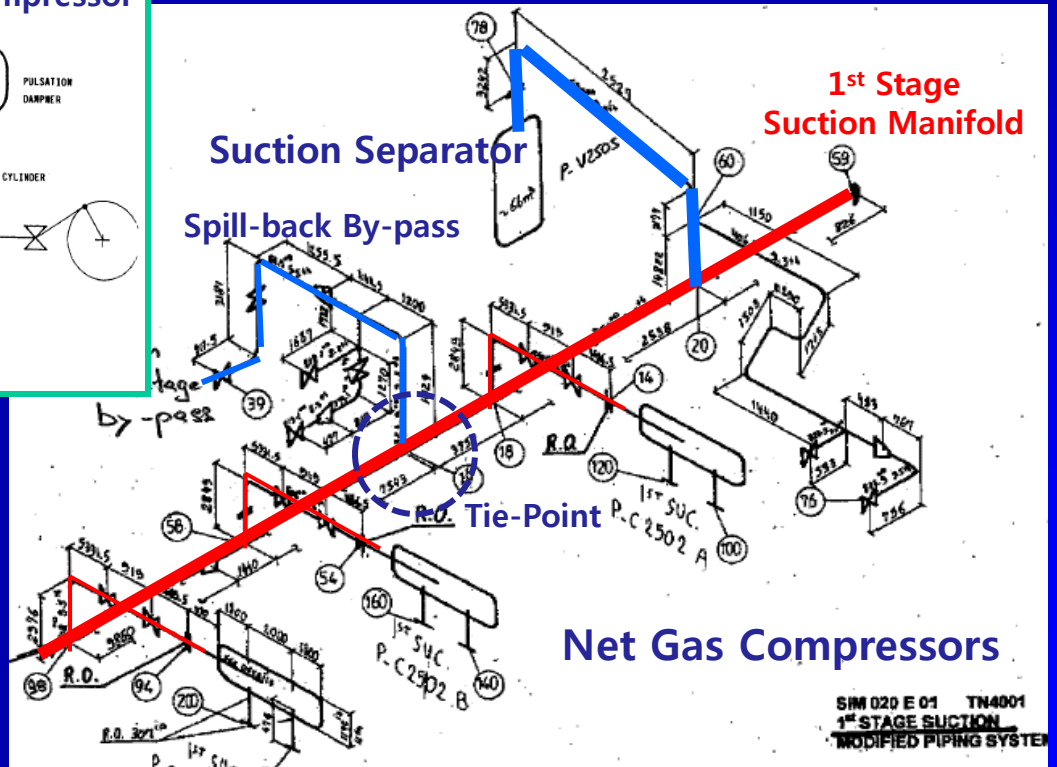
ISO Drawing (1st Suction)

Condensed liquid will be collected at suction manifold piping and can be ingressed to compressor suction as liquid slug because of its layout

- ③ **Drain traps were added** at end point of suction manifold to prevent accumulation of condensed liquid and let manifold **piping sloped** to ease collection to trap

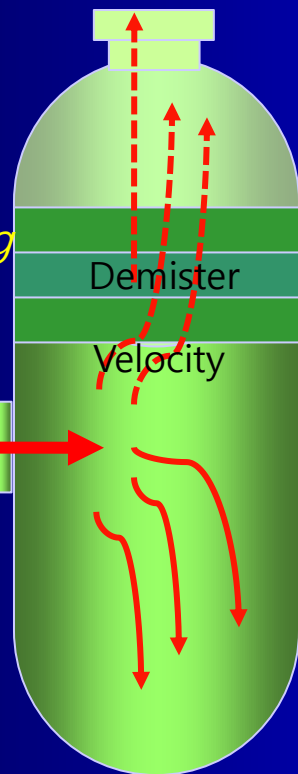
*To lower drifting of heavy hydrocarbon*

*As separator operating temperature decrease*

*~52 → 47 C*

- ① To Decrease Suction gas temperature decreased as low as possible to expect minimize of heavy hydrocarbon carry-over

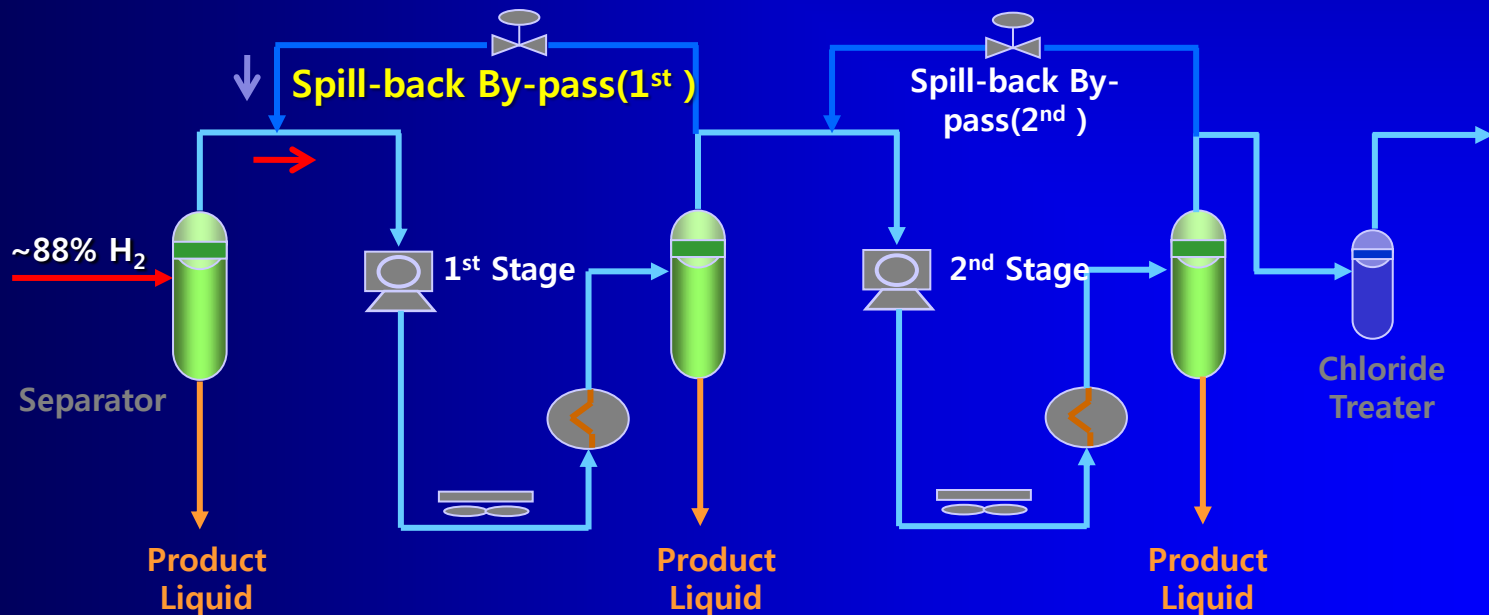
Stage	Before Improve	After Improve
Load	100 /100/100%(36,798 Nm <sup>3</sup> /Hr) (29 % spill-backed)	100 /75/75% (15 % spill-backed)

Reducing inlet flow condensing by reduced cold spill-back flow makes expected to give positive effect influence to compressor valve

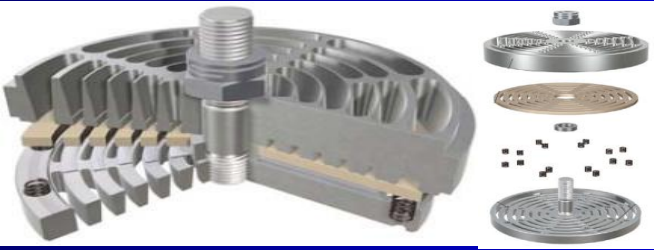
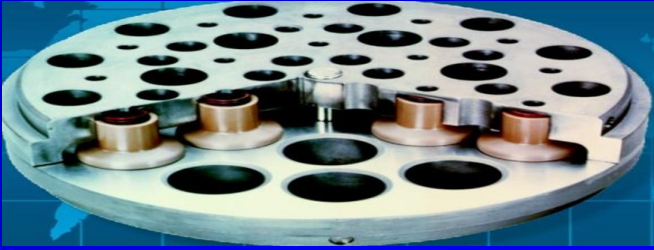
Type	Plate	Poppet
Shape

Remark	<ul style="list-style-type: none"> <li>- Widely Used (Economical)</li> <li>- Bounced at edge area at late closing by sticky liquid</li> </ul>	<ul style="list-style-type: none"> <li>- <b>Better at sticktion</b> (from a inherent structure)</li> <li>- Wear at edge of poppet</li> <li>- <u>Recently widely used and life proven for CCR</u></li> </ul>

Possible Cause	Solution	Implementation Phase
✓ <b>Excessive valve impact stress</b> by late closing at a presence of sticky hydrocarbon	⑤ To change valve type from plate to "poppet" valve to minimize sticktion	Phase I
