39th Turbomachinery Symposium

PREVENTION OF SHAFT END DAMAGE DUE TO HIGH CONTACT PRESSURE

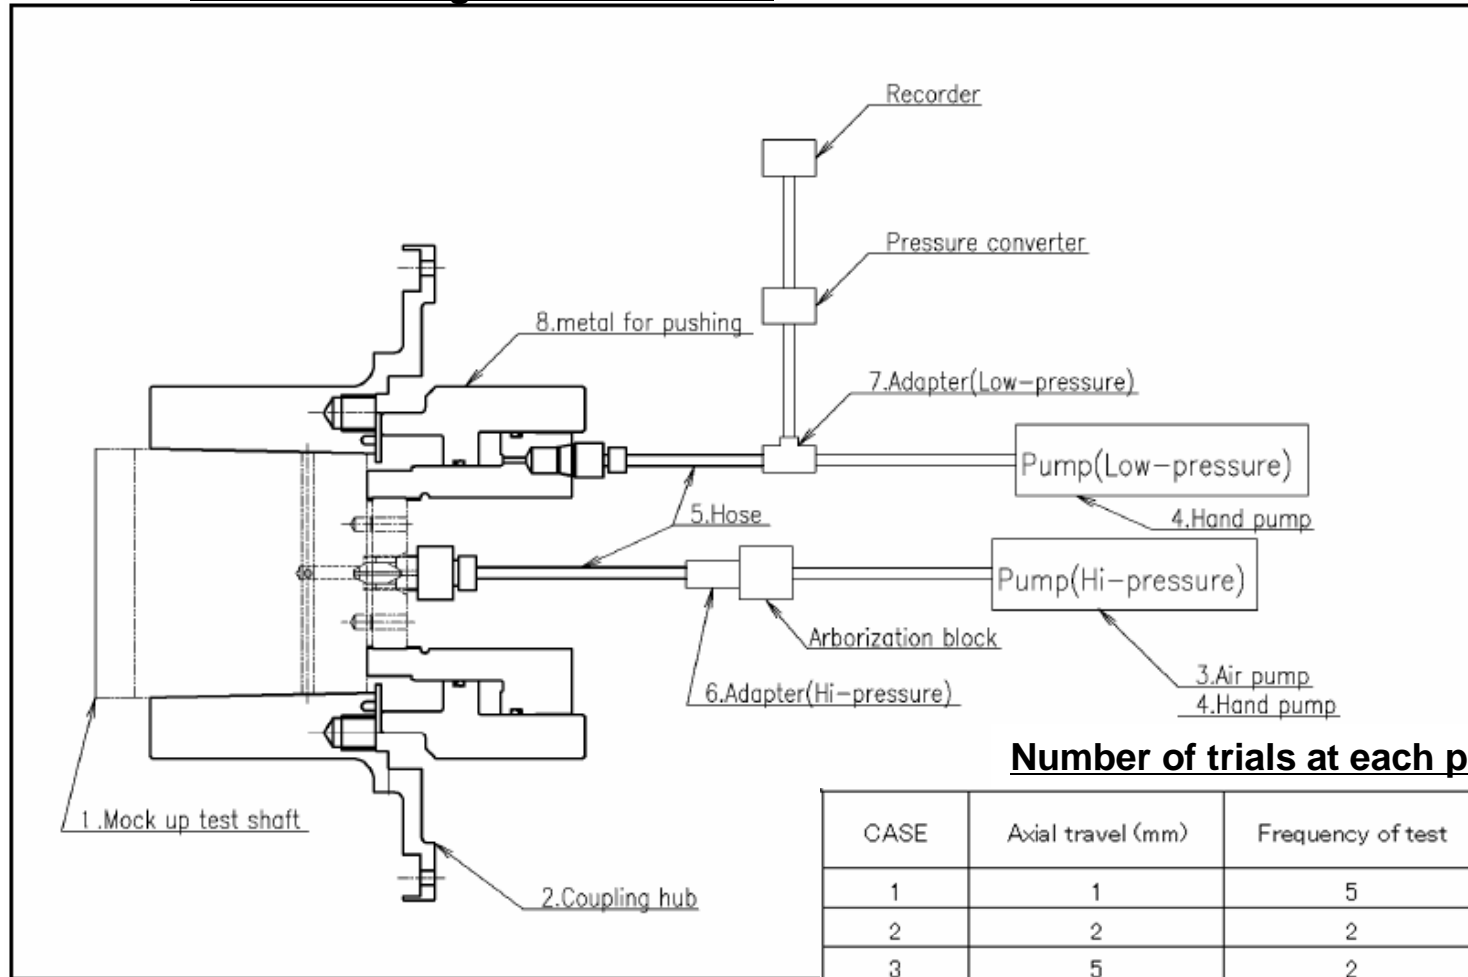
Test tool arrangement schematic

Mock-up Test Arrangement (8 inch hub)

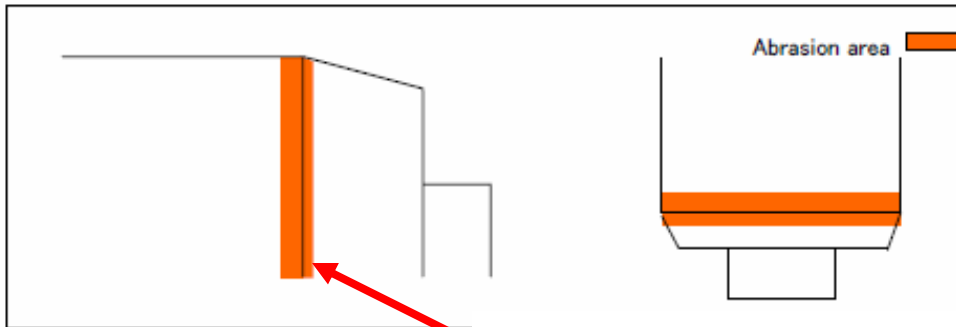
Reconditioned dummy shaft geometry

Additional material removed from abrasion area to restore surface finish

Relief groove depth was increased to prevent damage.
