# Intermittent Spikes on Vibration and Motor Current Caused by Water Carry Over on the 3rd stage of a Centrifugal Air Compressor.

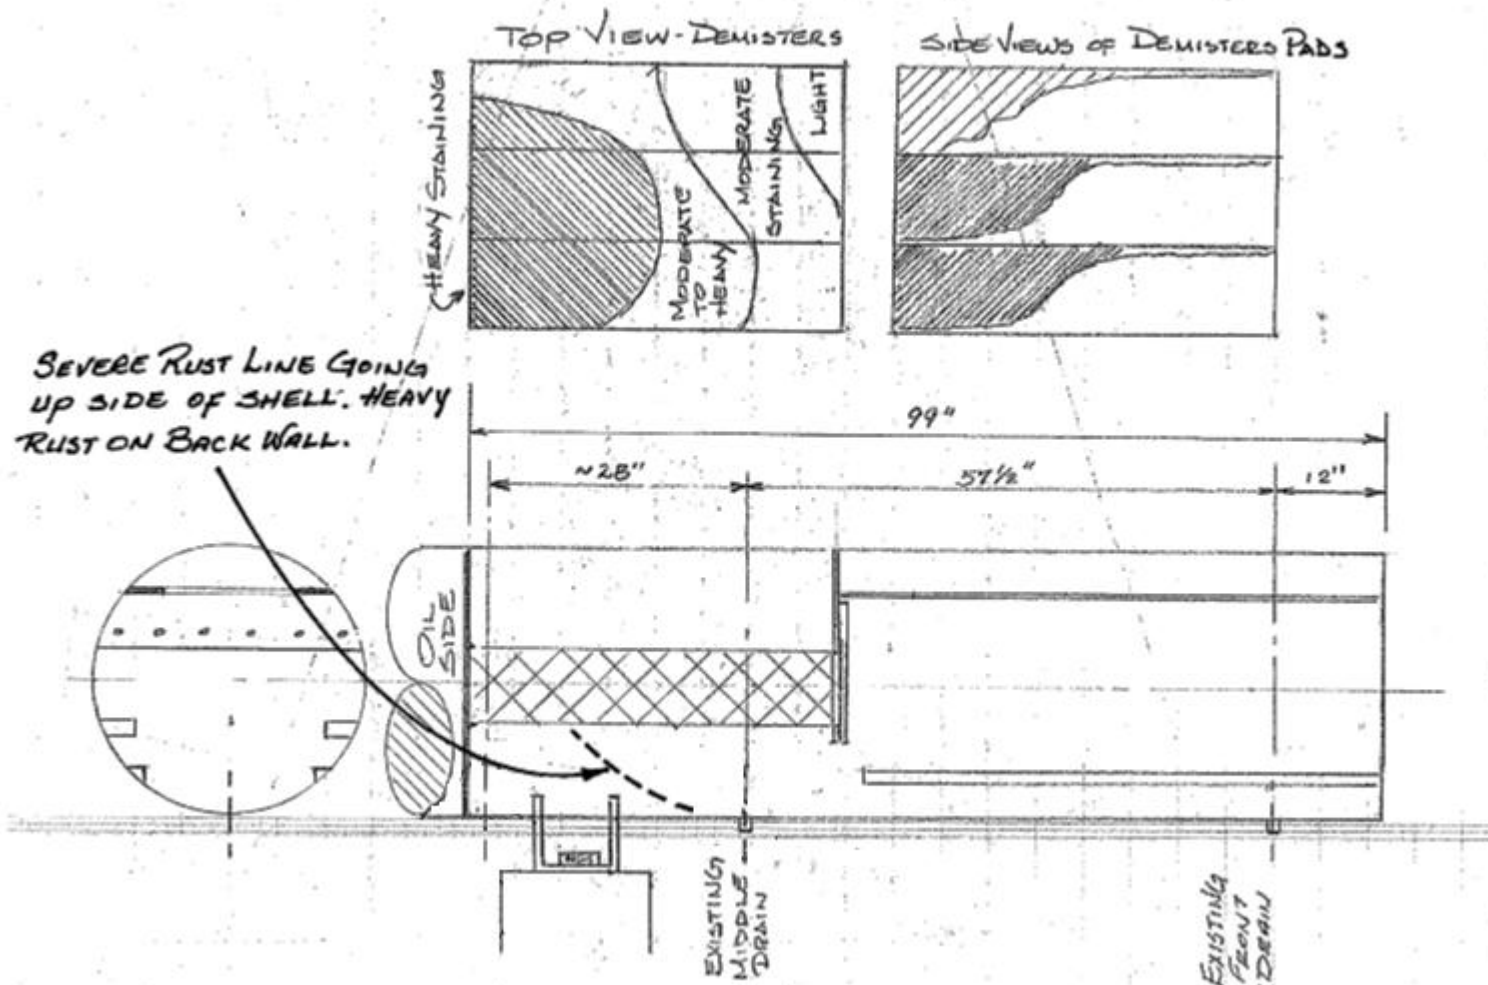
Demister pads on Second Intercooler (between 2<sup>nd</sup> and 3<sup>rd</sup> stage) showing rust and corrosion scale

- ❑ Replaced the rusted 3<sup>rd</sup> stage inlet pipe with a new stainless-steel inlet pipe.
- ❑ Coated the second intercooler shell with epoxy (Carboline 450)
- ❑ Replaced the 3<sup>rd</sup> stage original bearings with a new flex-pivot bearing that was designed as an upgrade retrofit.
- ❑ Installed a baffle above the 2<sup>nd</sup> intercooler drain connection.
- ❑ Added a second drain connection at the rear of the 2<sup>nd</sup> intercooler where we believed we had standing water.
- ❑ Replaced the old, malfunctioning water traps with “Drain-Alls.”

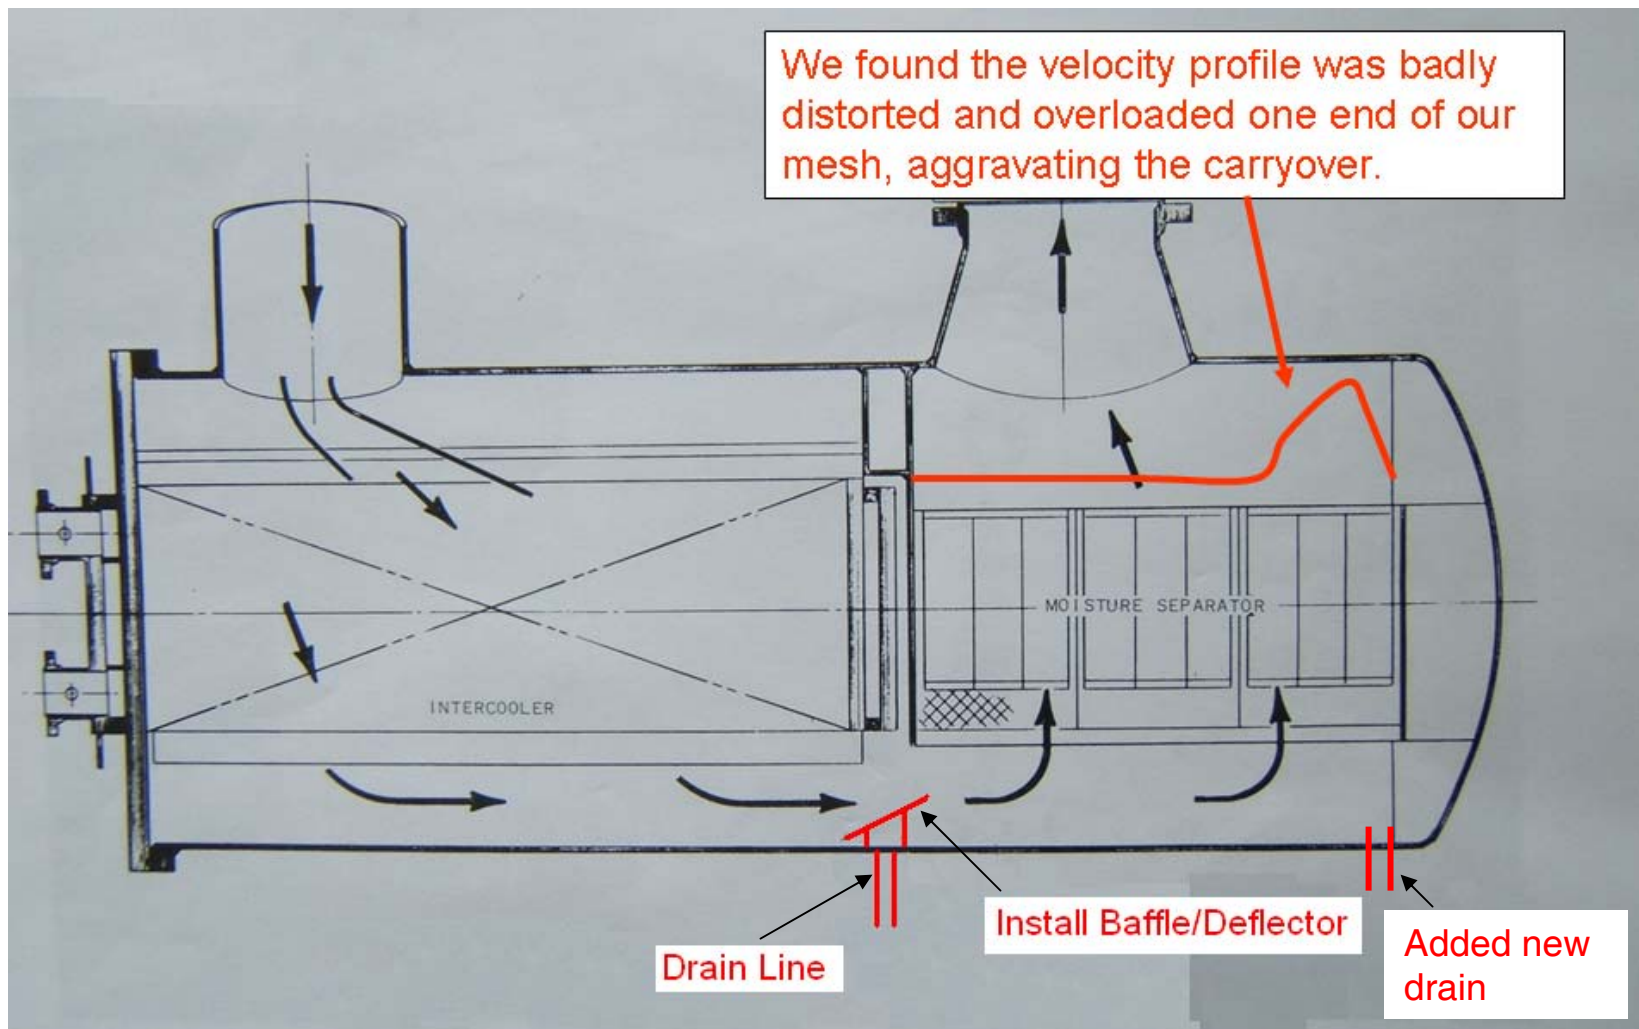
# Modifications – 2<sup>nd</sup> intercooler

- The water also rusted out the 2nd intercooler shell, fouled the demister pads, badly corroded the 3rd stage inlet pipe and caused erosion at the base of the blades on the impeller.
- Water did not exit the 2nd intercooler drain line as expected. High velocity air along the bottom of the cooler was pushing water to the back of the cooler and preventing it from draining properly at the centrally located drain connection
