**37<sup>th</sup> Turbomachinery Symposium**

**Case Study:**

***TORSIONAL OSCILLATION TROUBLE ON VFD MOTOR DRIVEN RECIP COMPRESOR***

***High vibration problems including failed coupling parts on a VFD motor driven reciprocating compressor are analyzed and the root causes and solutions are discussed in this costly field issue.***

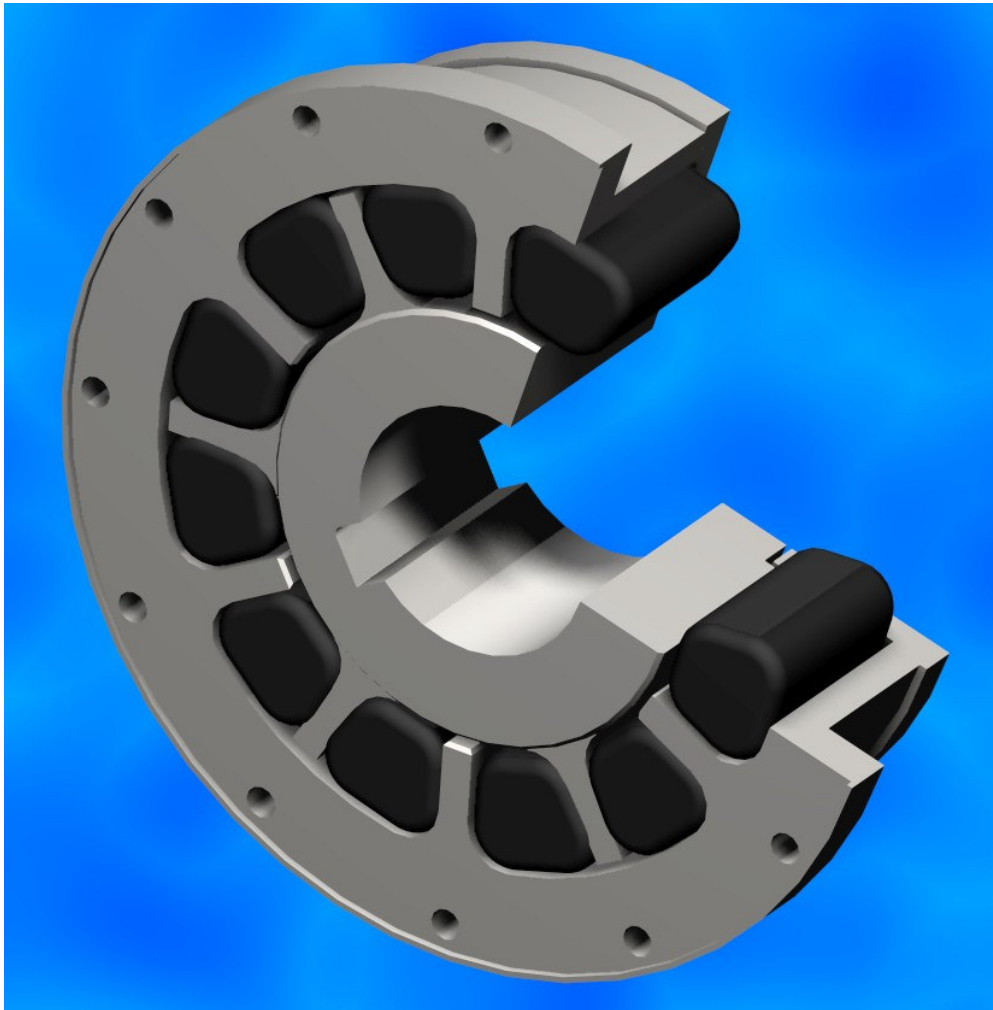
- VFD Controlled Electric Motor Driving a 4 Throw Reciprocating Compressor (1230 Kw @ 600 RPM – 1000 RPM)
- Connected by an Elastomeric Block Type Coupling
- High Vibrations Noticed on the Motor

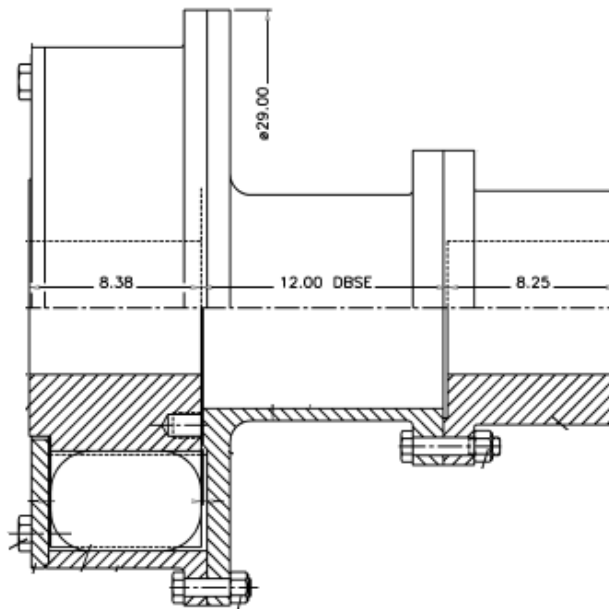
## MASS ELASTIC SYSTEM

- J1 = (1/2 BLOCKS + HUB) = 40.13 LB-IN-SEC<sup>2</sup>
- K1 = BLOCK STIFFNESS = 4.65 X 10<sup>6</sup> LB-IN/RAD
- J2 = (1/2 SPACER + SLEEVE ASS'Y + 1/2 BLOCKS) = 51.34 LB-IN-SEC<sup>2</sup>
- K2 = SPACER STIFFNESS = 480 X 10<sup>6</sup> LB-IN/RAD
- J3 = (1/2 SPACER + RIGID) = 45.70 LB-IN-SEC<sup>2</sup>

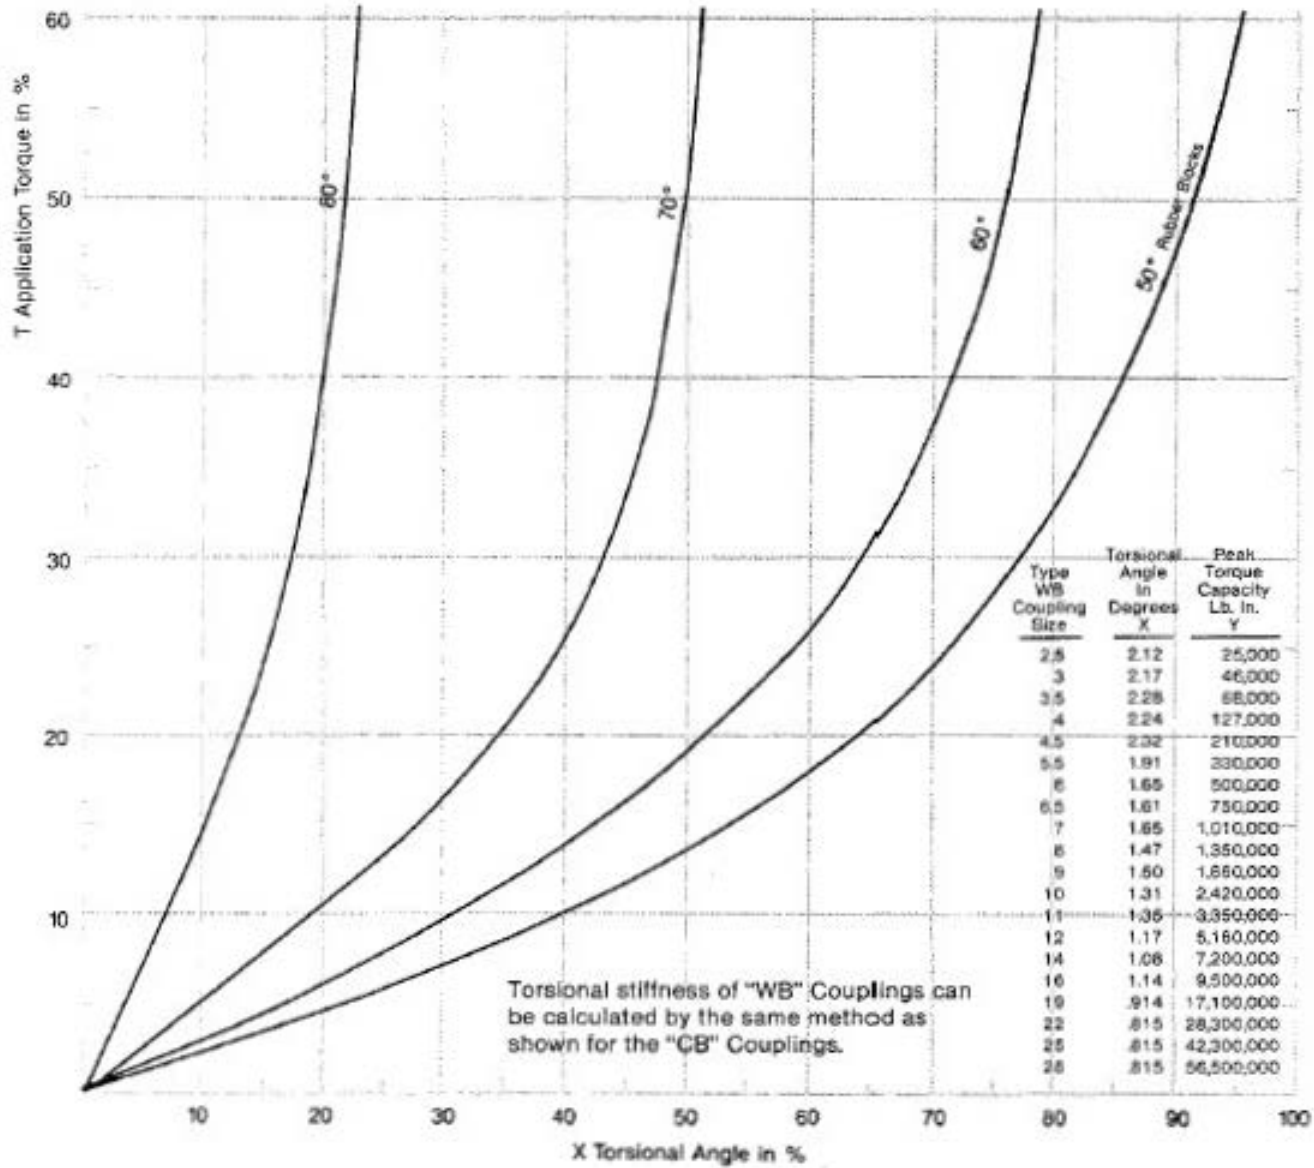
- Original Torsional Analysis Reviewed by Coupling Vendor
- Issues Found
  - Only One Coupling Stiffness Used in Model (Block Coupling Stiffness Varies with Torque and Alignment, Amongst Other Factors)
    - Tolerance
    - Durometer, Age
    - Temperature
