TurboExpander Wheel Damage Analysis

A Case Study

Introduction

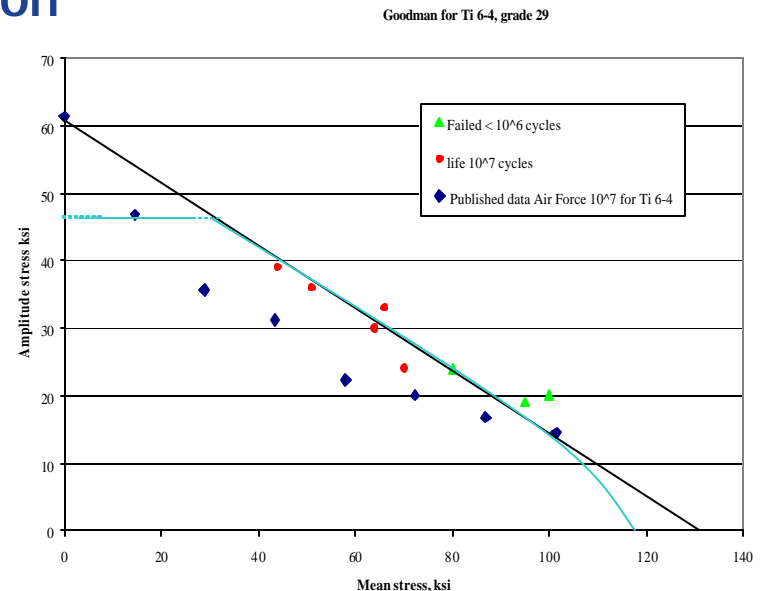
- Material tests show no influence of environment
- Tensile tests & % elongation in the specified range
- Goodman diagram created from fatigue test data meets expectation

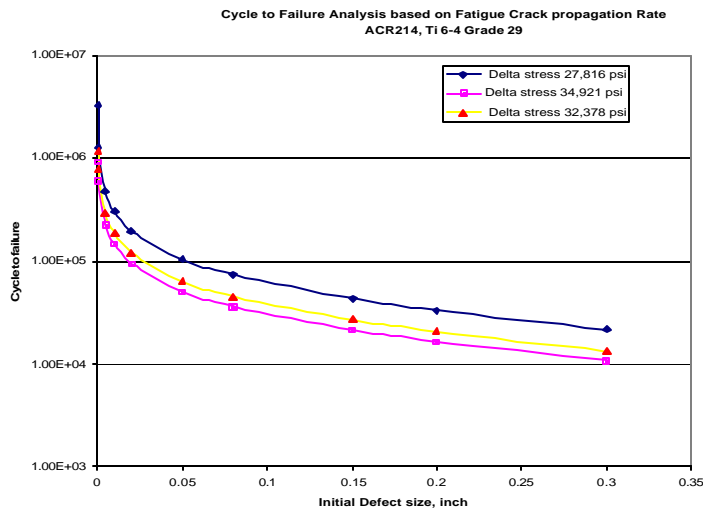
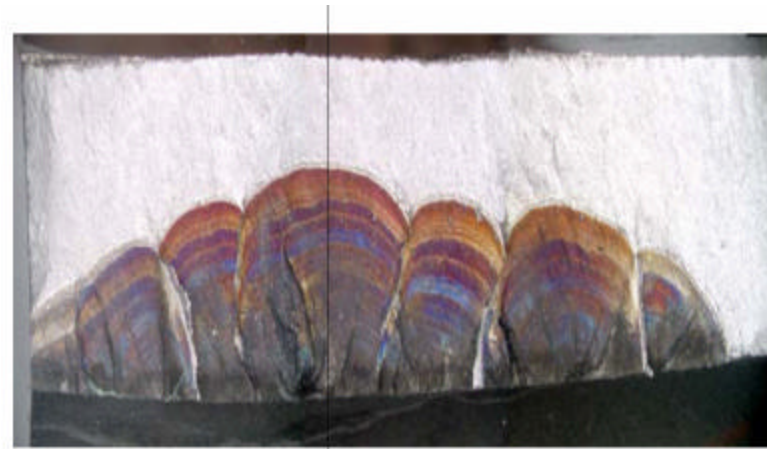
- Fatigue crack growth rate SEM test data matched to empirical data/ striations

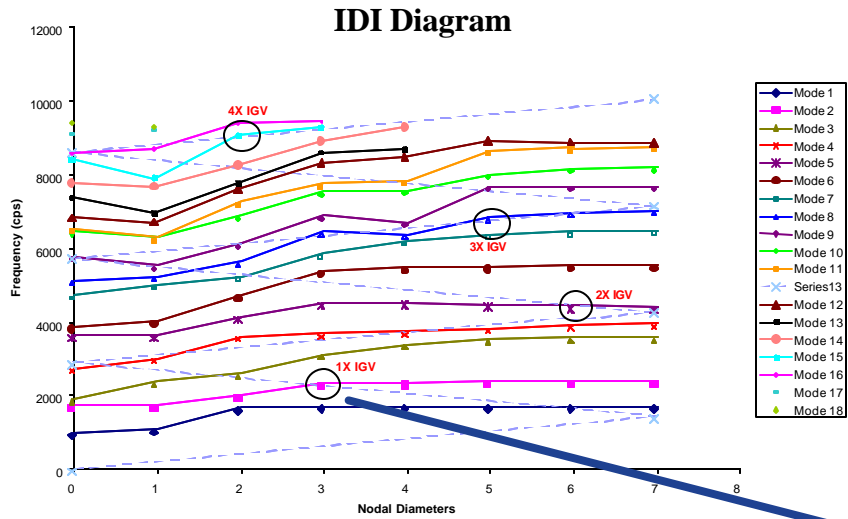
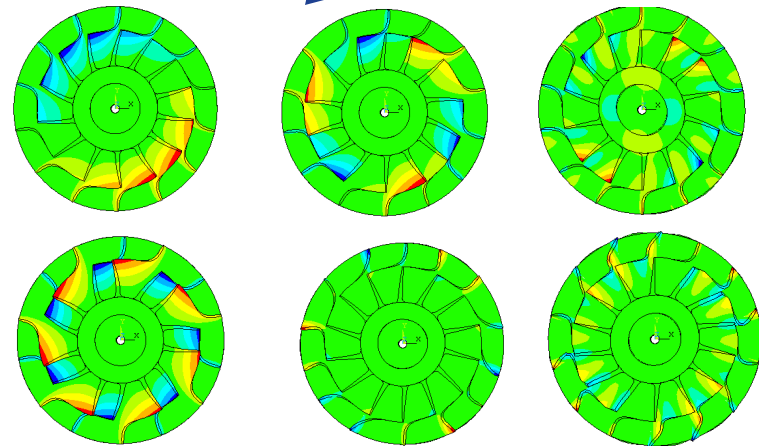
- Which mode is causing this reduced life of wheel?
- Modal Analysis completed and variation examined to modes in the operating range.....
- Transient (start ramp) modes needed further examination to see which mode shape matched to fracture pattern

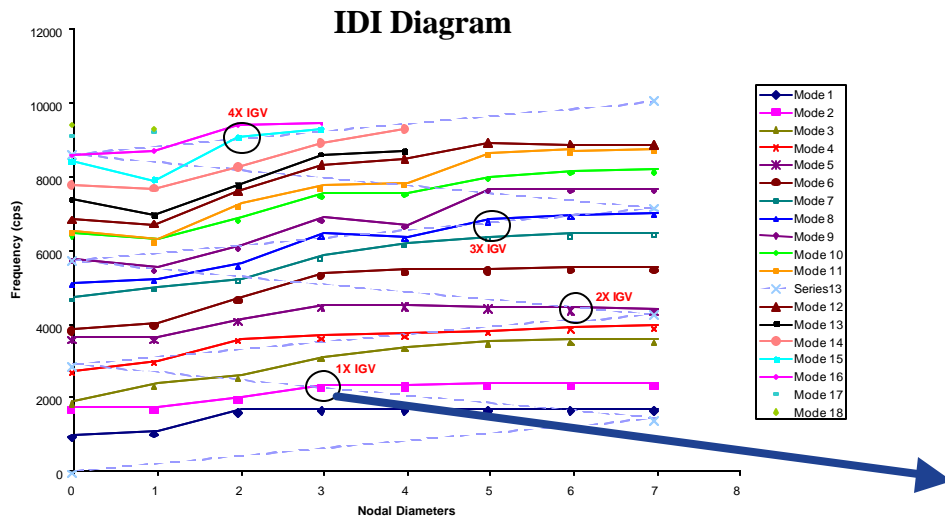
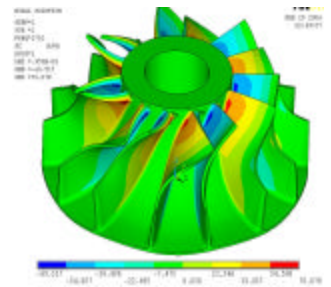
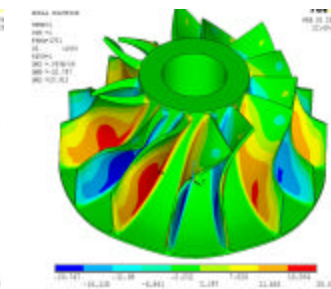
Forced Response Analysis

Up to 4XIGV excitation was considered for forced response analysis.

List of estimated response due to various harmonics IGV

Order of Excitation	Alternating Stress, psi
1xIGV	7515
2xIGV	2625
3xIGV	1436
4xIGV	1756

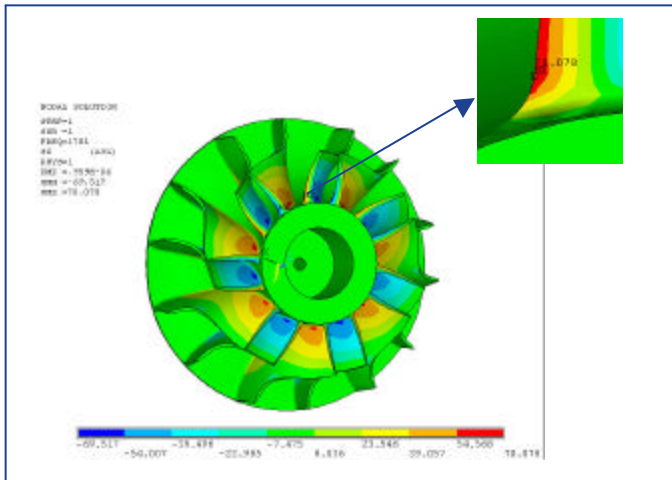
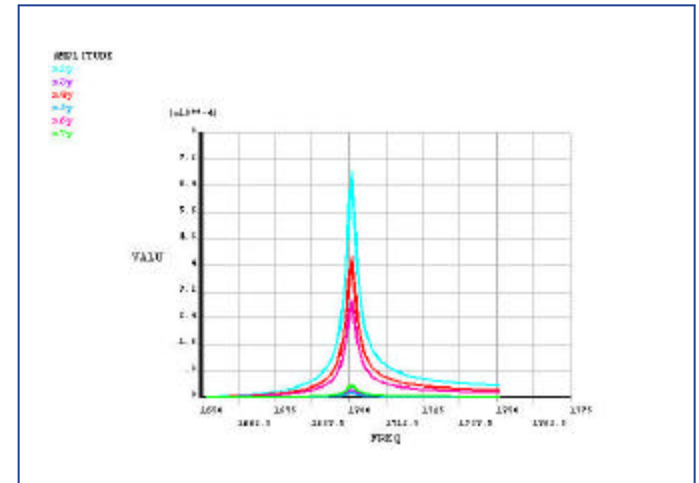
Displacement Vs Frequency of excitation

Peak/ ALT stress amplitudes were examined from Forced Response analysis to the fatigue seen in blade....

No one mode had alternating stress within 10X of that from SEM results.
