ANALYSIS OF HOT SECTION FAILURES ON GAS TURBINES IN PROCESS PLANT SERVICE

BWD Turbines Limited

ABSTRACT

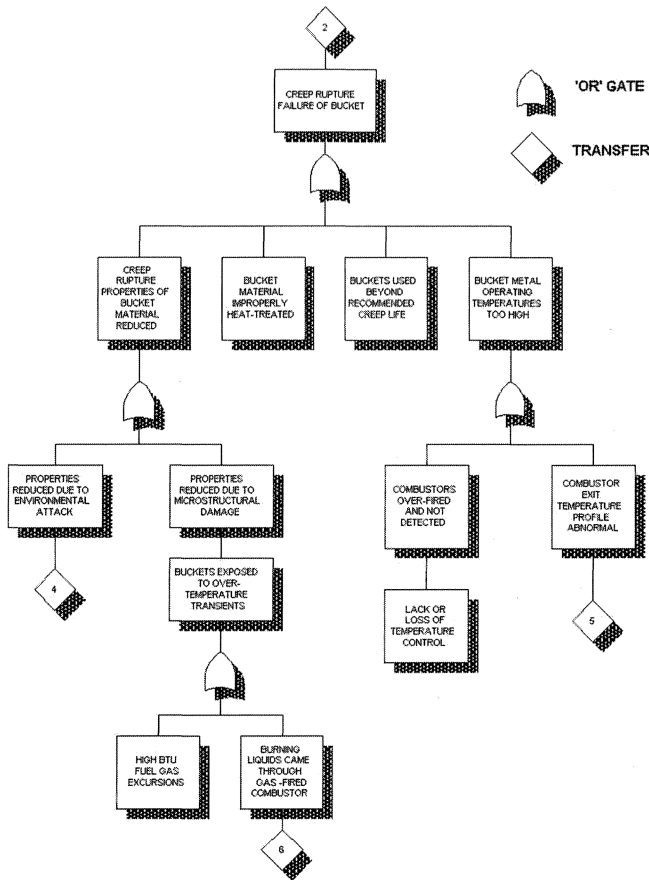
Since fault trees can be quite extensive, only portions can be included in this paper. Parts of two representative diagrams are shown. The diagram, shown in Figure 3, was actually developed following another fault tree put together by the plant investigation team subsequent to a catastrophic turbine failure (Case History B). This first fault tree had been used to help systematically eliminate turbine operational factors, such as instrumentation and control system faults, as causal factors in the failure, thereby narrowing down the range of possibilities to mechanical degradation of components. These issues were then specifically addressed in the second phase of the investigation for which the fault tree here was created. Figure 3 shows an intermediate "branch" of the tree concerned with failure by creep rupture. Other portions of the diagram considered high cycle fatigue, foreign object damage, etc.

Figure 3. Intermediate Branch of Fault Tree Diagram Used to Analyze the Failure Described in Case History B.

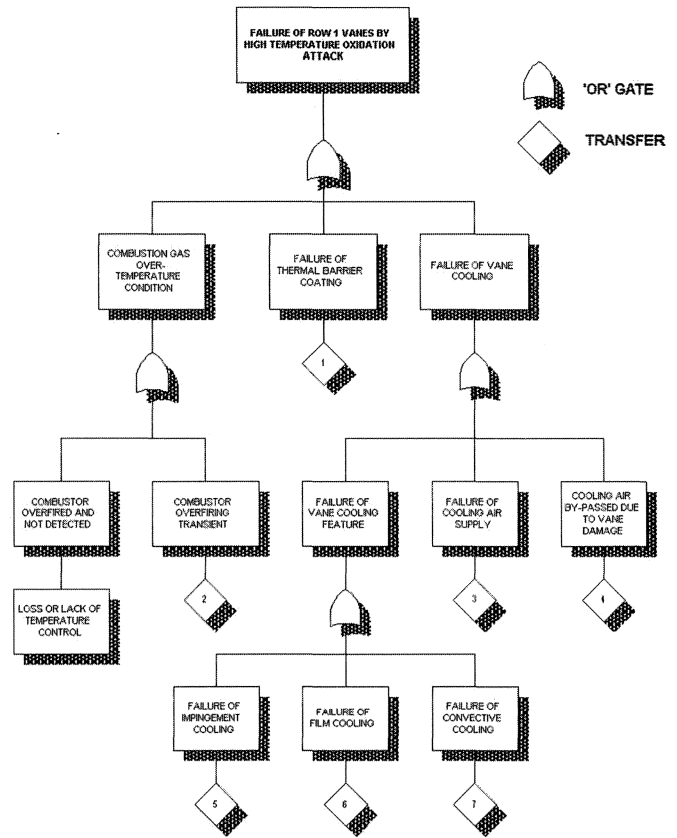
Figure 4 shows the "top" part of another fault tree. This diagram, prepared for Case History D, explored the potential causes of severe

overheating damage to a row of cooled turbine nozzle vanes. Cause-and-effect chains were developed for exposure of the vanes to excessively high gas temperatures and for failures of the cooling on the vane that comprised impingement, convection, and film features.

Figure 4. Top Portion of Fault Tree Diagram Used to Analyze the Overheating Failure of Cooled Vanes Described in Case History D.

As part of the failure analysis, a fault tree was created (Figure 4). Based on the condition of the combustor baskets, transition pieces, first stage rotating blades, and other evidence, it did not appear that the nozzles had been exposed to abnormally high gas temperatures. A cooling failure scenario was more probable, therefore.
