# GAS TURBINE BLADE FAILURES—CAUSES, AVOIDANCE, AND TROUBLESHOOTING

by  
**Cyrus B. Meher-Homji**  
Engineering Specialist  
Bechtel Corporation  
Houston, Texas  
and  
**George Gabriles**  
Consultant  
G&B Consultants  
Lake Jackson, Texas

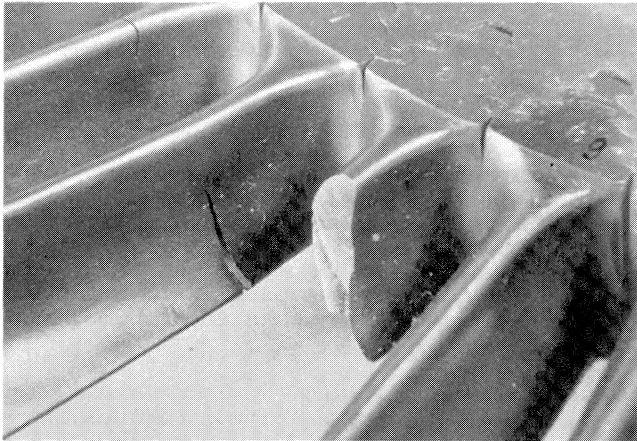
Figure 2. Fatigue Failure on a Turbocharger Used on the Heinkel 111 Aircraft. (Courtesy of Dr. Max Bentele)

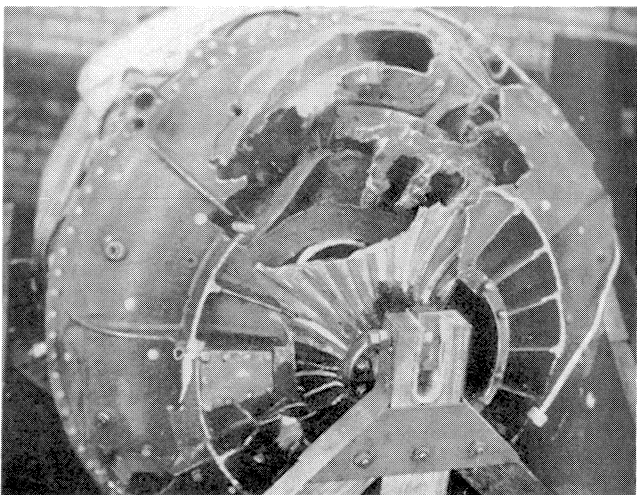
Figure 3. Impeller Failure of One of Whittle's Early Jet Engines. (Meher-Homji, 1997)

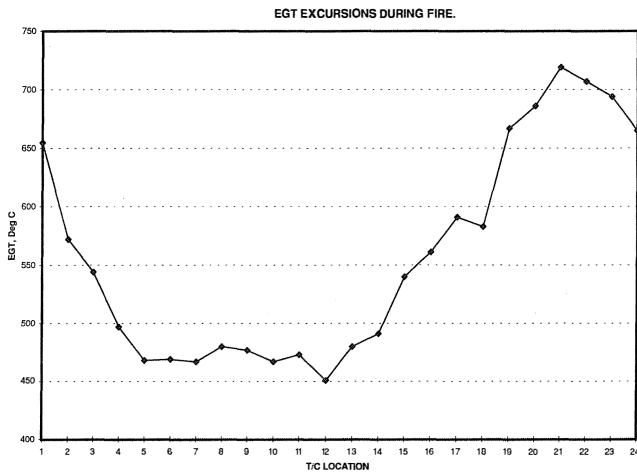
On the day of the failure, the machine tripped and a purge cycle was initiated. An exhaust gas temperature (EGT) scan made indicated a maximum temperature of 1346°F (730°C), which was much higher than the expected 932°F (500°C). An EGT spread of 500°F (277°C) was also noted. The exhaust gas temperature profile that occurred is shown in Figure 20. Blade metallurgical analysis confirmed that catastrophically high temperatures had been reached. A gamma prime phase modification was found in the microstructure of the blade material.

This high temperature occurred as the engine took fire (autoignition) in an uncontrolled manner, with a fire occurring in the third stage blade area of the machine. The tip shrouds of the

Figure 20. Exhaust Gas Temperature Profile Distortion During Fire (Showing Temperatures as High as 730°C).

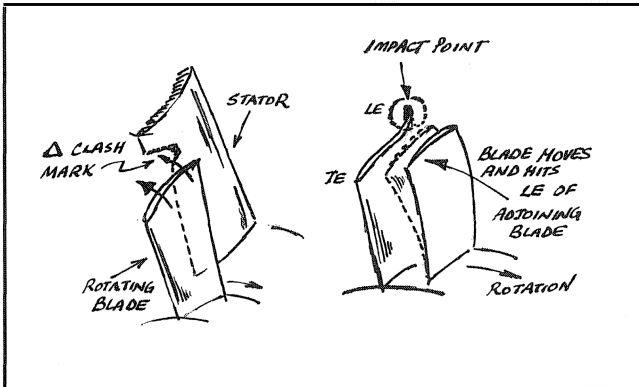
Blade “clash” and “clang” are descriptive terms applied to damage in the compressor that typically results from surge. Clashing is the term given to stator-rotor contact due to the high blade deflections caused by the surge event. Blades clash with the trailing edges of the prior stator vanes. This often results in a characteristic triangular impact mark on the vane as shown in Figure 23. Blade clang occurs when groups of rotating blades deflect, causing the tip trailing edges to strike the leading edges of the adjacent blades on the pressure sides (Dundas, 1993b; Walker, 1987). Damage caused due to a clash failure is shown in Figure 24. A photograph of a stator blade that failed in fatigue is shown in Figure 25.

Figure 23. Blade Clash and Clang.

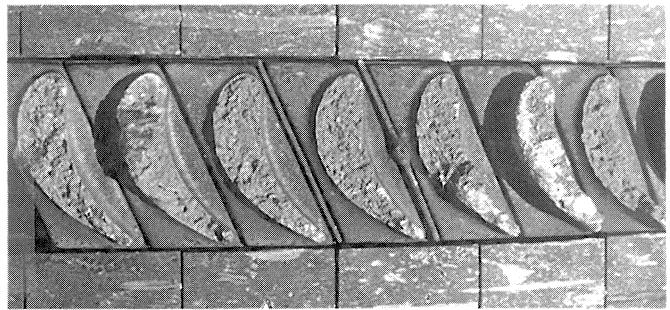
The result of FOD on a gas turbine compressor rotor is depicted in Figure 29. The fracture surfaces of an FOD failure are typical of impact overload and display a “candy rock” appearance as shown in Figure 30. Some relatively minor FOD damage on a turbine stator vane is shown in Figure 31. It is important to note that often the *root cause* of the problem is lost when a pronouncement is made that the damage is due to FOD. Unfortunately, FOD tends to become a “catch all” failure mode when no other clear explanation exists.

Figure 30. Typical “Candy Rock” Appearance of Damaged Surface with Impact Overload Type FOD Damage.

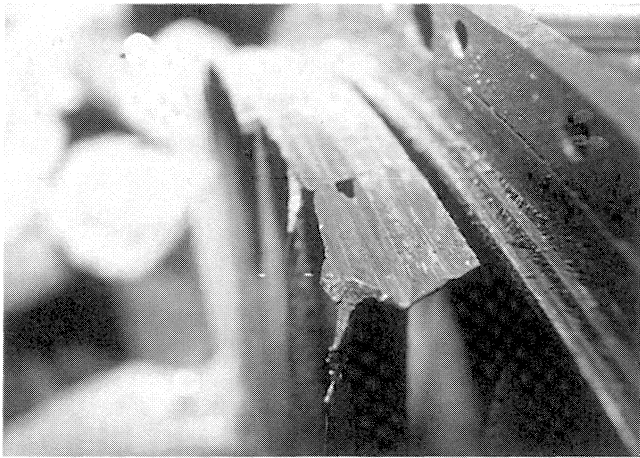
A rub on the tip of an axial flow compressor is shown in Figure 32. A severe radial blade tip rub is shown in Figure 33. The blade tip shroud has been severely rubbed in this case.

Figure 33. Severe Shroud Tip Rub in Turbine Section of an Aeroderivative Gas Turbine.

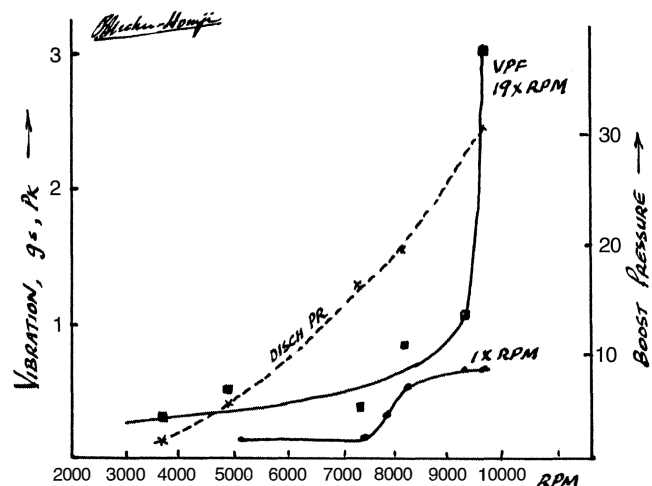
This case pertains to a 10,000 rpm centrifugal turbocharger that had undergone an uprate. Upon startup, as turbocharger speeds exceeded 9,400 rpm, high vibrations at predominantly the vane passing frequency (VPF) appeared. Figure 39 shows a graph made to troubleshoot the problem in the field. Graphs such as these are valuable as they provide the troubleshooter with a quick feel for the situation. The rapid growth of the vane pass frequency at 19× rpm and its extreme sensitivity to speed is evident from the graph. To investigate the vibration behavior, accelerometers were mounted on the turbocharger and data were taped on a AM/FM recorder. A real time analyzer was used to obtain an instant correlation between vibration and noise. Concurrently, dynamic pressure at the compressor discharge was measured and recorded. Three test runs were made including an initial test run, and runs with and without the inlet silencer. The test run data were analyzed on an RTA, and an examination made of the vibration with and without the inlet silencer. These indicated that the silencer was accentuating the problem.

Figure 39. Graph to Show Vibration Response on Centrifugal Impeller (Showing Sensitivity of the Vane Passing Frequency (19×rpm) with Speed).

Physical inspection of the inlet silencer revealed distortion of the intake baffles, which resulted in nonuniform compressor air flow. Even though the distorted silencer existed prior to the rerate, the new flow/pressure characteristics created conditions conducive to stall. Mitchell (1975) has documented a case where approaching surge caused a tenfold increase in vane pass frequency amplitude.

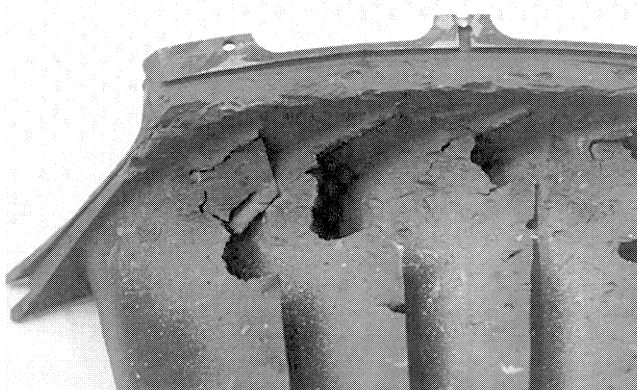
The liberation of a blade or ingestion of debris or combustor hardware can cause massive hot section damage. Damage surfaces bear the characteristic impact overload pock marks. Frequently, a parabolic trajectory pattern can be noted on the stator segments, as can be seen in Figure 48.

Figure 48. Typical Parabolic Trajectory Caused by an FOD/DOD Failure.

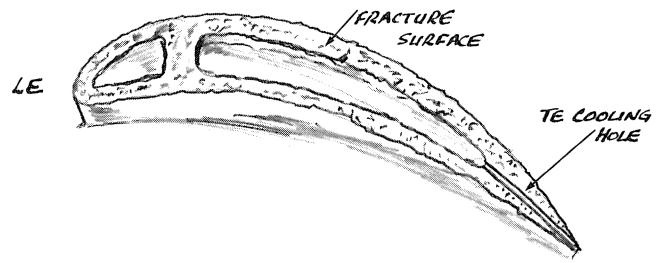
The observation that the aft portion of the fracture surface on a first stage blade was caused by fatigue, suggested that a fatigue mechanism was present. Observations of the trailing edge (TE)

region of another first stage blade indicated that hot corrosion damage had reduced the pressure side wall of the lowest cooling hole to an extreme thinness. This, in conjunction with the fact that the plane of maximum bending stress coincided with this hole, explained the nucleation and propagation of a fatigue crack. The failure location is shown in Figures 54 and 55.

Figure 54. Sketch of Fracture Surface Bisecting Bottom of TE Cooling Hole.

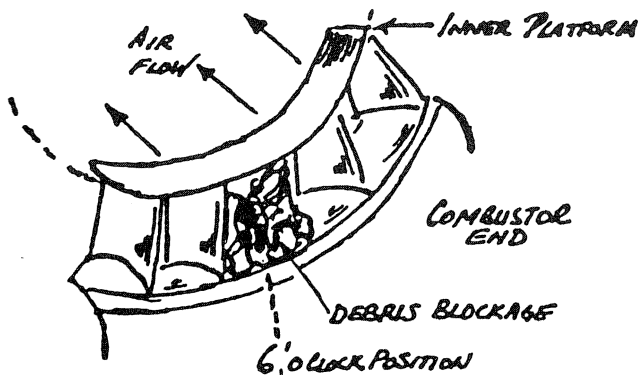
Figure 56 shows a sketch of the section of the brick that was found lodged in the six o'clock position of the nozzle, accounting for a blockage of about 80 percent of that vane space. This was a significant contributing factor to the failure, as blockage of this nature produced damaging vibratory stresses on the rotating blades by disrupting airflow.

Figure 56. Sketch Showing Brick Trapped in Nozzle Segment.

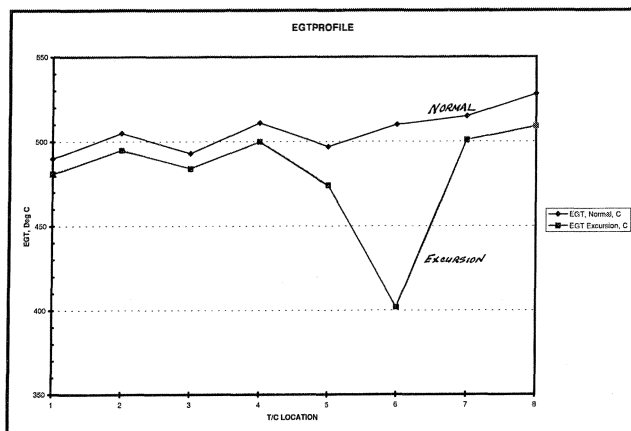
A graphical plot was made of the EGT profile, based on the eight exhaust temperature thermocouples, and is presented in Figure 57. In general, the pattern held reasonably well, except for an excursion in the data a few days prior to the failure. Of considerable significance was the fact that for two consecutive hours, thermocouple No. 6 exhibited a significant drop in temperature to 405°C, when the expected value was 490°C.

Figure 57. EGT Temperature Profile Excursion Due to Stator Nozzle Blockage.

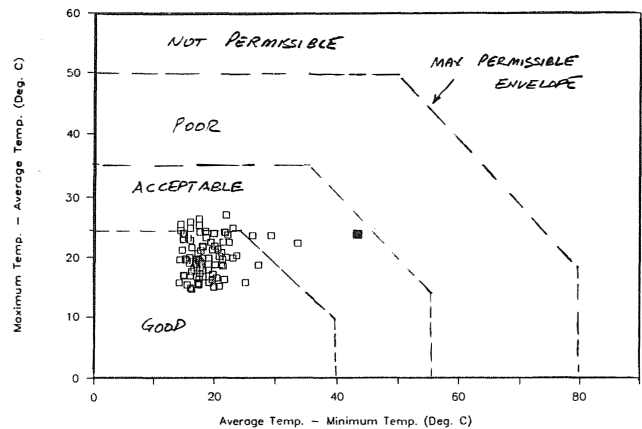
With respect to the temperature spreads, an X-Y scatter plot was created from log sheet data, by plotting  $(EGT_{Avg} - EGT_{min})$  on the abscissa and  $(EGT_{Avg} - EGT_{max})$  on the ordinate. This is shown in Figure 58. It is interesting to note that whereas all the

data were within an “acceptable zone” defined by the OEM, there was a significant excursion on the day of the failure. All other data points were highly clustered around coordinates (20, 20).

Figure 58. Excursion of Exhaust Temperature Spread. (This clearly shows the importance of monitoring the qualitative shape of the profile to detect changes that may still be within “acceptable” numeric limits.)

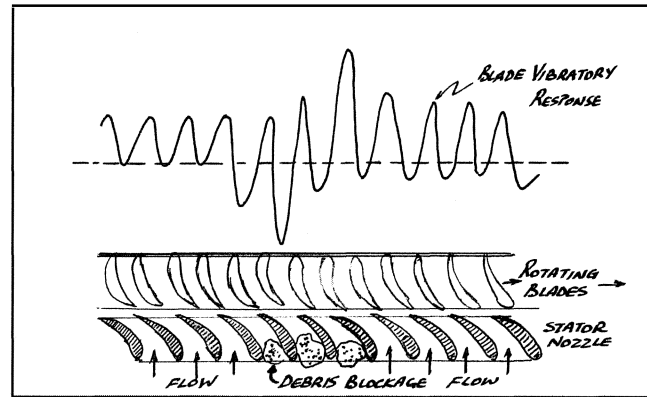
The effect of the blockage was to increase vibratory stresses on the blades, resulting in abrupt loading/unloading as the blades traversed this position, as shown in Figure 61. This situation is analogous to partial admission shock loading in a steam turbine. Due to the blockage, the localized mach number and pressure drop affected rotating blade loads. It is difficult to analytically predict the effects of blockage as the severity would depend on the excitation magnitude and the damping associated with the excited mode. However, it is common knowledge that blockage of this nature can promote fatigue failures. Impulse harmonics and weakening of the blade due to sulphidation worked in unison to promote the failure.

Figure 61. Increase in Blade Vibratory Stresses Due to Blockage.

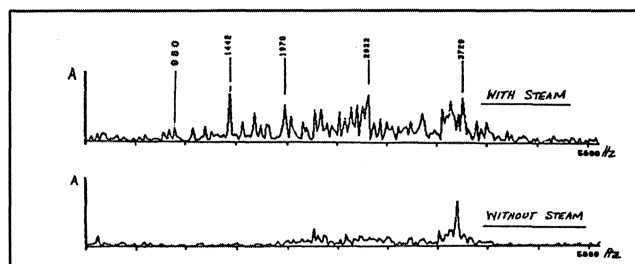
The vibration response with and without steam injection is shown in Figure 62. This shows how blades resonated as a result of steam injection. Figure 63 depicts the vibration behavior as steam flow increases, indicating an increase in excitation at frequencies of 980 Hz, 1442 Hz, and 1978 Hz (which were close to the blade natural frequencies). The vibration analysis indicated two problems:

Figure 62. Vibration Response With and Without Cooling Steam Injection.

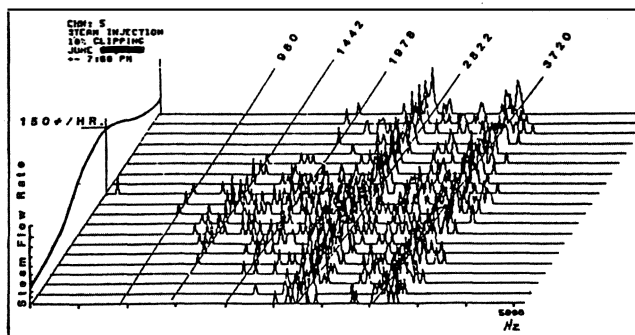
Figure 63. Accelerometer Based Vibration Cascade Showing Resonance Response with Steam Injection.

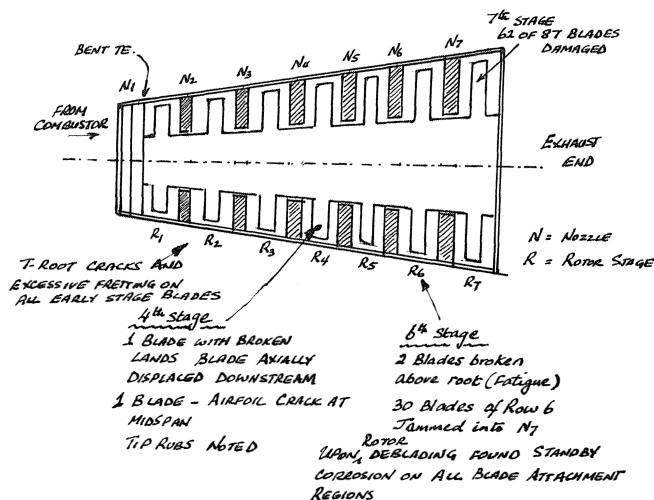
- One blade in the fourth stage had migrated and was found cocked axially. This blade was found to have suffered a total failure in the leading edge T-root section (both lands), as shown in Figure 64.
- Severe damage was found in the sixth stage blading with two blades being found broken approximately 1.25 inch from the base. Fracture surfaces were typical of fatigue. One of the fatigued blades is shown in Figure 65.
- Severe blading damage was found in the seventh stage (DOD).
- Vanes in row 6 and 7 were severely damaged (DOD).
- Upon deblading and subsequent NDT inspection, it was found that cracks were present at the T-root sections of the second through fifth stages' blades.
- The blade attachment regions in the drum type rotor indicated wear and corrosion, with the first and seventh stages being in the worst condition.

Figure 66 depicts the damage pictorially and is a sketch made in the field.

Figure 66. Pictorial Sketch Indicating Extent of Turbine Section Damage.

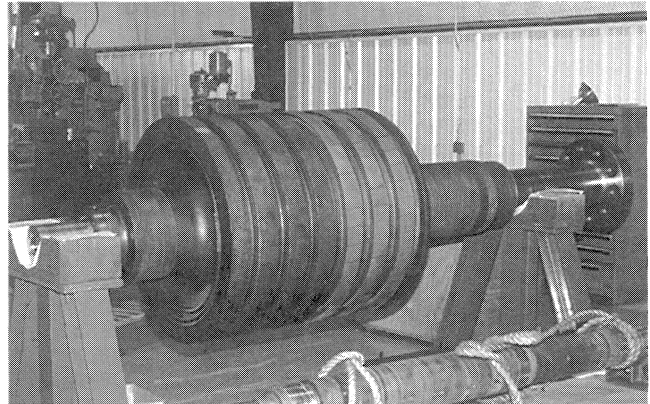
Excessive vibration that occurred in the turbine accelerated the process of fretting that caused the cracks found in the roots of almost all stages. The gas turbine hot section uses an internal groove double T-slot arrangement. In this type of design, the assembly is considerably “softer” in the circumferential direction. The circumferential component of the alternating bending forces has historically been a common cause of failure for the internal groove root. This type of root utilizes parallelogram shaped root platforms and is vulnerable to fatigue failures. The highest loading occurs at the top serration near the trailing edge and this is often responsible for inducing fatigue cracks in the adjacent fillet and shank corner. The rotor drum shown in Figure 68 had also experienced severe standby corrosion in the blade attachment regions (Figure 69).

Figure 68. Overview of Drum Type Rotor After Deblading.

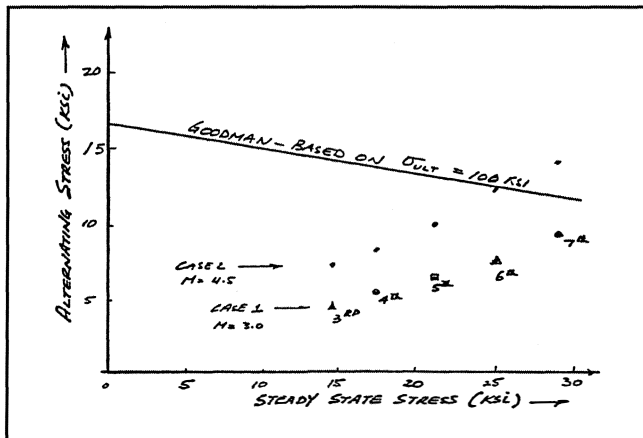
A Goodman diagram created for the third through the seventh stage blading is shown in Figure 70. All of the stage materials have a UTS of approximately 100 ksi. The steady state stress was considered the sum of the gas bending stress and the centrifugal stress. The alternating stress is determined by applying a magnification factor of three to the gas bending stresses (Scalzo, 1991). This has been designated as Case 1. The results have been shown plotted on a Goodman diagram. The results with a higher magnification factor of 4.5 (magnification factor of three, multiplied by a stress concentration factor of 1.5) are also shown in the diagram (Case 2). It is clear that both the sixth and seventh stages are close to design fatigue limit, with factors of safety rapidly eroding as alternating stresses go up. The Goodman factor of safety dips below 1.5 (normally, the minimum acceptable) for the sixth and seventh stages. Thus, any loss of damping would result in a relatively rapid fatigue failure.

Figure 70. Goodman Diagram Showing Erosion of Safety Factor, Especially for the Sixth and Seventh Stages.

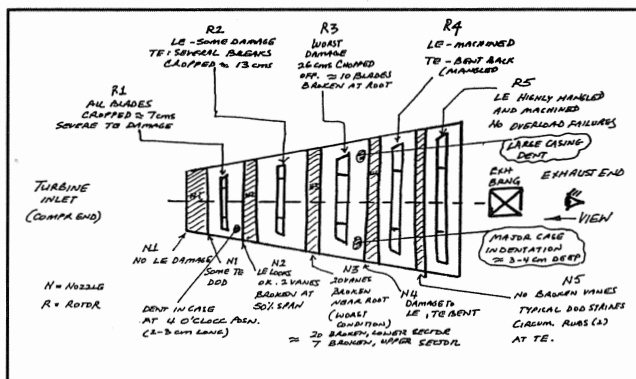
The turbine section was totally destroyed and is shown in Figure 71 and Figure 72. A sketch created in the field showing the extent of the damage is depicted in Figure 73. All five turbine stages were severely damaged, with fracture damage being indicative of impact overload. The stator nozzles, the rotor blades, and drum were badly battered. Numerous blades from the first three stages had been cropped, with the third stage rotor blades being totally wiped out.

Figure 73. Field Sketch Detailing Damage. (Sketches, such as these made in the field, are a rapid way of documenting damage.)

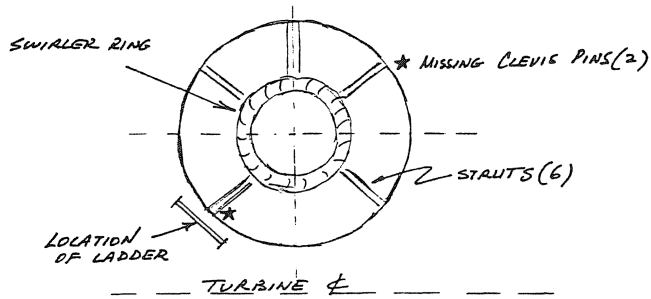
This battered piece shown in Figure 76, was approximately 40 mm long and had a diameter ranging between 15 to 20 mm, and did not look like a turbine section component. Thereafter, the combustor dome was inspected. The dome had six struts to hold the swirl vane support inner ring, which were held by clevis pins approximately 55 mm in length and a diameter of 20 mm. These clevis pins held the strut and were then locked in place by cotter pins. Figure 77 shows details of the construction of the silo combustor and shows the locations of the missing pins. Two of the six struts had missing clevis pins (Figure 78). The ingestion of these clevis pins was the cause of the domestic object damage in the turbine section.

Figure 77. Sketch of Combustor Dome Showing Location of Missing Clevis Pins.

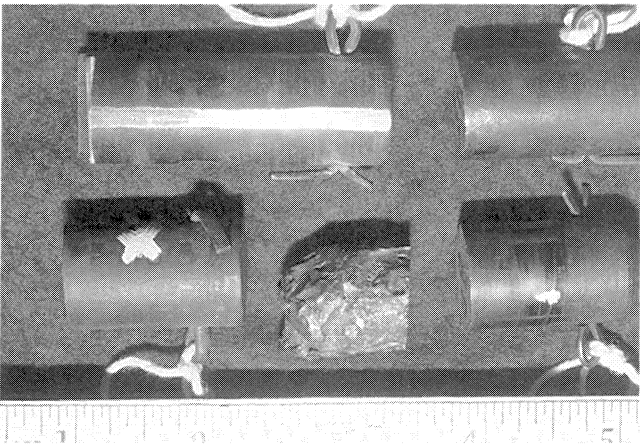
Selected hardware items, including blades, stator blades, and other clevis pins from the combustor, were selected for metallurgical examination. The assortment of clevis pins selected for analysis with a section of the battered "foreign object" is shown in Figure 79.

Figure 79. Assortment of Items for Metallurgical Investigation.
