# DISCOVERING, THE HARD WAY, HOW A HIGH PERFORMANCE COUPLING INFLUENCED THE CRITICAL SPEEDS AND BEARING LOADING OF AN OVERHUNG RADIAL COMPRESSOR—A CASE HISTORY

## ABSTRACT

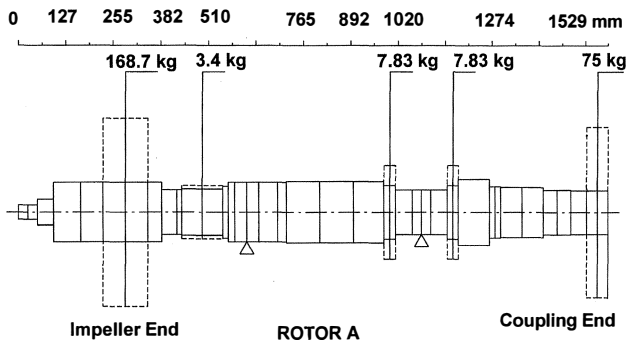
Figure 10. Rotor Model A—Design Model with Design Coupling Weight.

Previous to this first test run, when an unexpectedly light coupling was delivered to the compressor manufacturer, a new lateral analysis was done with the actual contract coupling weight. The analysis had been done originally using a coupling mass of 75 kg at the outboard compressor shaft end (rotor A, Table 1). The model for rotor A is shown in Figure 10. Depicted in Figure 11 is the forced damped unbalance response mode shape at 10,500 rpm, with an unbalance of 1.06 kg-mm at the coupling end of the rotor, and a resultant deflection amplitude of 16 μm (0-p). Lateral critical speeds, based on the unbalance response for the compressor, were originally predicted at 2750, 6250 (Table 1, column A), and 26,000 rpm.

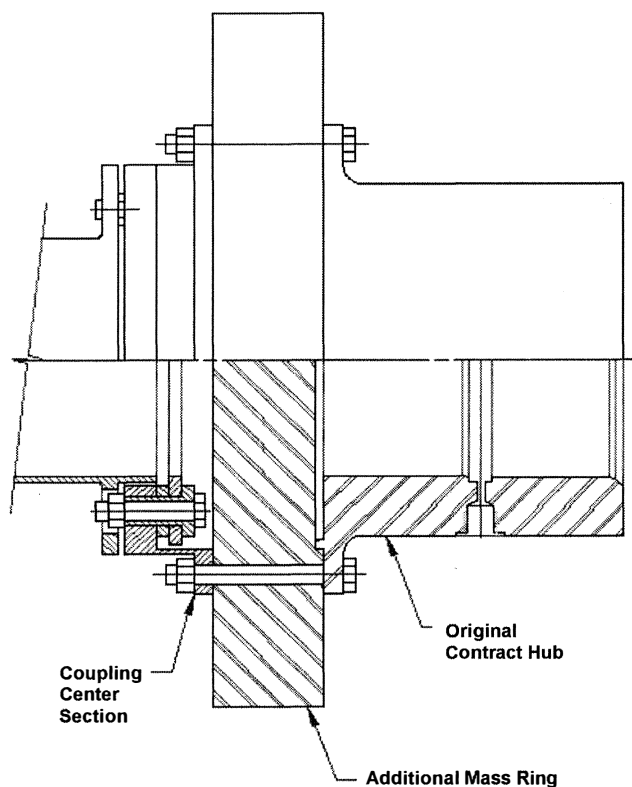
Figure 20. Original Test Coupling with First Trial Weight.

To check the original lateral model, a test was devised whereby an additional mass, a weight ring (Figure 20), was added to the contract coupling hub. Although the results (Figure 21) were promising, in that the resonant center frequency was decreased to 7000 rpm, the amplification factor was still too high (between 9 and 10). The ability to manufacture the ring to acceptable tolerances (for balance purposes) was cited as part of the reason for the high amplification factor. In other words, in order for a coupling/weight ring to run properly, tight tolerances on the locating diameters between the coupling hub and the trial weight were required, but were not achieved. It was at this point that thought was given to manufacturing a new half coupling that had the extra weight used in the original rotor lateral analysis.

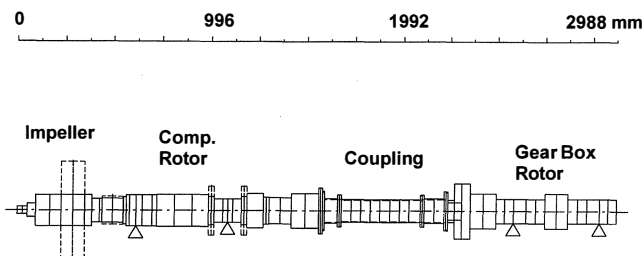
Figure 22. Test Train Model.

Normally, the rotor lateral analysis is modelled assuming the coupling can be divided into two distinct half sections, and that each rotor is isolated from the other by the coupling flexible elements. A more thorough test stand rotor analysis (with the compressor and the gearbox rotor) was done using the coupling flexible element bending moments and lateral stiffnesses (Figure 22), but no significant difference was calculated between the models.

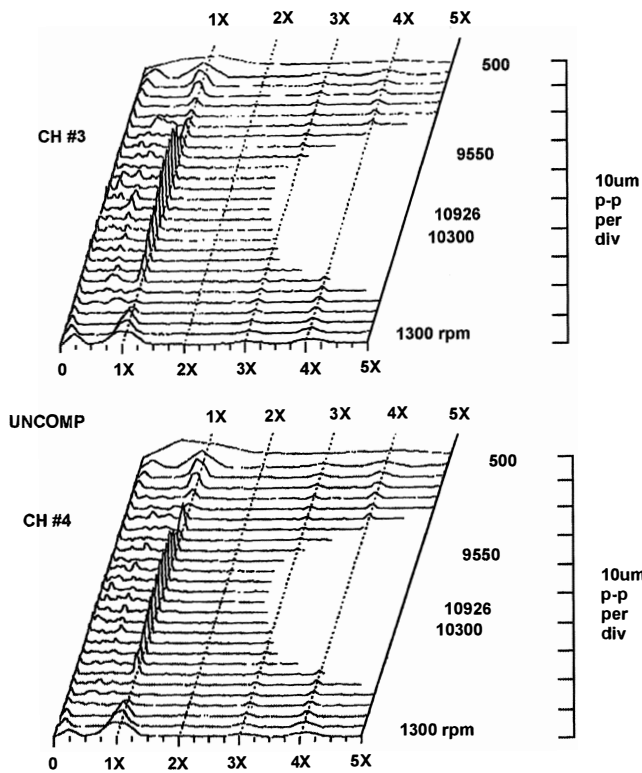
Figure 24. Shop Test Coupling Waterfall Diagram.

This arrangement was able to run successfully. The overall vibration was within API levels, there were no phase changing effects at speeds up to 10,900 rpm, and there was no significant amplification factor during shutdown (Figure 24). But, as before, there were questions about the validity of using these test results to deduce that the contract coupling was the problem. First of all, the couplings were completely different designs with different physical characteristics.

It can be seen here that the overhung mass of a coupling can have a significant effect on rotor critical speeds, as noted by Wolford [5]. The effect of the reduced overhung test mass was not only to raise the second critical speed, but also to raise the ratio of the second to first critical, as predicted by Weaver [6].

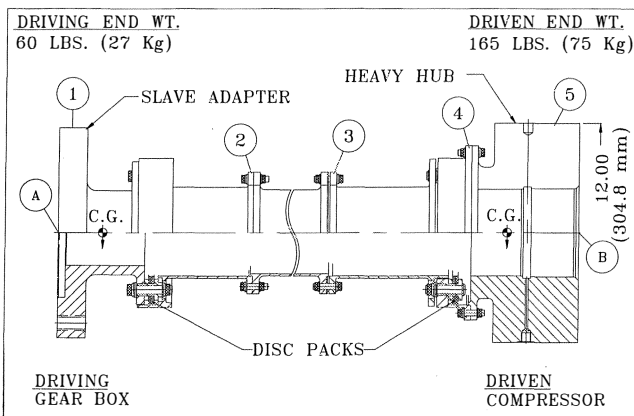
Figure 28. Final Test Coupling with Contract Heavy Hub with Indication Points.

The final test series at full operating speed included the new “heavy” 75 kg half coupling mated to the rest of the test stand coupling (Figure 28), and significant bearing modifications.

This was an important inspection, just as important as the coupling balancing operation. For example, if it were determined from indicator readings that the hub body (measurement 5 in Figure 28) ran out 0.002 in (51 μm) TIR to the center of shaft rotation, that would mean that the coupling’s axis of rotation was shifted 0.001 in (0.002/2) from the center of shaft rotation. This is equivalent to 1000 micro-in (25,400 μm), which would be 20 times the API 671 [3] assembly balance tolerance of 4W/N (50 μm). This topic is covered in the literature [4].

There were a few things done to ensure that the coupling operated well balance-wise. The main focus of these other efforts was on installation. Specific instructions were given to the test floor to turnover the coupled rotors before the test and check the runouts of key diameters on the installed coupling (Figure 28) to ensure that they were within the values of Table 3.
