RETROFIT OF A STEAM TURBINE WITH DRY GAS SEALS

The solution to a chronic utility problem, with a critical natural gas compression unit, at the Ammonia plant at Du Pont's Beaumont, Texas facility, is described. The most critical problem, chronic steam leakage from the turbine and subsequent oil system contamination, was corrected by the installation of noncontacting spiral groove seals. In addition, vibration problems caused by coupling lockup and subsequent premature coupling failure were solved by replacing the grease lubricated gear type coupling with a nonlubricated flexible coupling. A feature of the coupling is a keyed hub, designed for hydraulic removal.

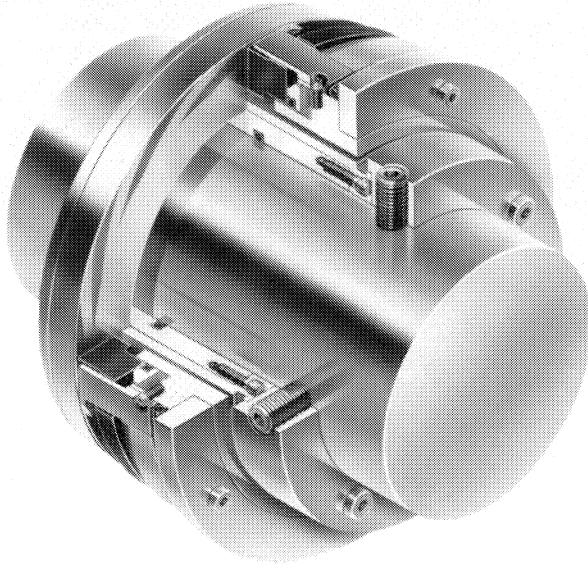
In an effort to find a solution to this utility problem, the authors discovered a manufacturer applying existing technology for non-contacting spiral groove dry gas seals to steam turbines (Figure 1). This is the first new development for steam turbines shaft seals in many years and appeared more reliable than current conventional sealing devices. Like the noncontacting spiral groove dry gas seals used in centrifugal compression equipment since the late 1970s, the steam seal uses its process gas (steam) to separate the seal faces by a minute amount, thereby effectively sealing the turbine steam.

Figure 1. Noncontacting Spiral Groove Steam Seal.

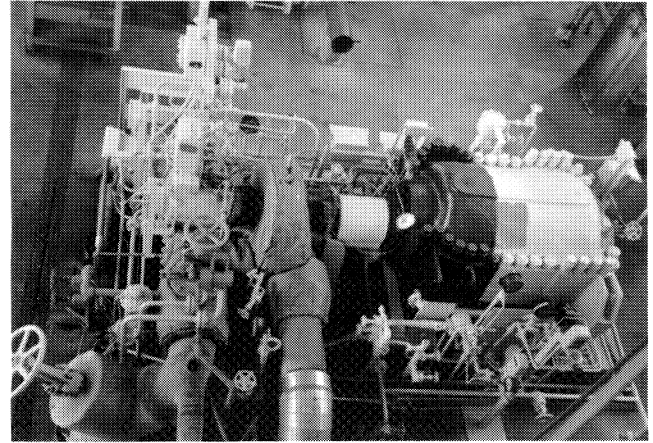
The ammonia plant at Du Pont’s petrochemical complex in Beaumont, Texas, was designed and built in the late 1960s, using the latest proven technology of that period. A multistage compressor driven by a medium speed, single stage, noncondensing turbine (Figure 2) is used to boost the pressure of natural gas used as a process feed stock. This compression train is critical to the unit and must be maintained in a high state of reliability. The turbine operates with 550 psig at 610°F steam inlet and discharges into a 200 psig header. The original design used conventional carbon

Figure 2. Natural Gas Compression Unit.

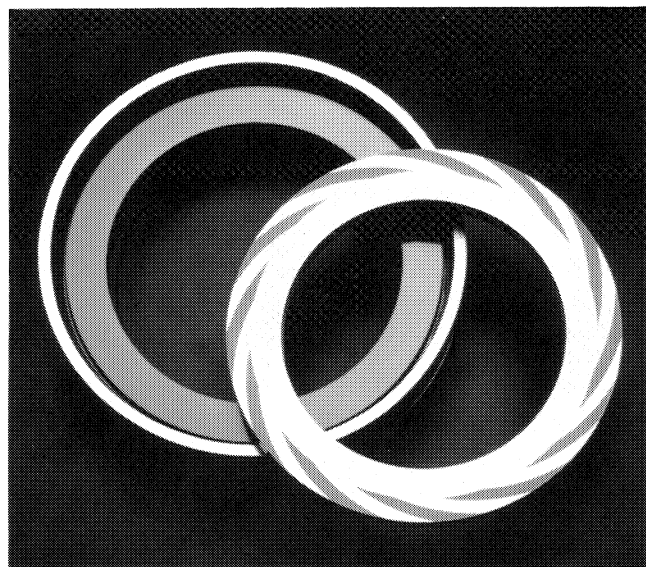
Spiral groove steam seals have been in commercial operation for about five years in low duty, single stage, noncondensing turbines. They are similar to conventional mechanical seals, except for wider sealing faces and spiral grooves in the mating ring, as shown in Figure 4. The seal consists of a tungsten carbide mating ring (face) that runs on an extremely thin steam film between itself and the carbon ring.

Figure 4. Mating Ring Showing Spiral Grooves.

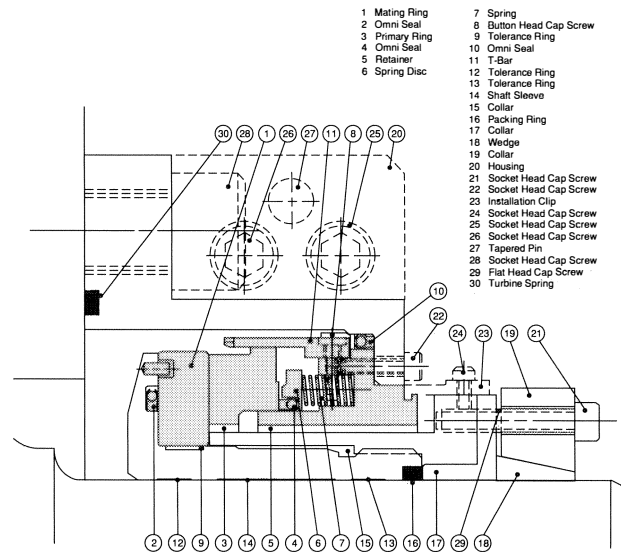
The steam seal that was installed has the configuration as shown in Figure 5.

Figure 5. Steam Seal Cross-Sectional View.
