## MAJOR REVAMP AND RETROFIT OF IDENTICAL PROCESS COMPRESSOR TRAINS

Standard Oil Chemical Company

Port Lavaca, Texas

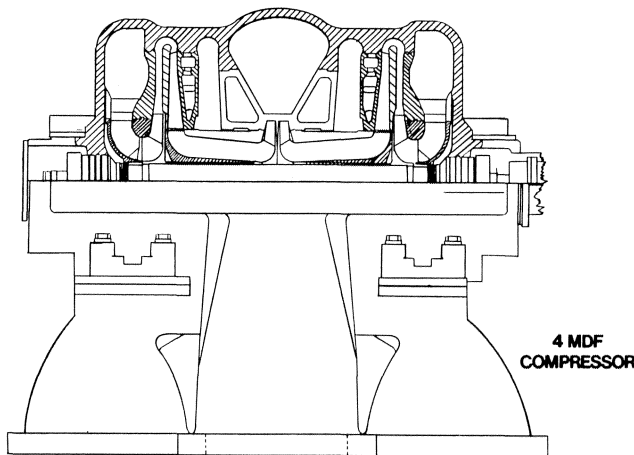
Figure 2. Air Compressor Cross Section.

The air compressor is of the double flow design having one 36 in discharge and two 36 in suction lines (Figure 2). The case is rated for a maximum air flow of 100,000 icfm. It is supported on four integral feet, two fixed and two sliding, which allow for axial expansion. A total of six closed welded impellers, three to a side, had diameters of 36, 34 and 36 in, respectively, and were made of 4330 alloy steel. Impellers are keyed and have a light shrink fit. The shaft is made of 4340 steel, has a 101 in bearing span and an 8 7/8 in diameter. Shaft sleeves are 12 percent to 14 percent chrome steel and the seals are of the aluminum labyrinth type. All of the bearings are tilt pad type and pressure lubricated. The case is cast iron, ASTM A247 Class 40 and the diaphragms are cast iron, ASTM-A278 Class 30 material. The coupling is a dry diaphragm type with a 30 in spacer. It has a 2.0 service factor. The hubs are taper fit and hydraulically mounted. Although the coupling guard is non-lubricated, it is totally enclosed and open to oil spray from the bearing housings. These coupling guards have been a source of nuisance oil leaks since the original startup. The assembled compressor weighs in at 50 tons.

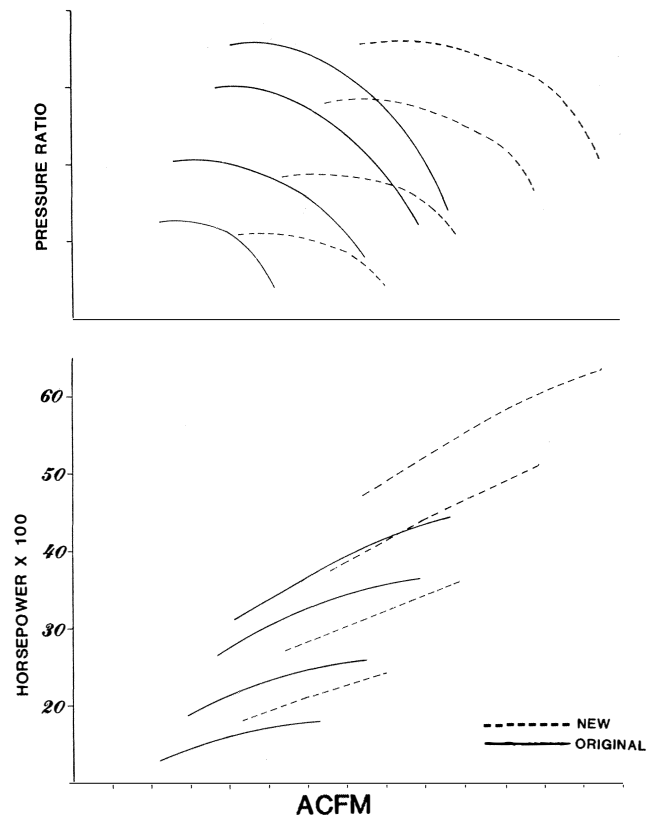
Figure 3. Air Compressor Performance Curves.

Up-rated performance of the air compressor is the primary factor in boosting the production rate. The modification raised air rates significantly (Figure 3). Normal discharge pressures increased slightly, primarily due to additional friction loss at higher flow rates.

Physical changes to the compressor were limited to elements in the flow path. Original impeller diameters of 36, 34 and 36 in were enlarged to 38, 36 and 32 in diameters. Impeller eye diameters were increased at each stage to allow more flow. Six of the original impellers were adaptable to the new service. They were trimmed to a 32 in diameter. Two operating rotors and the common spare were modified. Twelve new impellers were ordered along with three sets of spacers, two sets of shaft seals and two sets of inlet guide vanes.

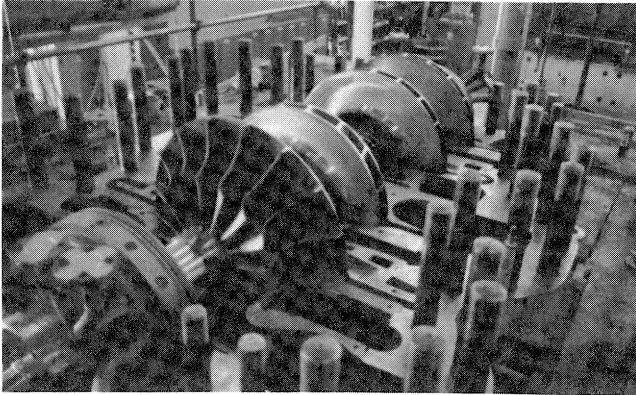
Figure 4. Process Compressor.

The compressor has a horizontally split casing, with five stages in two sections (Figure 4). The casing has three integral

feet, two fixed and one wobble foot to allow axial thermal growth. The suction and discharge flanges are 36 in and 30 in for section one and 30 in and 20 in for section two. The maximum flow capacity for the case was 60,000 acfm. The case itself is made of cast steel while the diaphragms are cast iron with stainless steel inserts at the impeller discharge volute. There were five stages, two in section one and three in section two. The first section, stage one, had an open 38 in cast impeller. The other four stages were enclosed welded impellers. All of the impellers were made of 410 stainless steel. The shaft has stainless steel sleeves and impeller spacers. It has a diameter of 8 7/8 in and a between-bearing span of 110 in. The bearings are all of the tilt pad type. Thrust bearing rated loading was 264 psi with a maximum allowable of 500 psi. The compressor weighs in at over 50 tons, dangerously more than the manufacturer listed 36 tons. Initial buffer gas requirements to the shaft labyrinth seal system were stated at 4.2 lb/min at one psia for each outer seal and 10.1 lb/min at five psia for the discharge end seal.

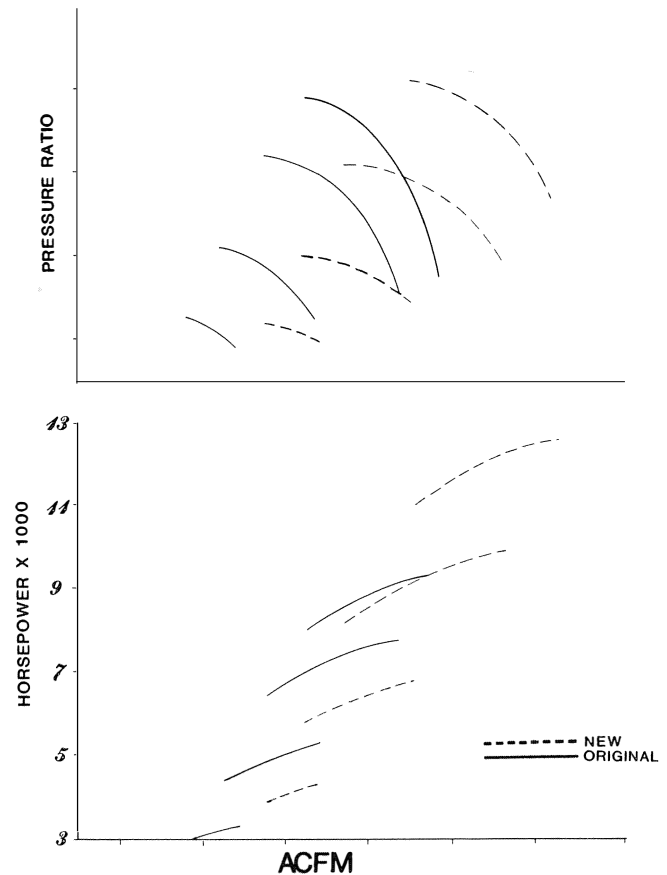
Figure 5. Process Compressor Performance Curves.

Performance changes were significant for the uprate (Figure 5). Flow was increased significantly through the compressor while discharge pressure was reduced. The maximum continuous operating speed was raised to 5300 rpm.

Mechanically, the changes have been sweeping. The redesign of the sealing system and addition of the balance piston are covered in a separate section. The aerodynamic section was extensively revamped. Bearings and the casing remained the same. Two relatively minor changes were made to the casing bore. The shafts were reused and several of the diaphragms were modified.

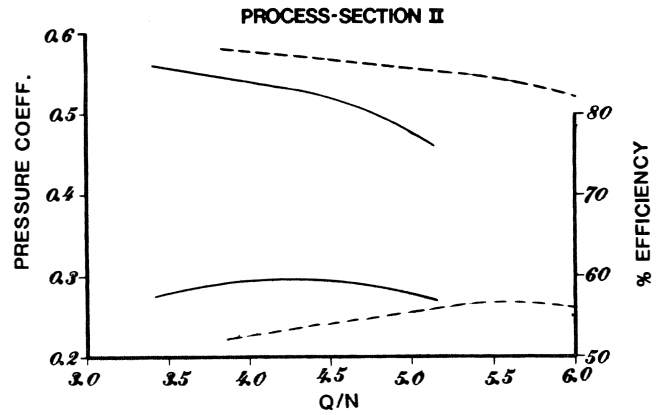
Figure 13. Process Compressor Expected Performance Curves.

The process gas compressor performance was also in question due to the actual data's relation to the expected performance on the pressure coefficient and efficiency curves (Figures 12 and 13). The most obvious problem was that inlet temperature was much higher than expected, boosting the actual cubic feet per minute ACFM significantly along with the corresponding horsepower required. Chemical cleaning of the suction coolers at the first opportunity solved that problem. The performance engineer also stated that the open impeller appeared to have a ten percent larger capacity than expected. This tended to lift actual data above the pressure coefficient curve. In addition, the higher calculated efficiency was due to liquid entrainment. Liquid entrainment has a positive effect in that evaporation of

liquid particles in the stream acts like an intercooler increasing calculated efficiency. However, film evaporation of liquid on the thermowell can distort discharge temperature readings to well below thermodynamically expected values. The performance engineer stated that although there was a net increase in performance, as supported by the net horsepower balance, the real efficiency and pressure increases were much lower than the calculations indicated. He also stated that he had no way of quantifying actual compressor performance for our two phase flow. The final conclusion was that the compressor was performing better than expected. Exactly how much better is not known. A strain gauge torque meter would give the best definition of actual horsepower, but was viewed as an unjustifiable cost.

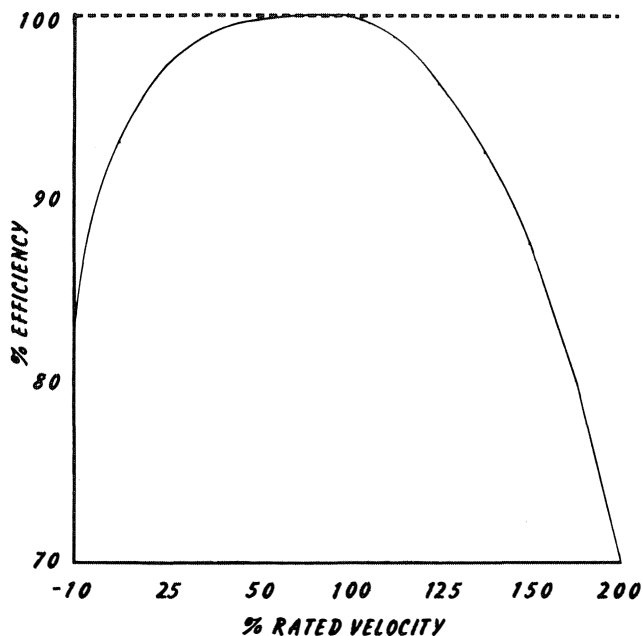
Figure 14. Typical Separation Efficiency vs Superficial Velocity through Vane Type Separation.

This phenomena and its effect on both sections of the process compressor are not well understood at this time. The makeup of the two phase flow is not defined, as yet, in terms of chemical composition and mole percent of the liquid versus the gas phases. Size, or even weight percent of liquid in each stream, is not known. What is known is that the efficiency of the inlet separators drops radically as flow increases (Figure 14) and that liquid exists in both compressor discharge lines.

For the given rotating speed, a higher pressure ratio and flow rate than predicted exists. Currently, the measured flow rate, in acfm, through the process compressor at 4900 rpm, should not be achievable, according to the manufacturer's data, until the speed exceeds 5200 rpm. Both flow and pressure ratio at 4900 rpm exceed expected values quoted for 5200 rpm, although calculated horsepower is similar. The expected final production rate is constrained by a maximum continuous speed of 5300 rpm, due to the speed limitations of the process compressor second stage wheel. This flow enhancement effect points to the possibility of significantly greater production rates than originally envisioned in the uprate. Naturally, the side effects of higher flow will have to be investigated; however, the prospects for higher rates look good.
