# ELECTROMAGNETIC SHAFT CURRENTS AND DEMAGNETIZATION ON ROTORS OF TURBINES AND COMPRESSORS

**John S. Sohre**

**Paul I. Nippes**

## ABSTRACT

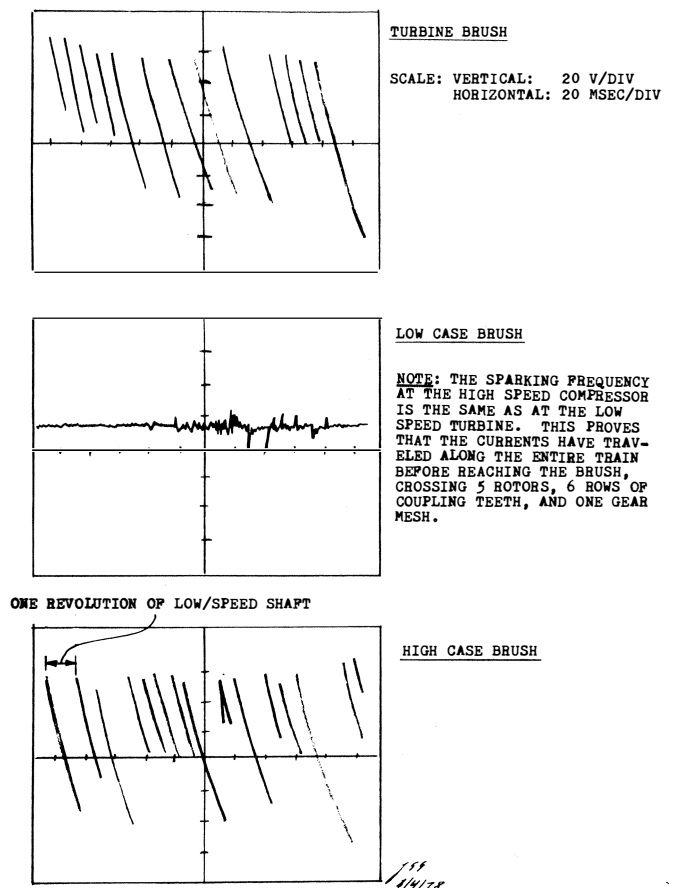
The shaft voltages were not checked for a couple of weeks, and then it was suddenly discovered that an alternating current was present, the voltage being approximately +100 volts to -9 volts, see Figure 6. At this point the brushes were lowered. However, extensive damage had already occurred, and the machine had to be shut down because of an apparent gear thrust failure. The total running time was about 12 months.

Figure 6. Oscilloscope Tracings of AC Type Shaft Currents.
