# REPAIR AND REHABILITATION OF TURBOMACHINERY FOUNDATIONS

E. M. Renfro

Adhesive Services Company

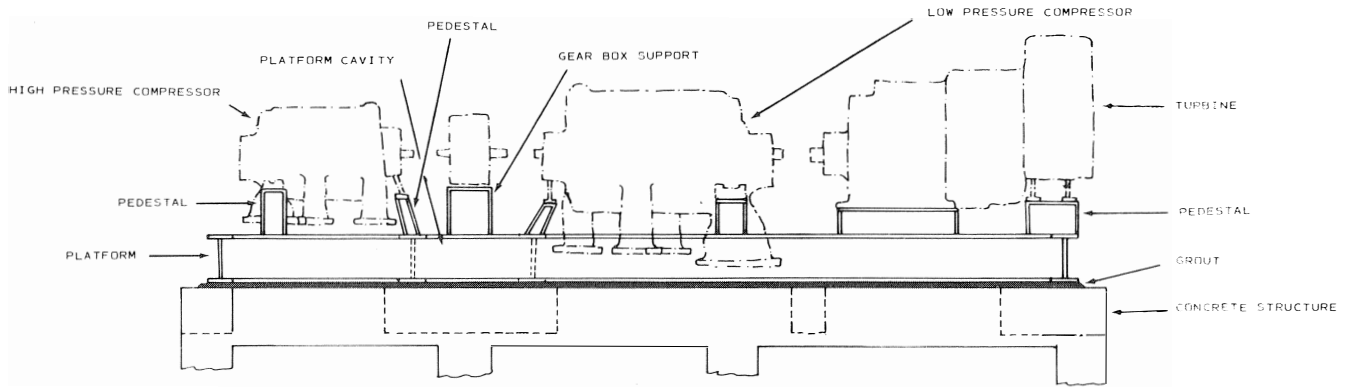
A typical compressor train containing a turbine and two compressor stages is illustrated in Figure 1. The "I" Beams on the platform are grouted to the concrete structure. When proper grouting techniques are carried out during the original installation, the grout should contact the entire lower surfaces of all longitudinal and transverse "I" Beams.

Figure 1. A Typical Compressor Train Containing a Turbine and Two Compressor Stages.

When excessive vibration is detected in the gear box of a compressor train, shown in Figure 1, and is transferred to the platform below, a dampening effect can be created by increasing the rigidity of the support below. This can be accomplished by first filling the platform cavity and then the gear box support with epoxy mortar. Figure 11 is a photograph of the gear box support after the gear box has been removed and an access hole cut in the plate at the top of the support. At the time this photograph was taken, epoxy mortar was being poured into the cavity. Since it is impossible to fill a cavity completely with mortar, filling was stopped at a level of approximately  $\frac{1}{4}$  inch below the top. The access hole plate was then welded back into position, and injection sites drilled into each corner of the support. A vent hole was then drilled in the center of the reinstalled access plate to facilitate air removal when pressure-grouting the remaining air space below the top. Figure 12 is a close-up view of a typical injection site at each corner.
