**“SUCCESSFUL MODIFICATION OF VERTICAL-TURBINE PUMPS FOR CAPACITY AND RELIABILITY IMPROVEMENT”**

**César A. Morales Casanova**  
*Rotating Equipment Specialist*  
*PDVSA – Pequiven*  
*UNF Morón, Edo. Carabobo*  
*Venezuela*

*17<sup>th</sup> International Pump Users Symposium*  
*March 6-9, 2000. Houston, Texas*

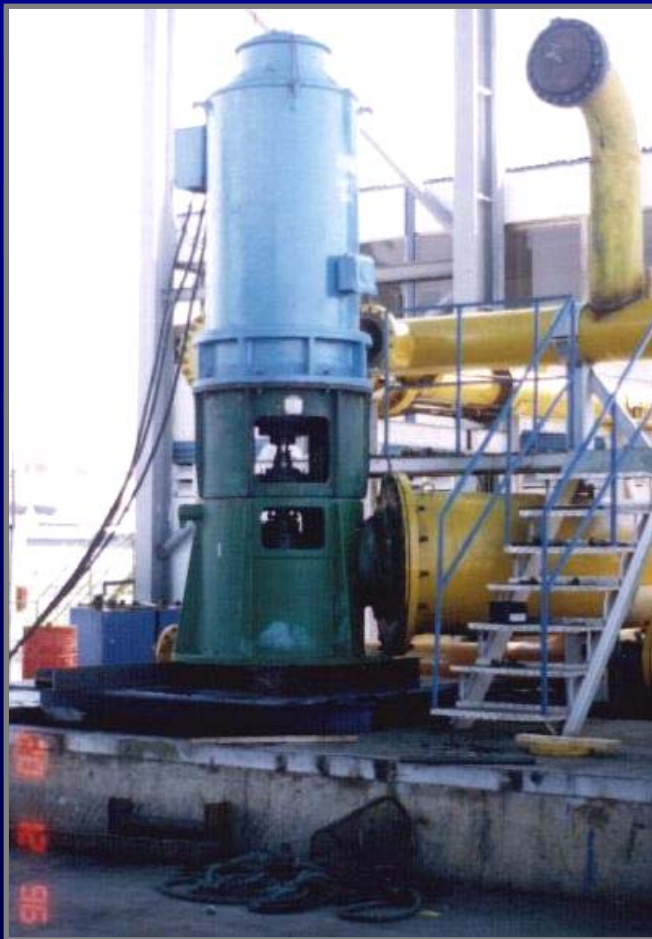
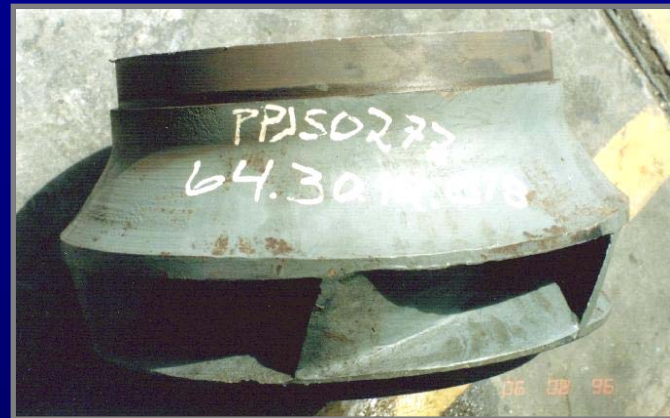
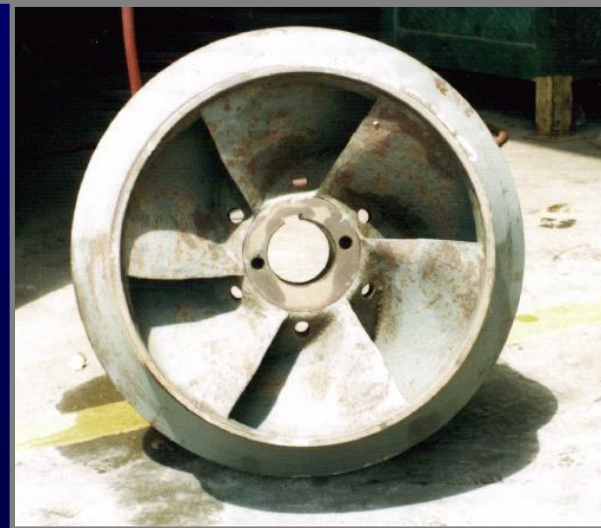
# ***CAPACITY EVALUATION OF EXISTING PUMPS***

- ▶ One pump completely overhauled for testing.
- ▶ A new impeller –as supplied by the OEM– installed.

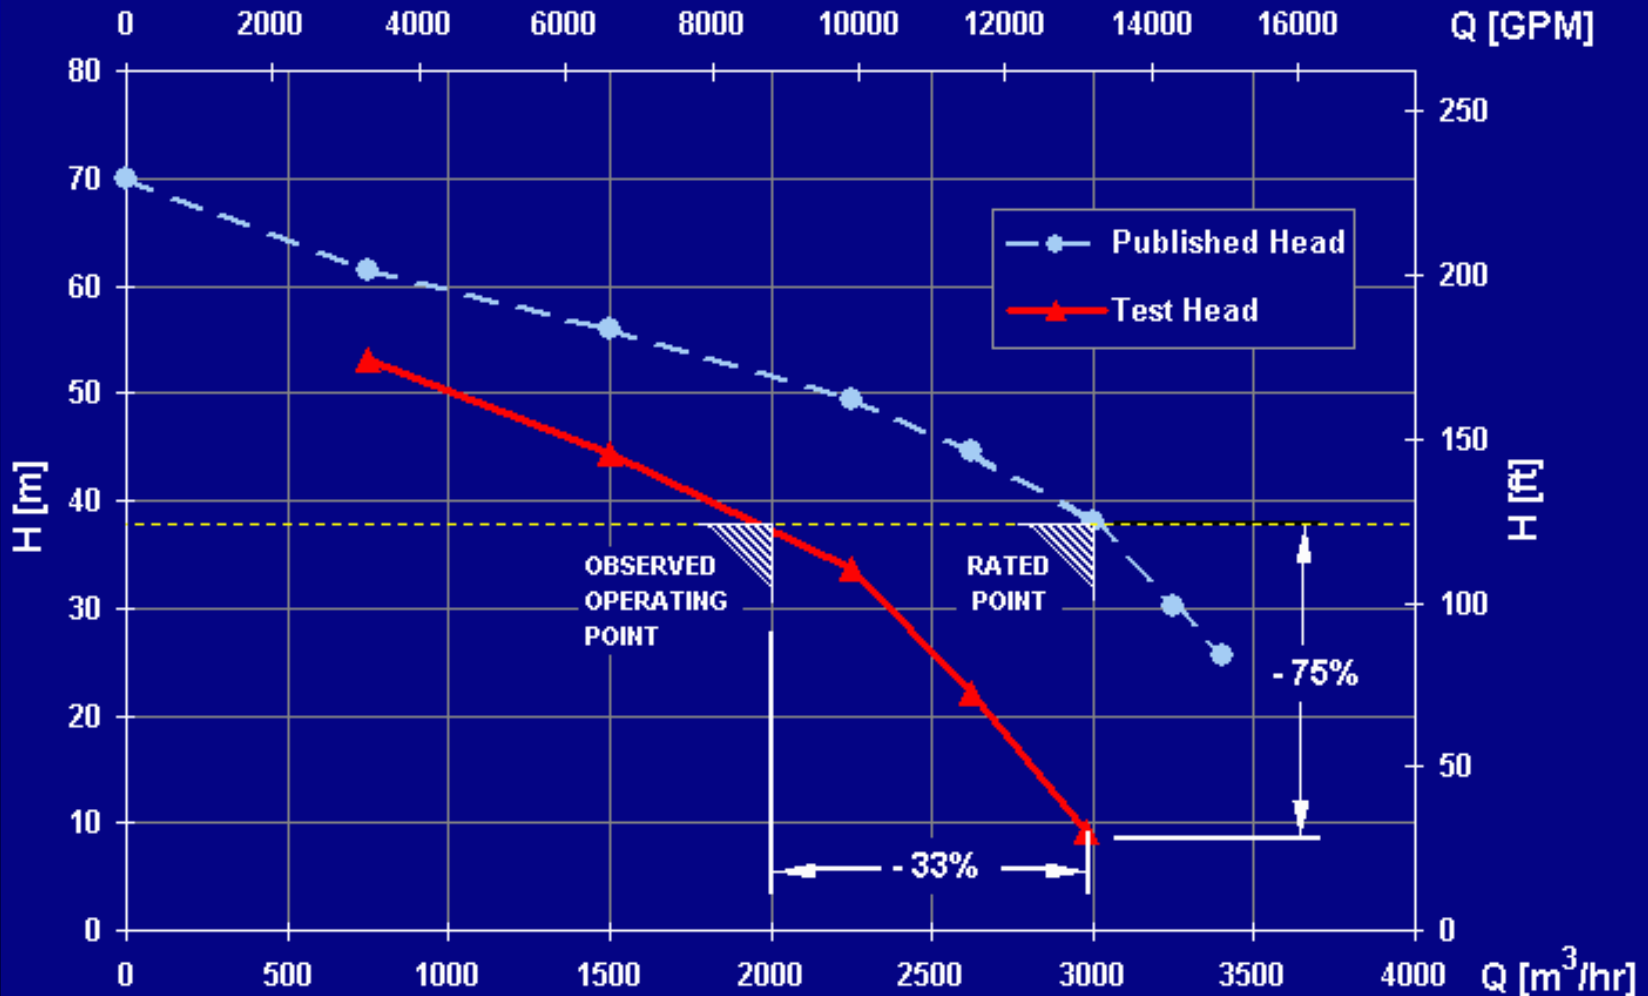
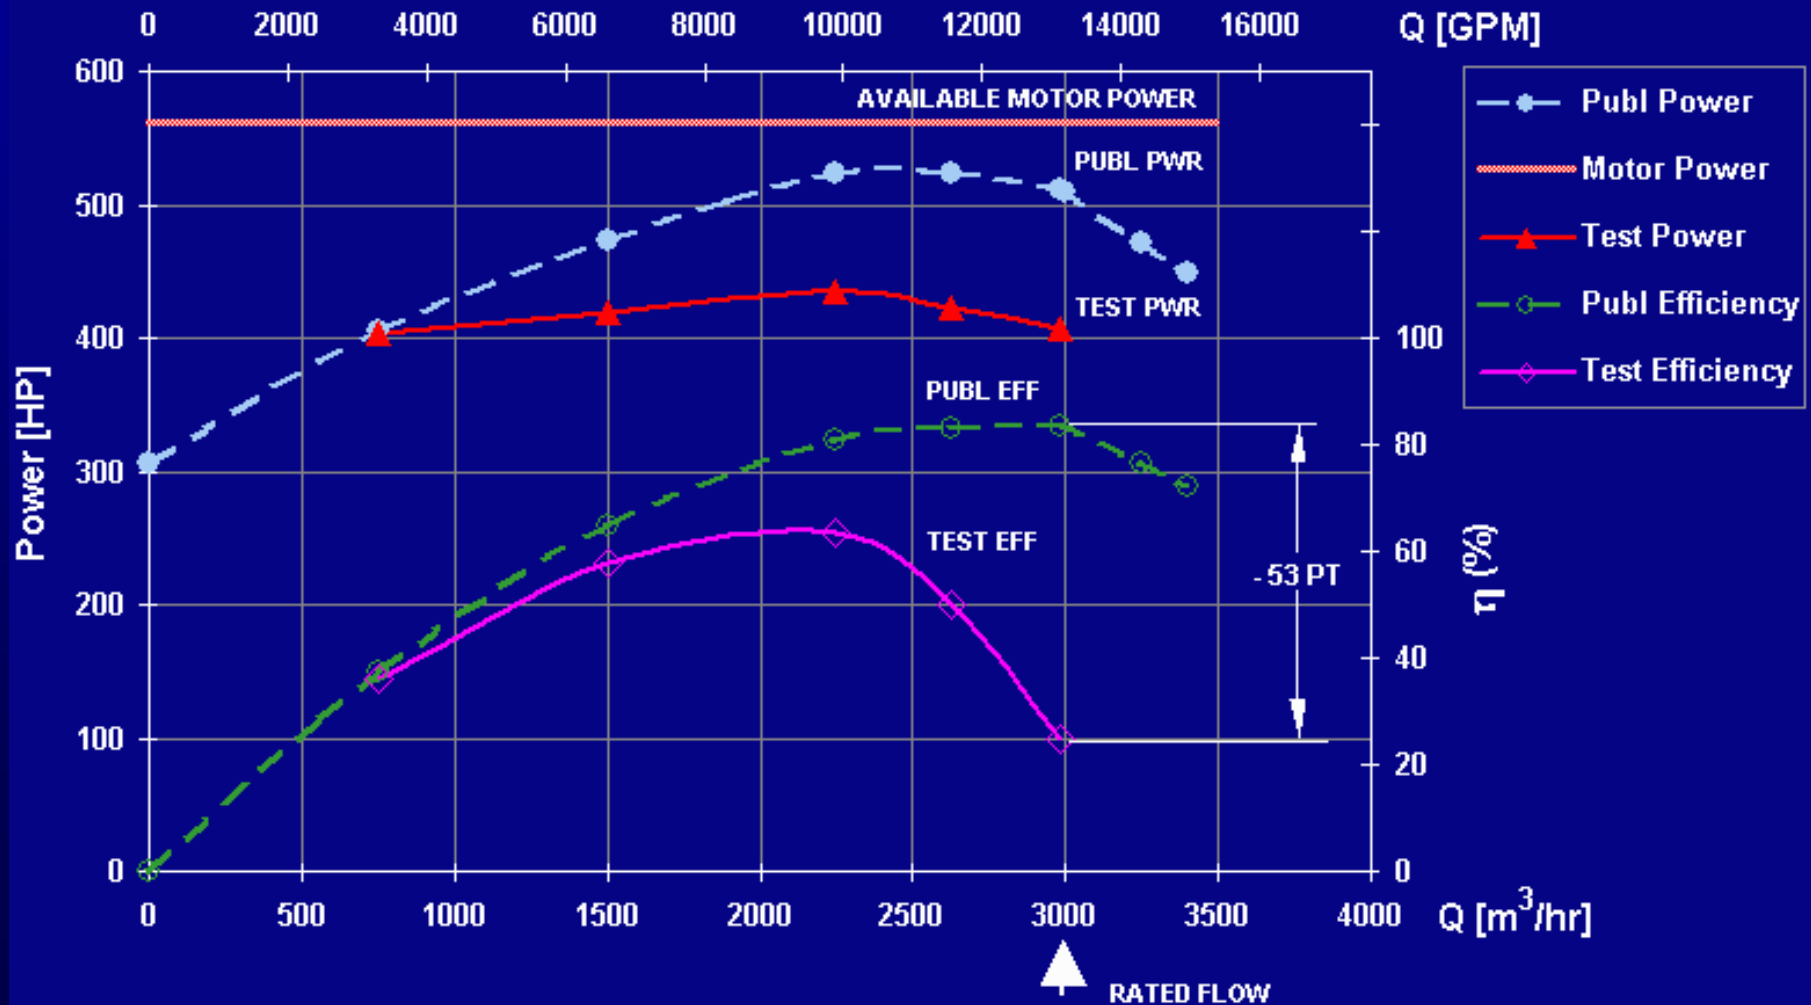
# TEST-STAND RESULTS – UNMODIFIED PUMP

PUBLISHED VS. TEST PERFORMANCE  
OEM IMPELLER  $\phi 550/500$  mm @1170 RPM

- ▶ **Actual capacity @ rated head found 33% below:**

**Found: 2,000 m<sup>3</sup>/hr (8,800 GPM)**

**Rated: 3,000 m<sup>3</sup>/hr (13,200 GPM)**

- ▶ **Pump could not reach rated flow:**

**Max attainable: 2,970 m<sup>3</sup>/hr (13,068 GPM)**

- ▶ **TDH nearest rated flow was 75% below:**

**Found: 9.5 m (30 ft)**

**Rated: 38.0 m (125 ft)**

- ▶ **BEP was found at 79% of the expected flow and well below in efficiency:**

**Found: 64% @ 2,200 m<sup>3</sup>/hr (9,680 GPM)**

**Expected: 83% @ 2,800 m<sup>3</sup>/hr (12,320 GPM)**

- ▶ **Considerable performance impairment compared to expected.**
- ▶ **Impeller subject to severe cavitation before reaching rated flow.**
- ▶ **Significant improvement not possible by reworking of existing impellers (underfilling).**
- ▶ **Major modifications required to accomplish project objectives.**
- ▶ **A prototype pump to be modified and re-tested.**

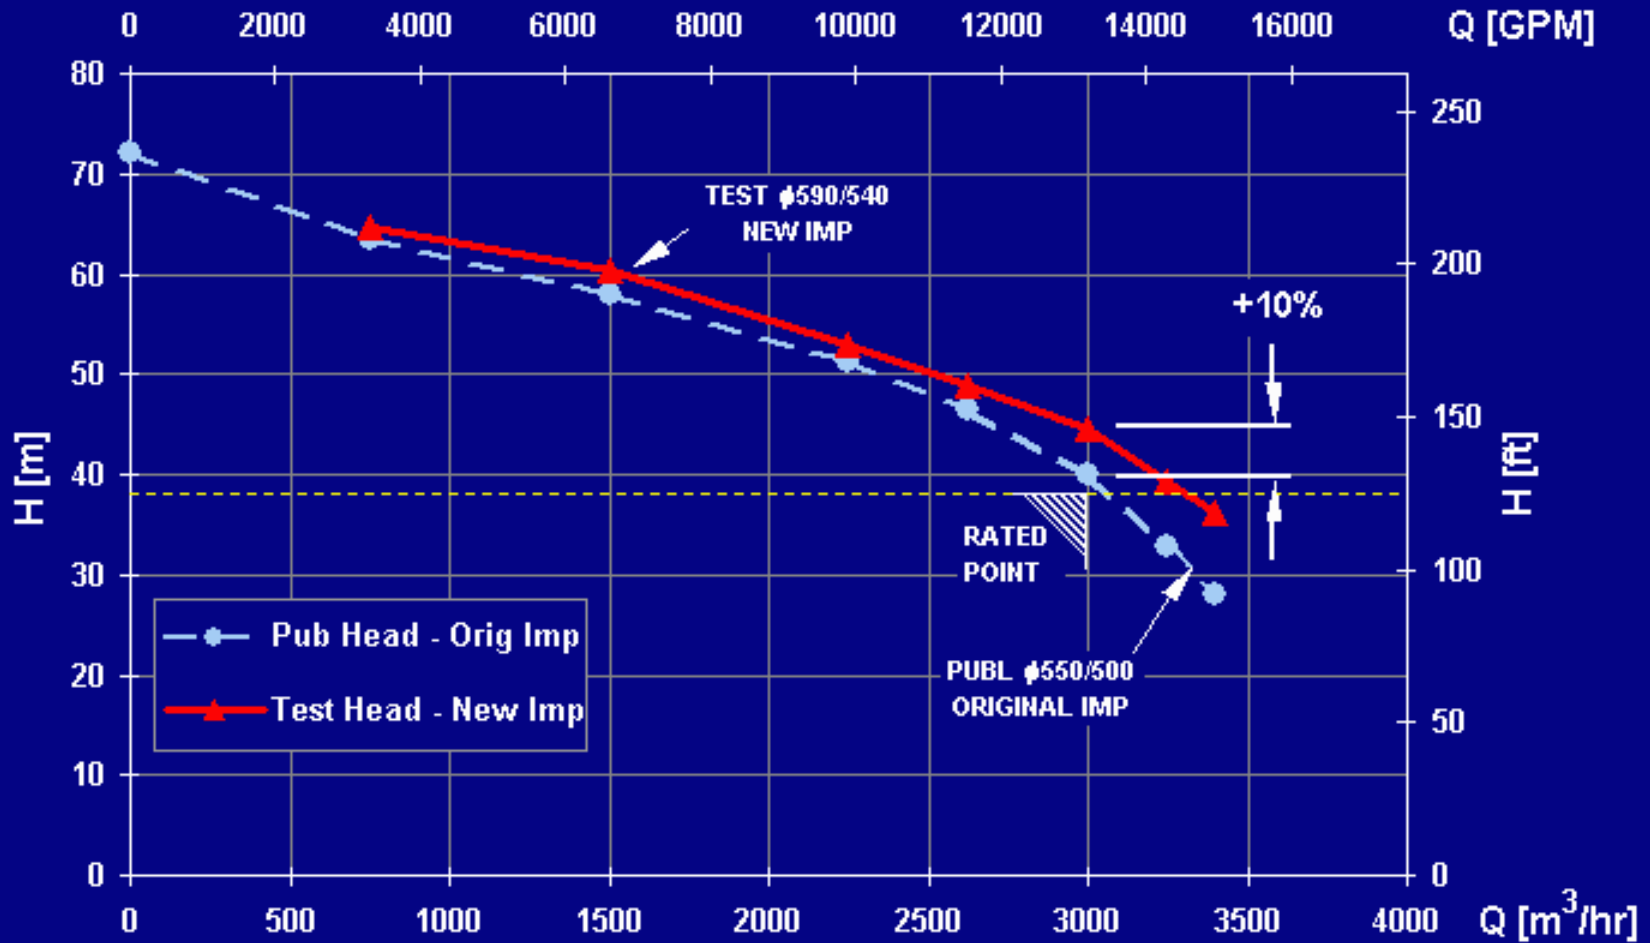
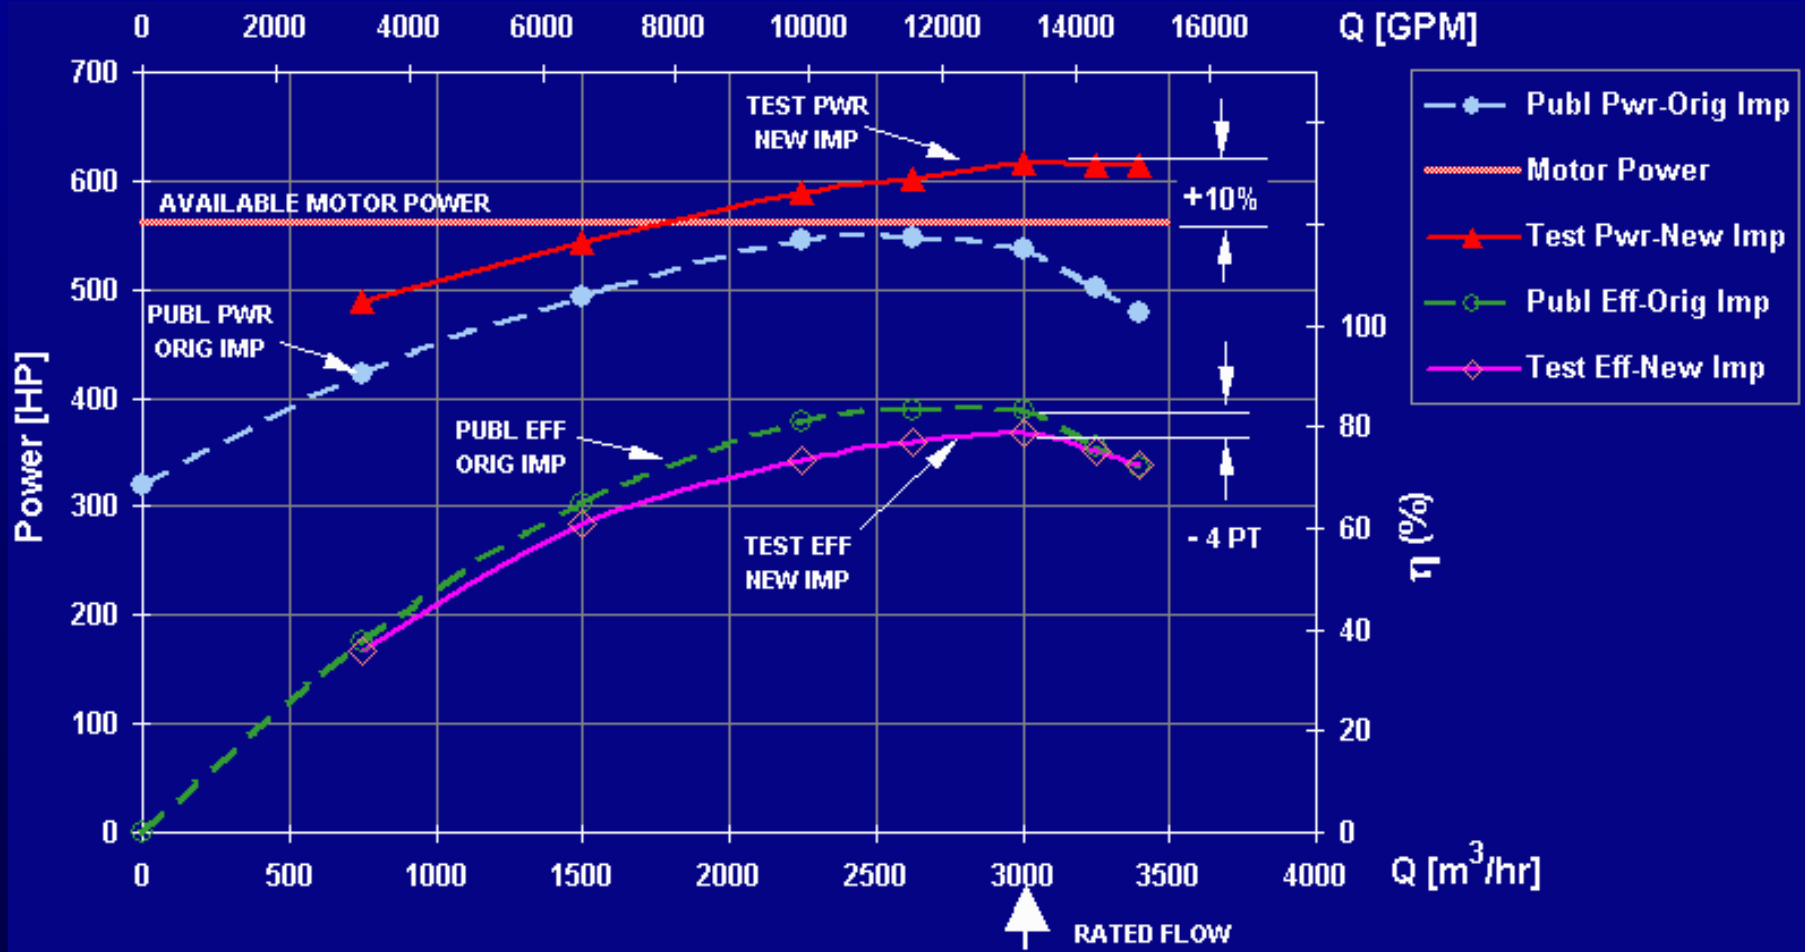
# TEST-STAND RESULTS – PROTOTYPE PUMP

PUBLISHED VS. TEST PERFORMANCE  
AS RECEIVED NEW IMPELLER  $\phi 590/540$  mm @1188 RPM

- ▶ **Actual capacity @ rated head found 8% above:**
  - Found: 3,250 m<sup>3</sup>/hr (14,300 GPM)**
  - Rated: 3,000 m<sup>3</sup>/hr (13,200 GPM)**
- ▶ **Pump exceeded rated flow:**
  - Max attainable: 3,400 m<sup>3</sup>/hr (14,960 GPM)**
- ▶ **TDH @ rated flow/rpm was 10% above:**
  - Found: 42 m (138 ft)**
  - Rated: 38 m (125 ft)**
- ▶ **BEP found @ rated flow and slightly below in efficiency:**
  - Found: 79% @ 3,000 m<sup>3</sup>/hr (13,200 GPM)**
  - OEM Published: 83% @ 2,800 m<sup>3</sup>/hr (12,320 GPM)**
- ▶ **BEP found @ rated flow and slightly below in efficiency:**
  - Max HP: 620 @ 3,000 m<sup>3</sup>/hr (13,200 GPM)**
  - Motor HP: 562 (1.0 S.F.)**

- ▶ **Performance significantly improved.**
- ▶ **Rated point easily reached and exceeded.**
- ▶ **BEP matched rated flow.**
- ▶ **Limitation in available power from installed electrical motors.**
- ▶ **Impeller rework required to adjust performance.**
- ▶ **Efficiency improvement required to reach rated point and limit power requirement.**

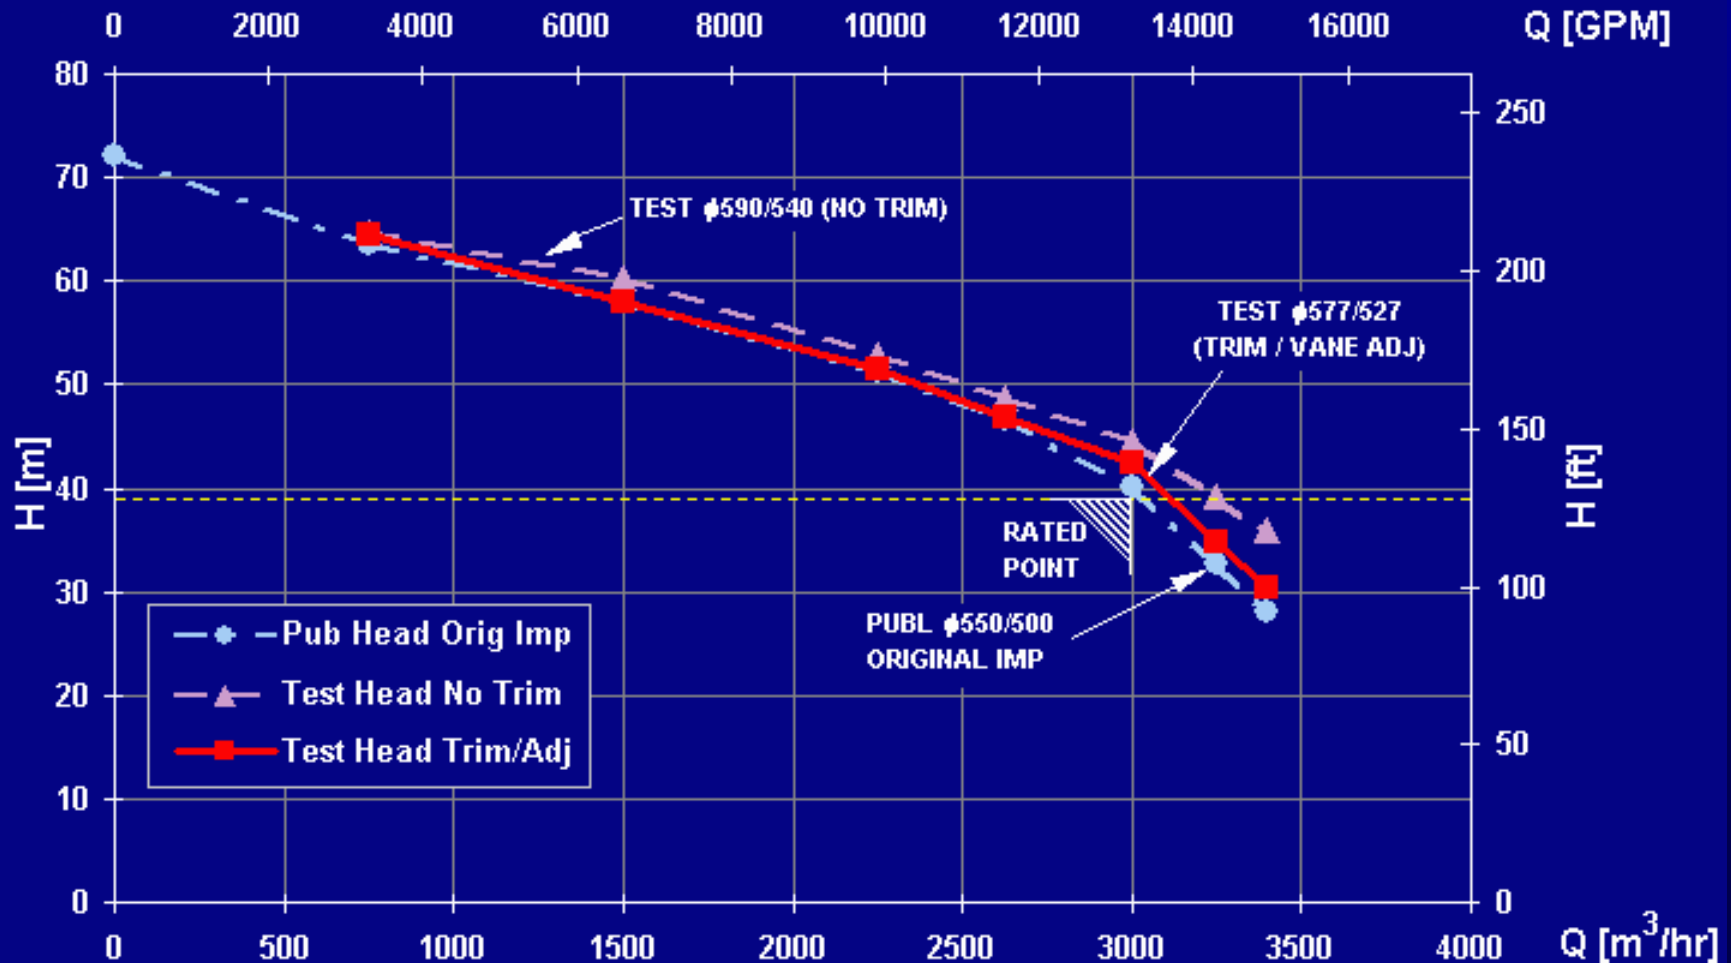
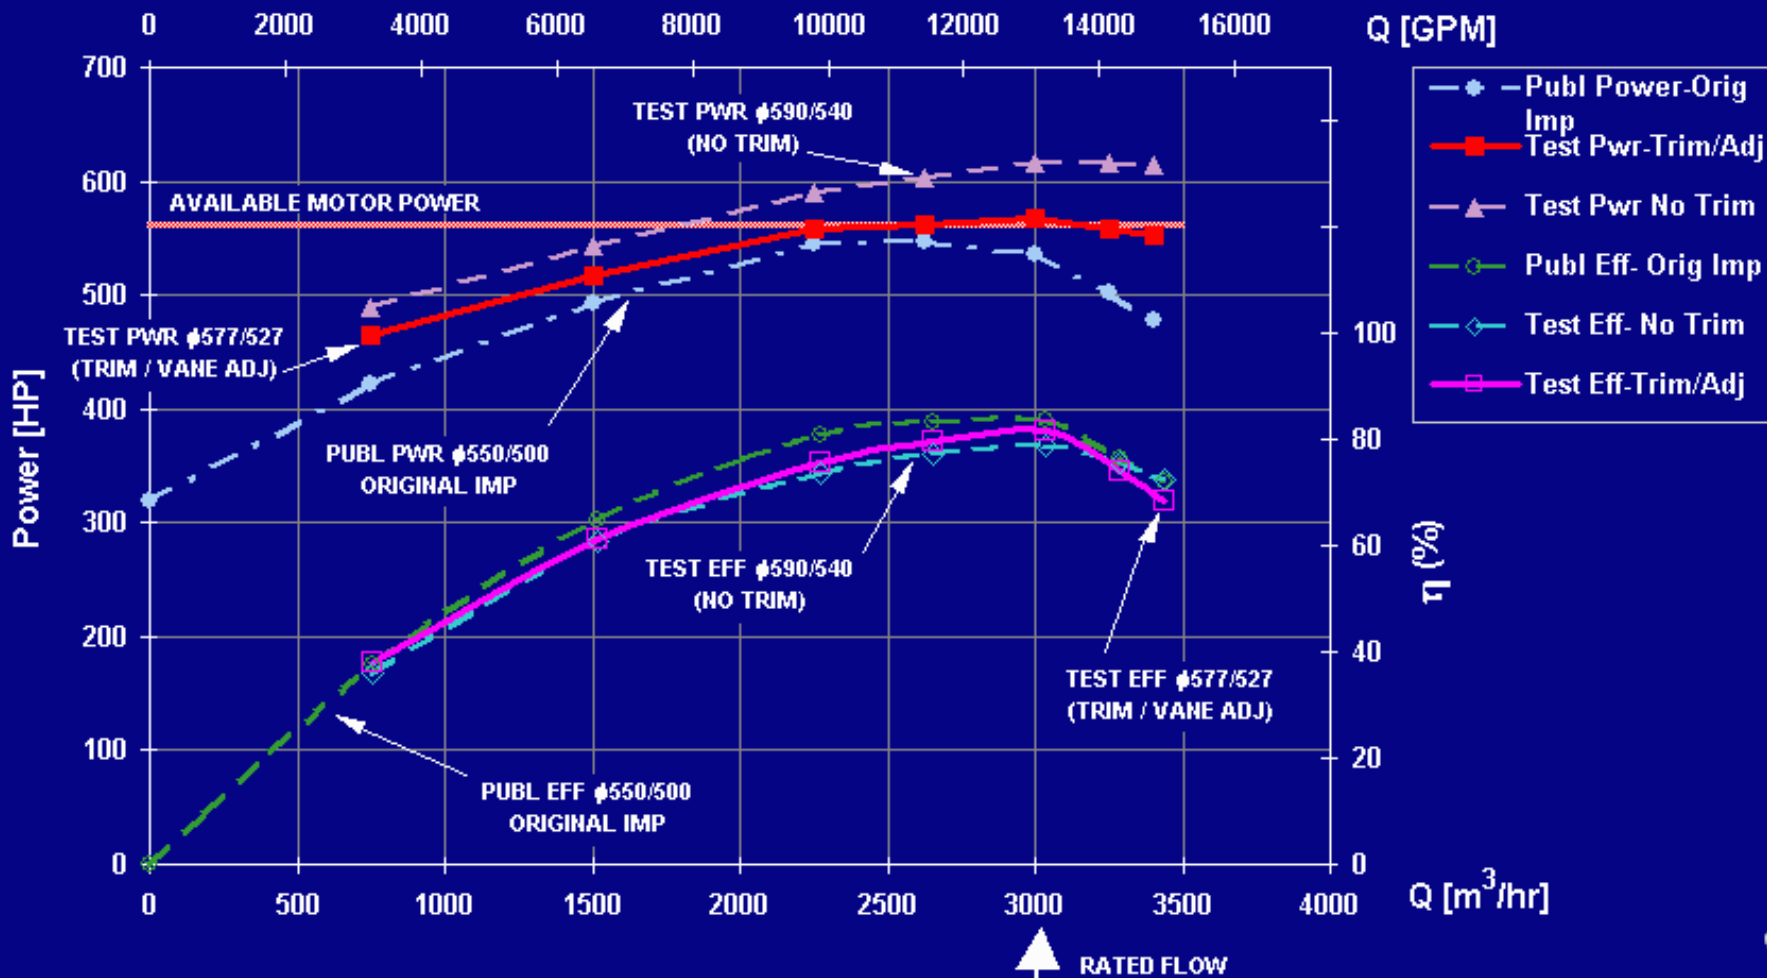
# TEST STAND RESULTS - FINAL

## PUBLISHED VS. TEST PERFORMANCE REWORKED NEW IMPELLER $\phi 577/527$ mm @1188 RPM
