Sborník vědeckých prací Vysoké školy báňské - Technické univerzity Ostrava
číslo 1, rok 2008, ročník VIII, řada stavební
článek č. 38

Marian MARSCHALKO¹, Libuše HOFRICHTEROVÁ², Lubomír TŘESLÍN

**ENGINEERING-GEOLOGICAL CONDITIONS OF LANDSLIDE IN THE OSTRAVA-KARVINÁ
COALFIELD**

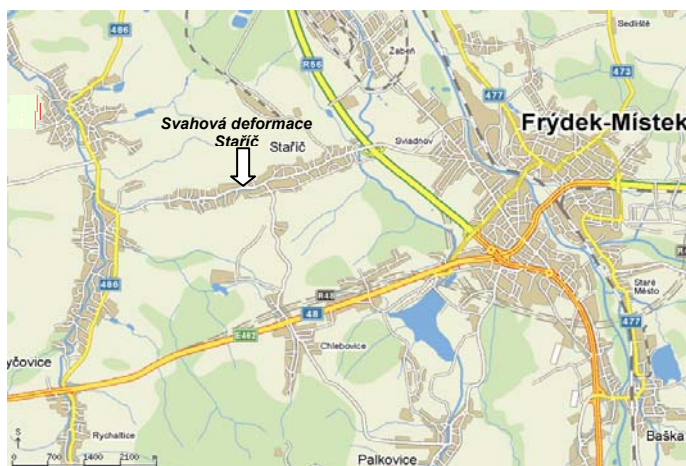
Fig. 1: Localization of the slope deformation Staříč

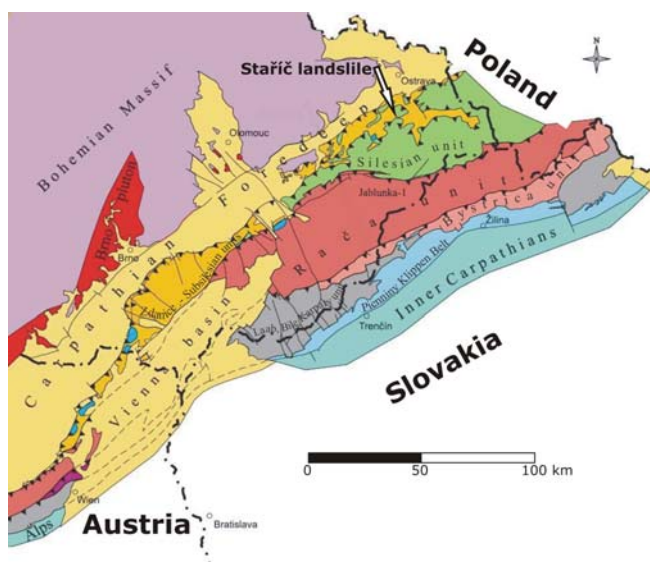
The Podbeskydská pahorkatina Uplands represent a range of highlands, uplands and troughs in the direction NE-SW with a predominantly denudational relief. It roughly takes up 1508 km², with the mean high of 353 m and gradient 4°20'. From the point of regionally geological view the locality falls in the North-Moravian part of the flysh belt (fig.2) of the Outer Western Carpathians, the so-called Moravian-Beskydy Flysh.

Fig. 2: Situation of Staříč landslide in Schematic geological map

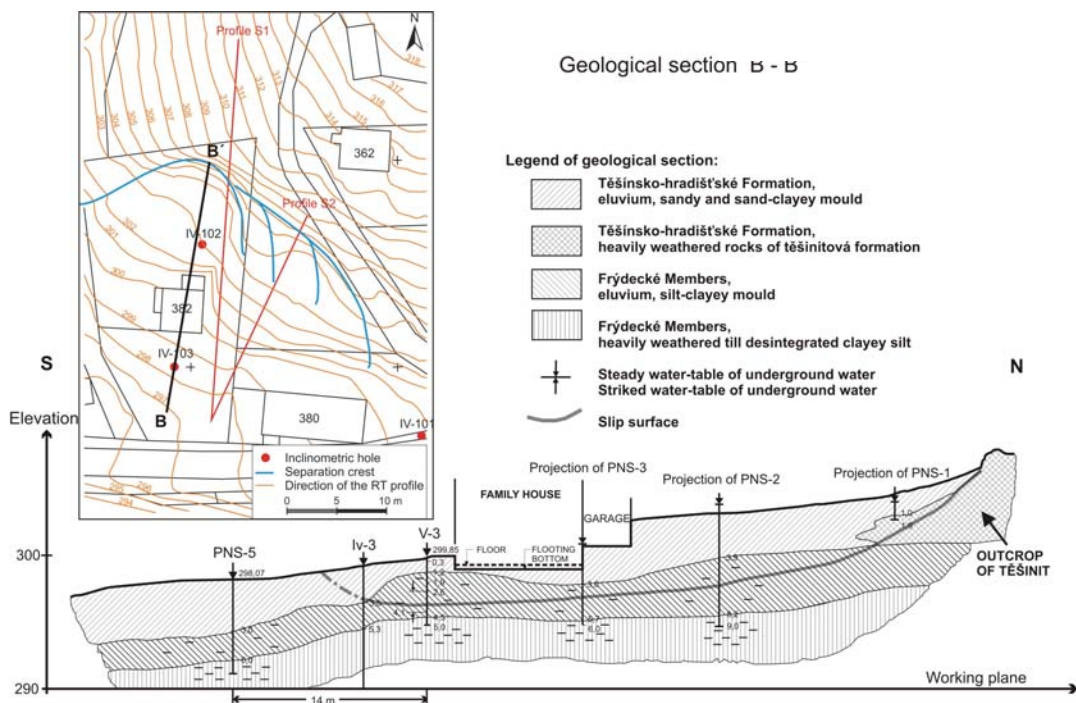
In the interest locality it is possible to interpret the following geological section on the basis of *a previous archive survey works* and *engineering-geological mapping* (Figure 3).

Fig. 3: Geological section and map of the interest area along with the sections placement

In the interest locality *resistive tomography* was used to measure two sections with pace survey 1 m. The first section S1, 95-metre long (96 electrodes) ran N–S with the azimuth 5° (See Figure 3 – map of the interest area along with the sections placement). The section began in the bottom part of the land belonging to house No. 382, went through an outcrop of teschenites and ended on the field of the neighbouring house No. 362. The second, shorter section S2 was 55 m long (56 electrodes). It originated from the identical source point as section 1 and with the azimuth 30° it intersected the plots belonging to houses No. 382, 380 and 362.
