# APPLICATION OF GPR DURING INVESTIGATION CONCERNING CAUSES OF FAILURE OF RAILWAY STATION PLATFORM IN JILEŠOVICE

## VYUŽITÍ GPR PŘI ZJIŠŤOVÁNÍ PŘÍČIN PORUŠENÍ NÁSTUPIŠTĚ NÁDRAŽÍ V JILEŠOVICÍCH

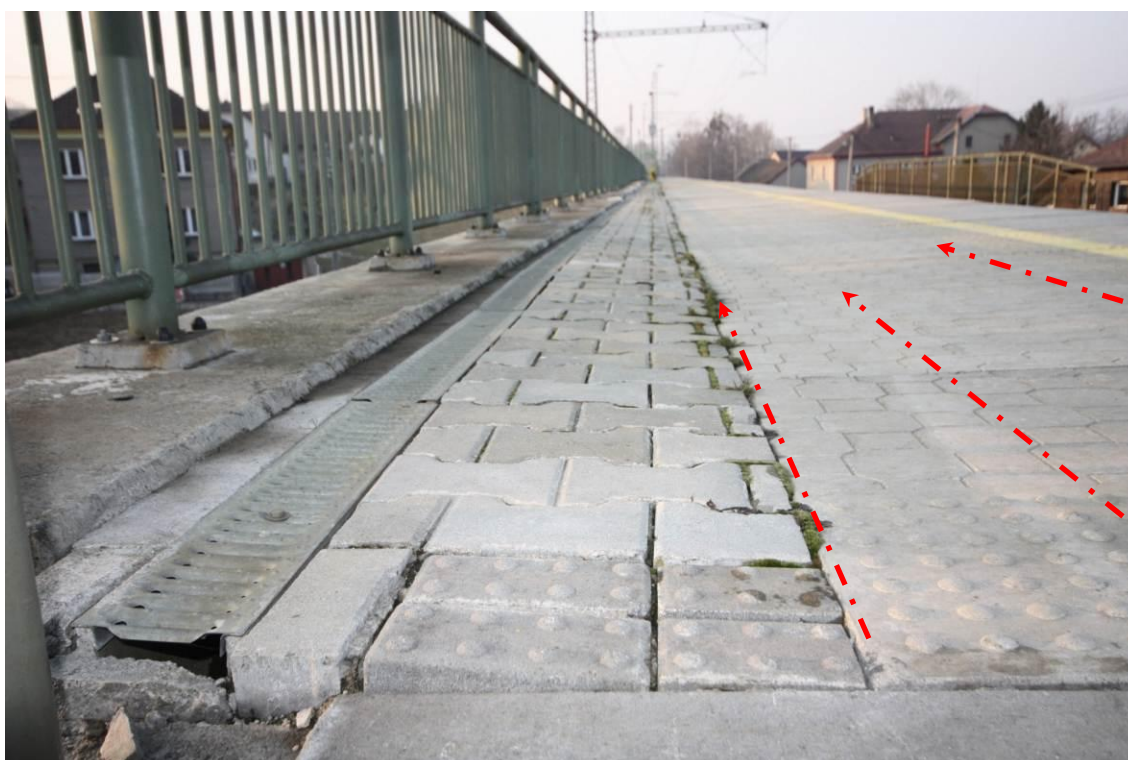
The measurements were performed in three mutually parallel profiles, spaced 80 cm. After the initial assessment of measured data one of the profiles measured by the set with the shielded 250 MHz antenna marked as PRad1, in Fig. 9 first left, was then selected for further interpretation.

**Fig. 9** Schematic representation of the directions of 3 parallel radar profiles, spaced 80 cm (used antennas with a frequency of 250 MHz and 500 MHz). Photo A. Poláček.
