A study of the low-cycle fatigue failure of a galvanised steel lighting column

Louise A. Alexander^a, James Wood^{b*}

ABSTRACT

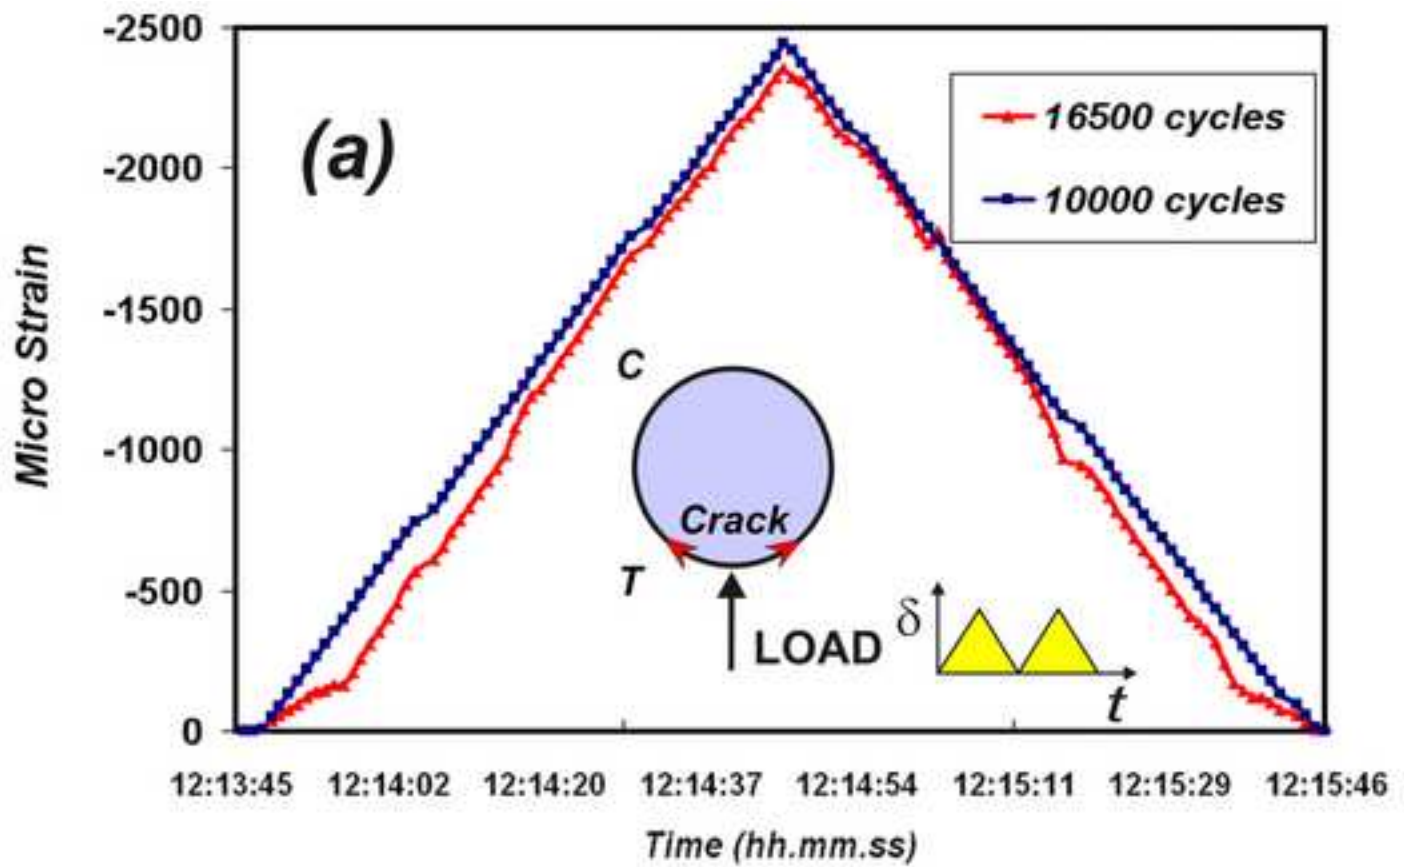
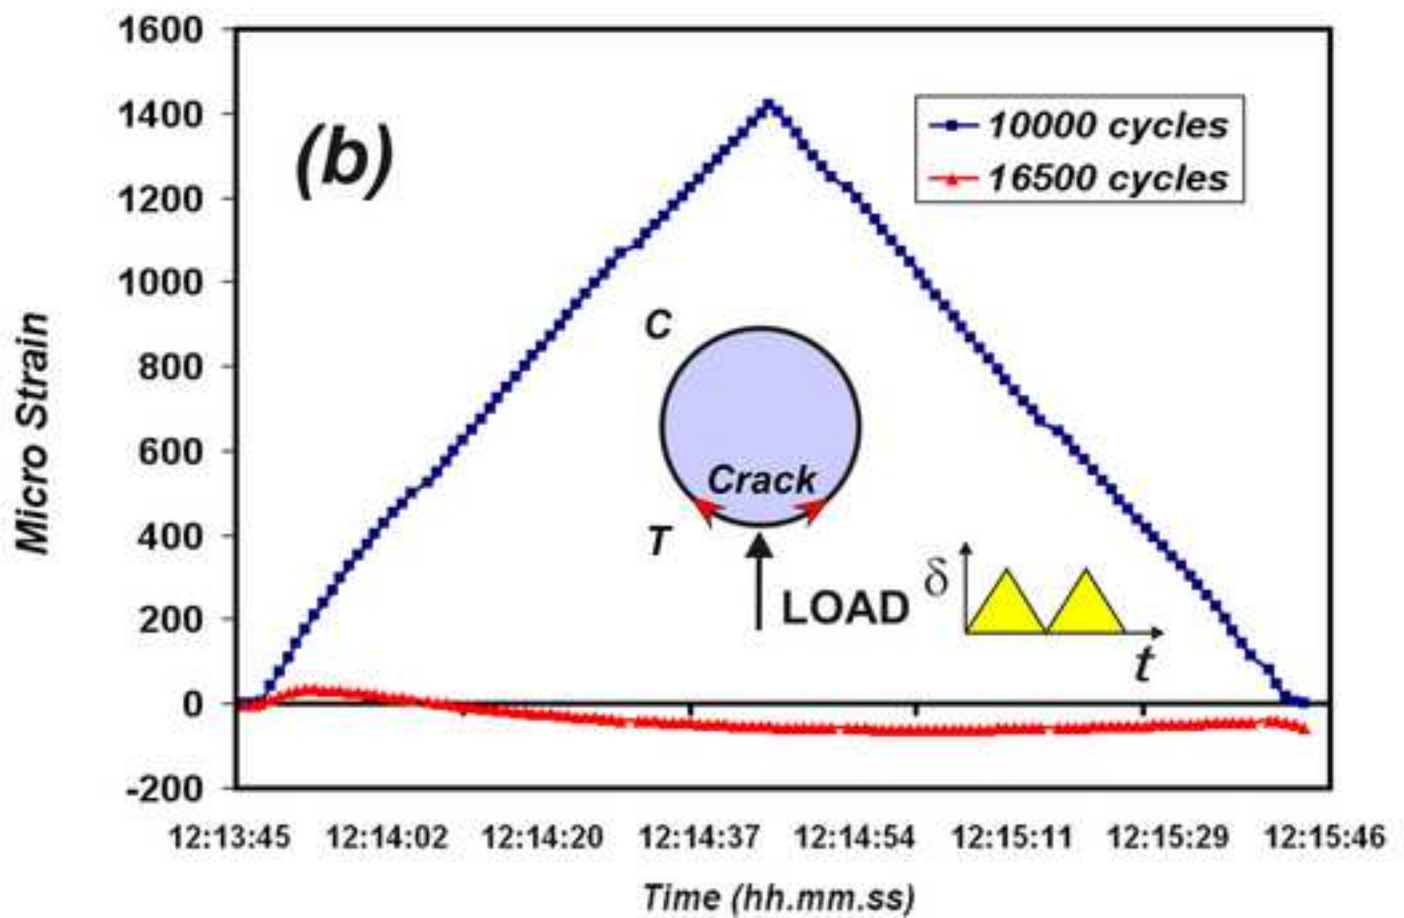
Figure 5

Shown in Fig. 5 is the location of the assumed crack initiation site on the outer surface of the column. Due to the nature of the low cycle fatigue test, the usual

To allow analysis of the fatigue failure, various micrographs were produced as shown in Figs. 5- 9. Section S2 was chosen as a position of through-thickness cracking, whereas sections S1 and S3 are sections where the crack has not yet propagated through the wall thickness.

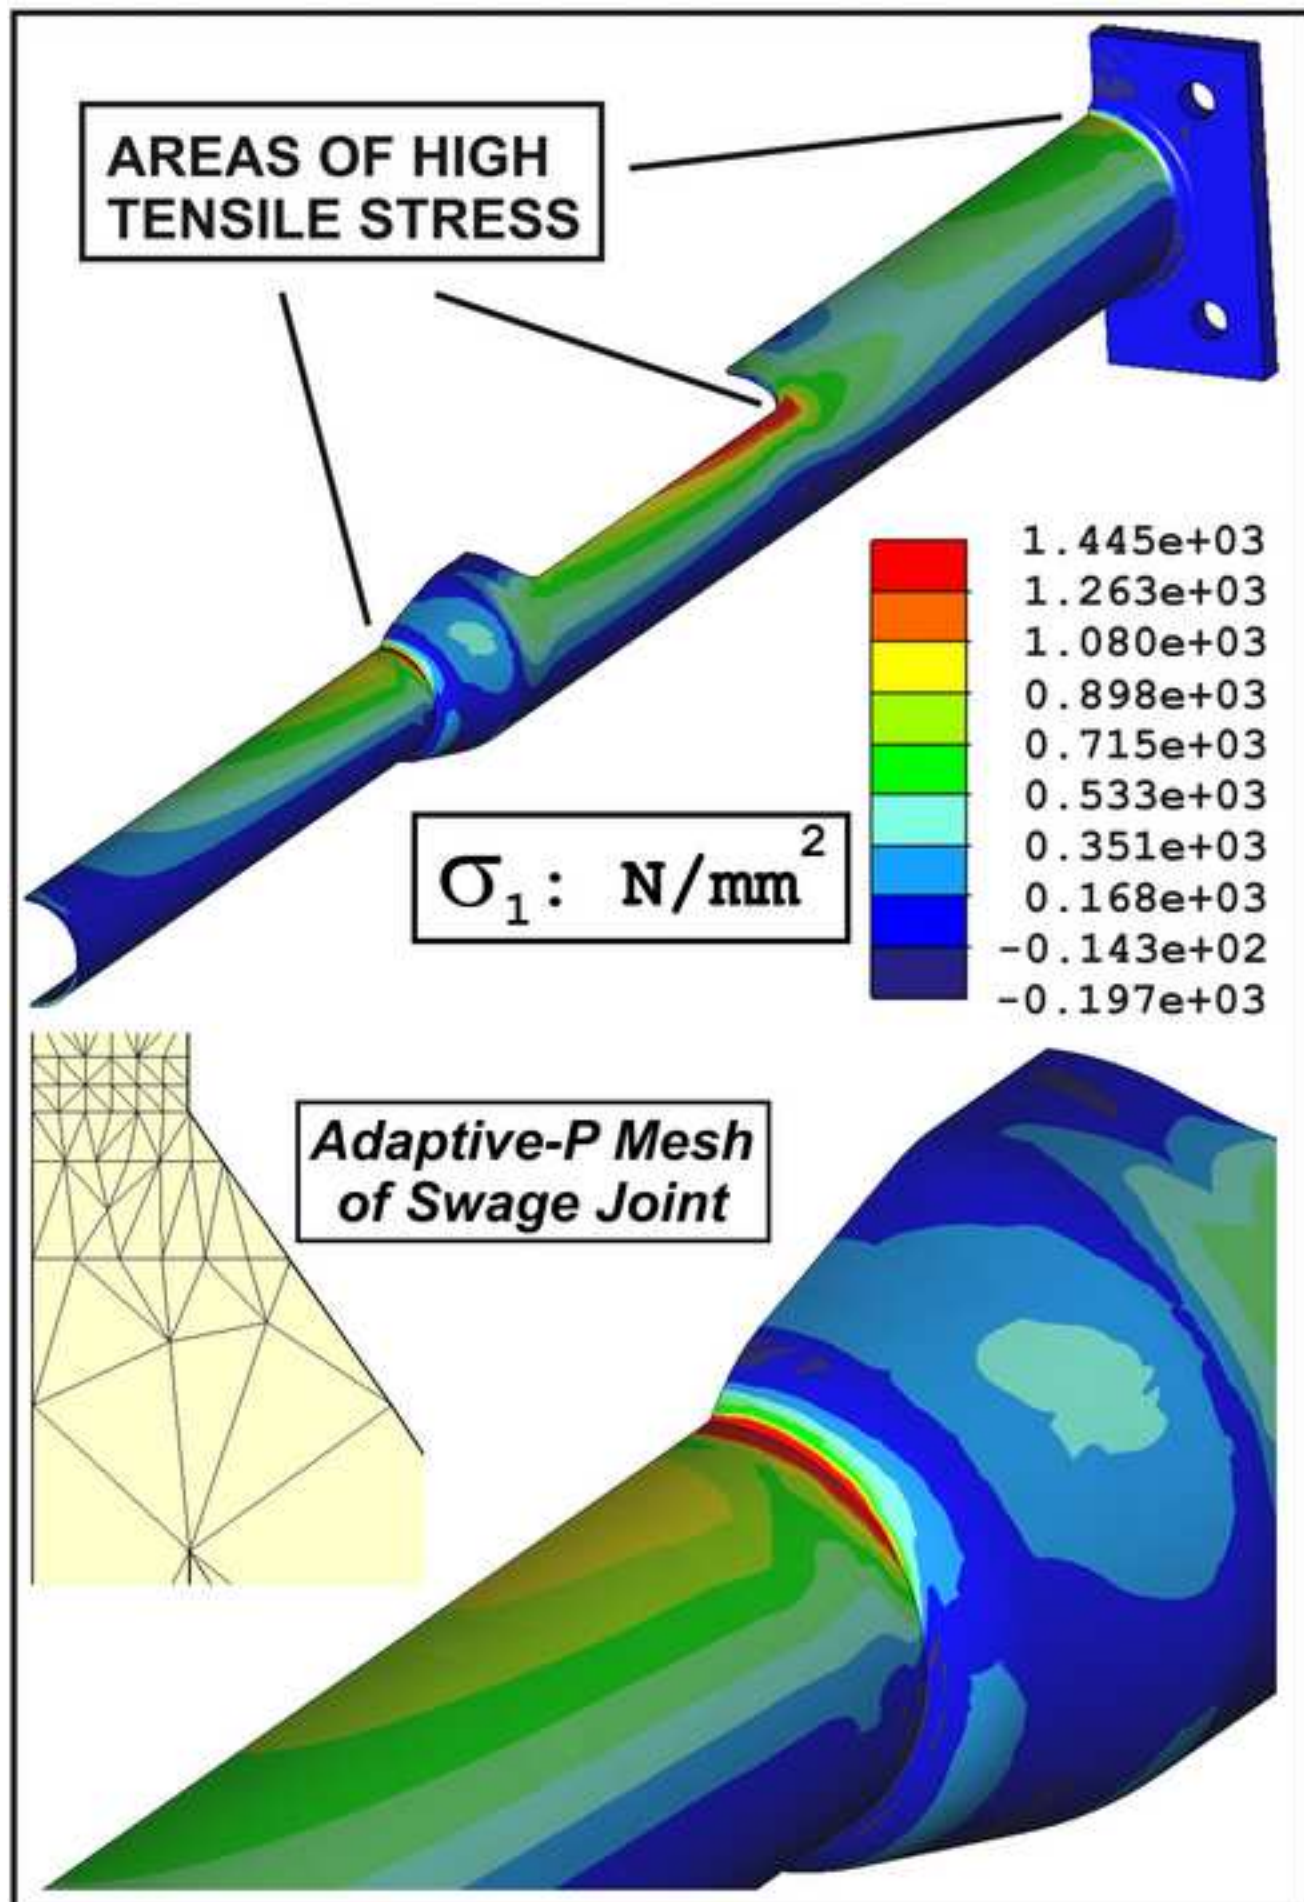
Figure12

Selected finite element results were compared with strain gauge results and hand calculations and the comparisons were generally favourable. The highest error (14%) occurred in the comparison with a strain gauge 2mm from the toe of the weld. Given the steep strain gradient in this area shown in Fig. 12 and the very small length of these gauges, this is perhaps a reflection of the difficulties in precise location and alignment. The irregular nature of the weld will also influence the experimental results.

The localized nature of the stress concentration at the swage joint is illustrated in Fig. 12. The stress distribution on the toe side tends to infinity with mesh refinement, due to the singularity. The extremely localised effect due to the weld (within a quarter of the tube thickness of the weld toe) is superimposed on the gross geometric stress concentration due to the swage.

The stress distribution on the inner surface is continuous however. This distribution is terminated opposite the toe, in Fig. 12, for comparative purposes. The very steep gradient on the inner surface is also apparent and the axial bending stress becomes compressive within a distance of one wall thickness of the weld toe position. The inner surface compressive strains, shown in Fig. 13, are likely to be the source of damage to the relatively low-ductility galvanised coating in this region. This in turn will result in fatigue cracks developing from the inner surface as observed in the experiment.
