**AN EXPERIMENTAL AND FINITE ELEMENT STUDY OF
THE LOW-CYCLE FATIGUE FAILURE OF A
GALVANIZED STEEL LIGHTING COLUMN**

James Wood^a, Louise A. Alexander^b and Ian Taylor^b

SUMMARY

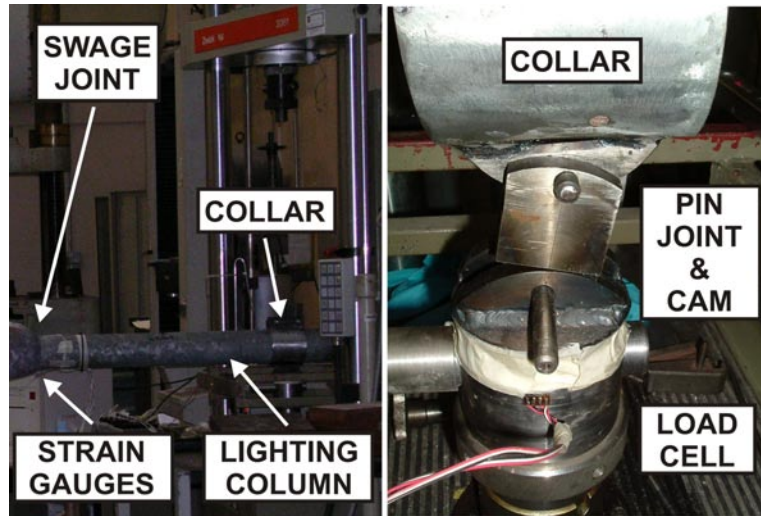
Figure 2: Test set-up showing servo-hydraulic test machine and loading arrangement.

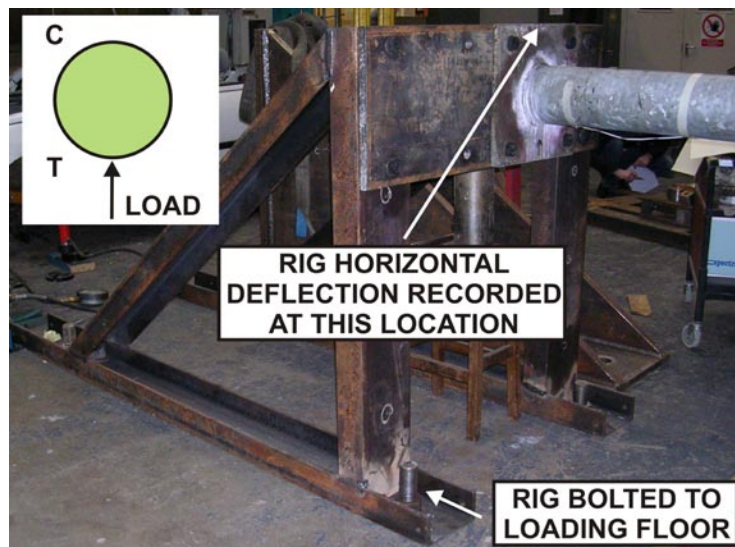
Figure 3: Test set-up showing test frame and lighting column.

The column was mounted horizontally in a test frame and the load was applied via a servo-hydraulic test machine. The shortening of the column was necessary due to the particular capacity of the test machine, in terms of load, cross head travel and cyclic rate.

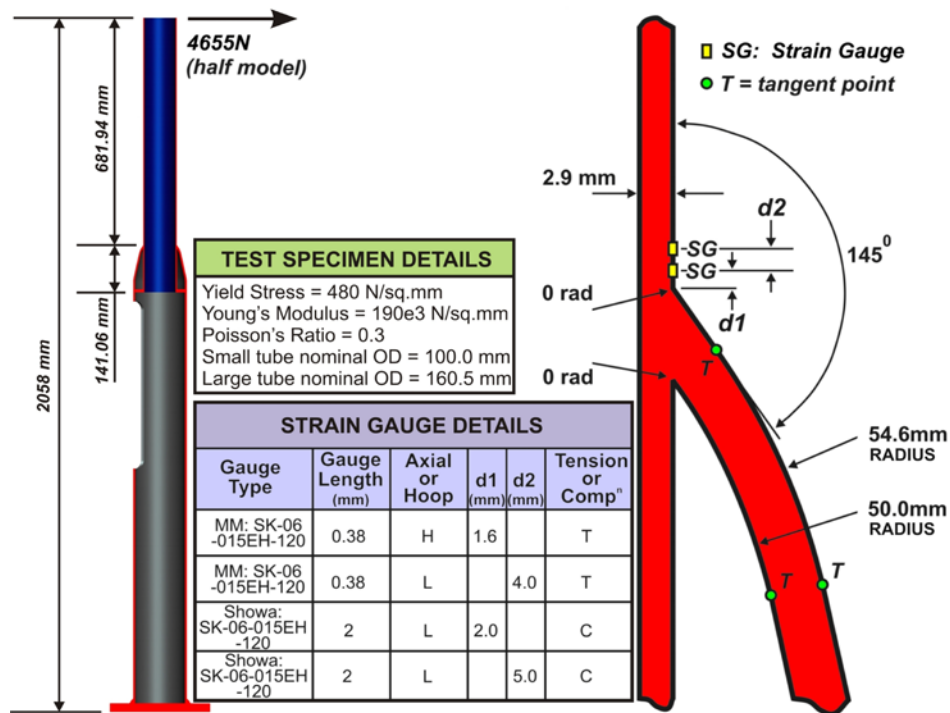
The shortened lighting column was instrumented with strain gauges (on both the tension and compression sides of the column) as shown in Figure 4.

Figure 4: Test specimen and instrumentation details.

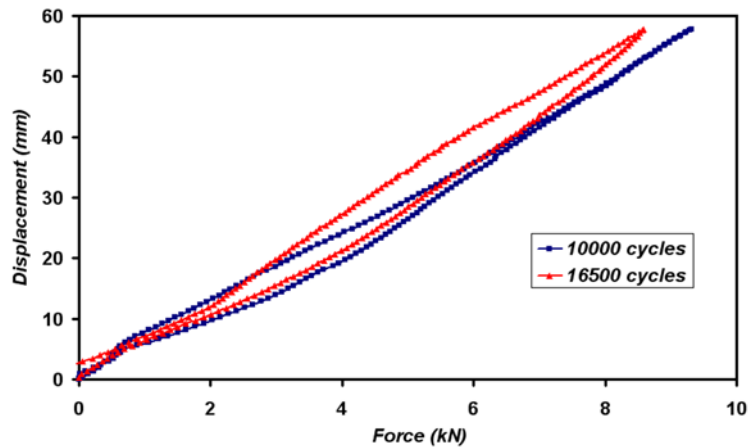
As mentioned previously, this was a displacement controlled test and Figure 6 shows that the load required to displace the column by 58mm had fallen slightly between the 10000 and 16500 cycles. There is also an observable increase in the size of the hysteresis loop, which is to be expected.

Figure 6: Load versus displacement for 10000 and 16500 cycles.

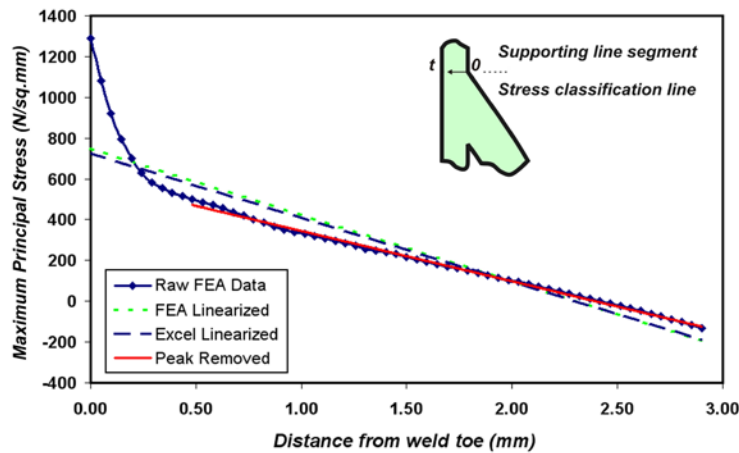
The differences in through-thickness approach are illustrated in Figure 11.

Figure 11: Through-thickness Peak Stress Removal Methods.

The Excel Linearized line is simply a best-fit straight line fitted to the entire data. The FEA Linearized line on the other hand, used the linearization algorithm inherent in most FEA systems. In this case the linearization is carried out on a stress component basis, before recombining to obtain the membrane plus bending components of the principal stresses.
