Fault Location and Diagnosis in a Medium Voltage EPR Power Cable

ABSTRACT

This paper presents a case study on fault location, characterisation and diagnosis in a length of shielded 11 kV medium voltage ethylene-propylene rubber (EPR) power cable. The defect was identified on-site as a low resistance fault occurring between the sheath and the core. A 43 m section was removed for further analysis. The fault resistance was characterised and the location of the defect pinpointed to within a few cm using a combination of time-difference-of-arrival location and infra-red imaging. A combination of X-ray computed tomography, scanning electron microscopy and energy dispersive X-ray spectroscopy were then applied to characterise any abnormalities in the dielectric surrounding the breakdown region. A significant number of high density contaminants were found to be embedded in the dielectric layer, having an average diameter of the order of 100 μm , a maximum diameter of 310 μm and an average density of 1 particle per 2.28 mm^3 . Scanning electron microscopy and energy-dispersive X-ray spectroscopy were used to determine the geometry and elemental composition of some initial contaminant samp

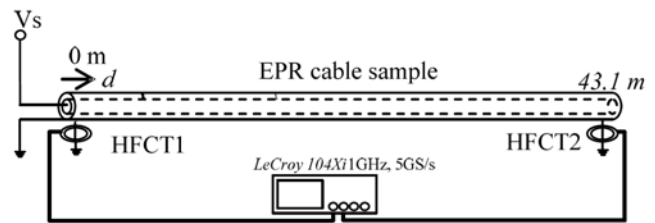
Figure 1. Experimental setup for TDOA location of breakdown pulse from cable fault.

where Δt is the time-difference-of-arrival between measured signals at HFCTs 1 and 2. This was achieved by identifying similar features on the respective waveforms arriving at each HFCT, such as the initial peaks, and estimating the time difference between these features. Taking into account measurement errors in Δt and ΔT , the signals shown in Figure 3 correspond to a fault location of $d = 2.18 \pm 0.56$ m from HFCT1 (see Figure 1).

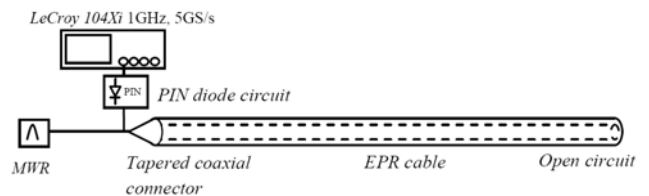
Figure 2. Experimental setup for measurement of propagation velocity u_p .

circuit based on PIN diodes, as shown in Figure 2. This novel approach protected the oscilloscope's input voltage from the initial high amplitude injected pulse, while still allowing the low amplitude reflected pulse to be measured with high sensitivity. The time difference between injected and reflected pulses was 581 ns, corresponding to twice the transit time of the cable. Since the exact physical length of the cable could be measured, u_p could be calculated using the equation $u_p = l/\Delta T$ where l is the physical length of the cable and T is transit time along its length. In this case, $u_p = 43.1/290.5 \times 10^{-9} = 1.48 \times 10^8 \text{ ms}^{-1}$.

The measurement error in time difference was estimated to be ± 4 ns, caused by limitation of the scope's horizontal resolution combined with the error in estimating the starting point of the reflected pulse's rising edge due to dispersion effects.

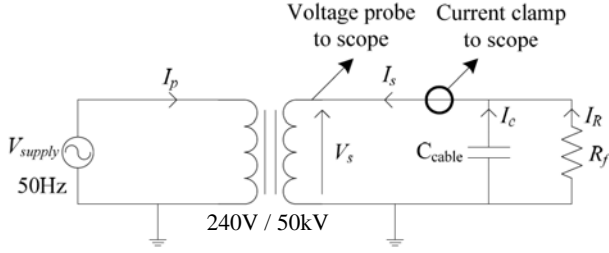
Figure 5. Experimental setup for measurement of fault resistance R_f of the conductive channel between core and sheath.

The fault resistance was calculated by dividing the secondary voltage by I_R . Four different tests were carried out to check repeatability. Due to the limitation in current which could be drawn from the LV supply (around 16 A), the maximum voltage that could be applied to the cable was around 35 V rms at the point where the defect resistance had reached a steady-state value. Figure 7 shows the variation in the fault resistance measurements for four repeated experiments.
