ULTRASONIC TOMOGRAPHY FOR DETECTING AND LOCATING DEFECTS IN  
CONCRETE STRUCTURES

A Thesis

JOSHUA BENJAMIN WHITE

Submitted to the Office of Graduate Studies of  
Texas A&M University  
in partial fulfillment of the requirements for the degree of  
MASTER OF SCIENCE

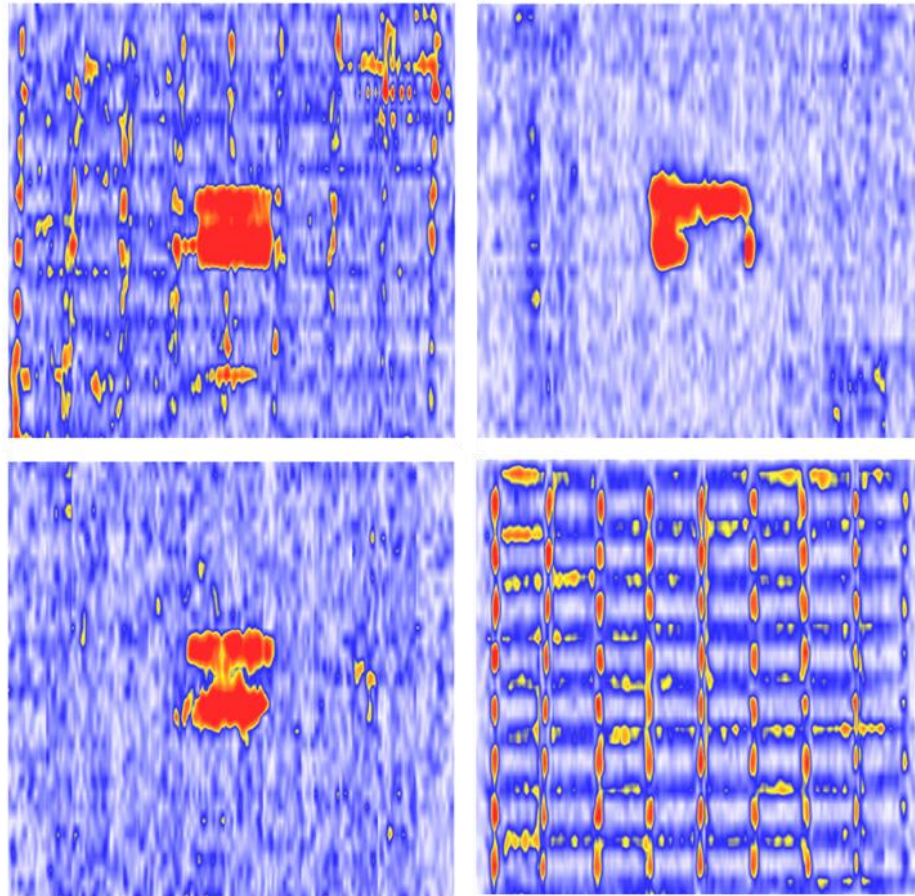
**Fig. 5. Typical C-scans for simulated defects in concrete slabs: Specimens Theta (top left), Lambda (top right), Kappa (bottom left), and Gamma (bottom right)**

C-scans, which offer the most comprehensive visual dimensioning of the simulated delaminations, are shown in Figs. 5 and 6. The images in these figures are representative of defect visualization for the simulated concrete and shotcrete slabs. Figs. 5 and 6 depict typical C-scans showing a simulated delamination (top left), an air-filled void (top

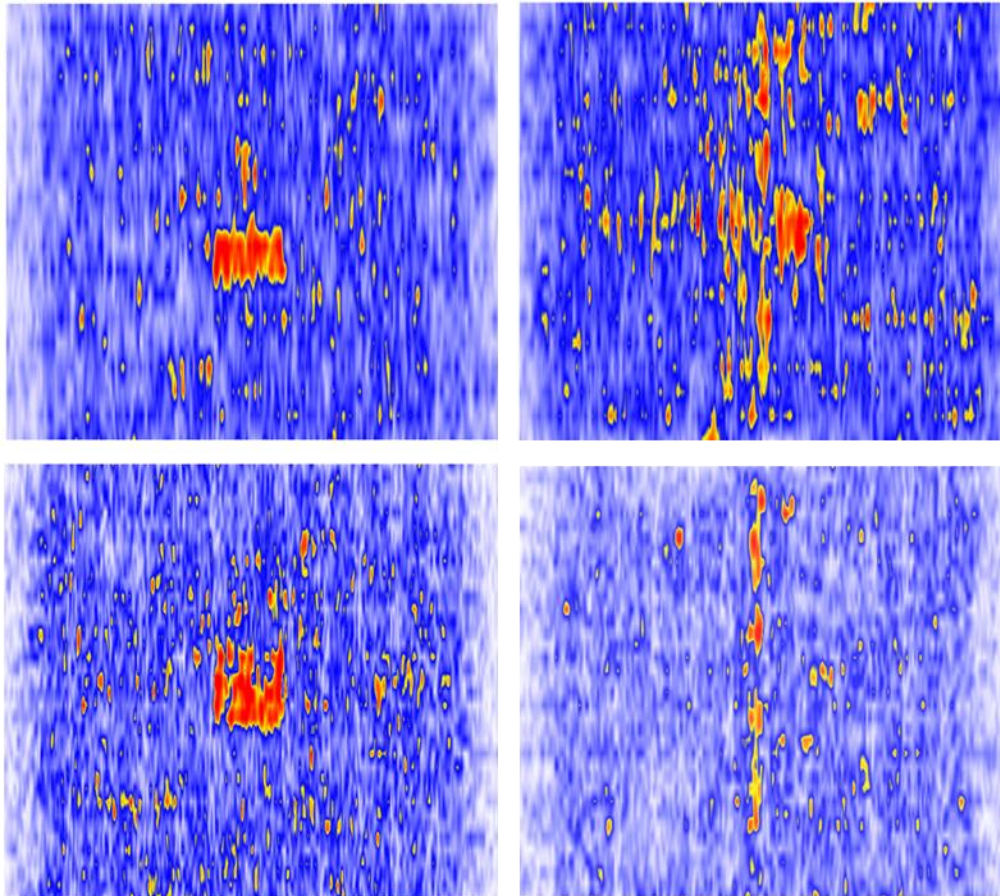
**Fig. 6. Typical C-scans for simulated defects in shotcrete slabs: Specimens D (top left), E (top right), I (bottom left), and M (bottom right)**

right), a water-filled void (bottom left), and a slab with only reinforcement (bottom right). A summary of all simulated defects and specimen characteristics for the concrete/shotcrete slabs with simulated defects (in addition to the simulated concrete specimens with clay lumps discussed in 3.2) is provided in Table 1. These images demonstrate that the discontinuities in normal-strength concrete are more clearly detectable than in the shotcrete specimens. One explanation is that the shotcrete application, perhaps when misapplied, can be more porous than typical concrete; within the shotcrete are numerous micro voids that more quickly attenuate the acoustic waves.

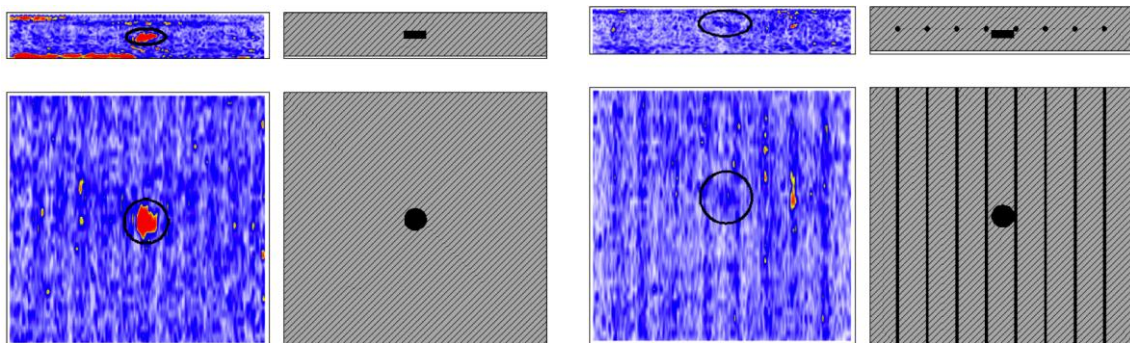
reflectivity regions, which denote any sort of discontinuity, represent the depth of these anomalies. Keys are provided alongside each ultrasonic image, Figs. 8 and 9, detailing the *intended* location of the lumps. It should be understood that during concrete pouring and vibrating, the lumps will inevitably be displaced from side to side (e.g., the inward movement of the two center lumps in Fig. 9, left) and upwards (e.g., the upward displacement of the lump in Fig. 8, right). The C- and B-scans from Figs. 8 and 9 show both the large and medium lumps were highly detectable both in slabs with no reinforcement and in slabs that include reinforcement. However, with lumps that are exactly at the layer of reinforcement (Fig. 8, right, and the middle set of lumps in Fig. 9, right), it is clear that lumps surrounding reinforcement are highly improbable

**Fig. 8. Large clay lump slabs: (a) without reinforcement, and (b) with reinforcement**

of detection. It would be difficult or highly improbable to know these areas had clay lumps if the system were to be applied in a field application with lumps caught in the reinforcement. At these levels within a specimen, it may be inferred that a lump is

present, but the clarity is not as persuasive as in the detection of lumps located farther from the reinforcement.

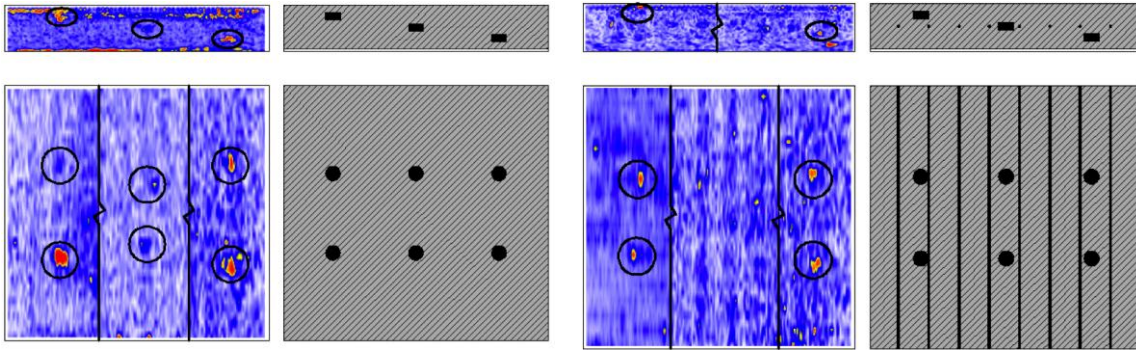
**Fig. 9. Medium clay lump slabs: (a) without reinforcement, and (b) with reinforcement**

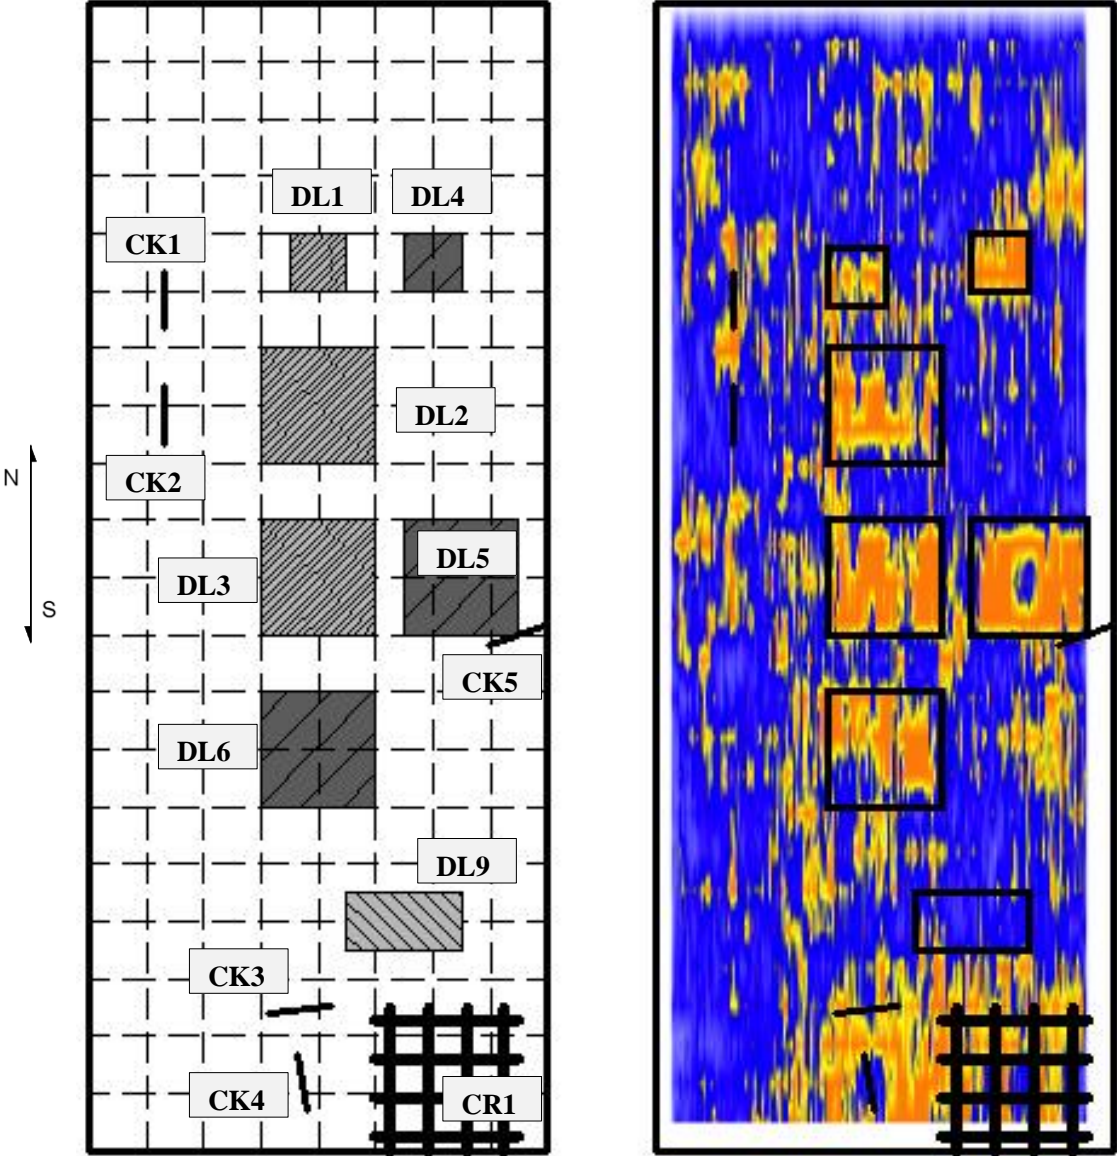
optimal increment was not yet established. In retrospect, this is a contributing factor for the defects in this specimen to be less defined than in the previous cases. Fig. 12 shows the defects present at 64 mm (2.5 in.) deep, and Fig. 13 shows the defects present at 152 mm (6 in.) deep. As can be seen from the UST results, six of the seven defects are detected. The one defect undetected was the 0.25 mm (0.01 in.) thin polyester fabric at 64 mm (2.5 in.) below the surface (DL 9), as well as details of the various cracks. This scan was not particularly useful for examining cracks, as the data set for the entire scan was too massive for careful evaluations via D-scans, and the B-scans were spaced too far apart for careful analysis. Nevertheless, a sample crack (CK1) is shown in Fig. 14 below. More on crack analysis and methods for mapping them can be found in Section 5.2 and 5.3. The following B-scans with their associated end-view keys are shown in Figs. 14-20 below.

Fig. 12. C-scan at 2.5" depth: construction key (left) and UST results (right)

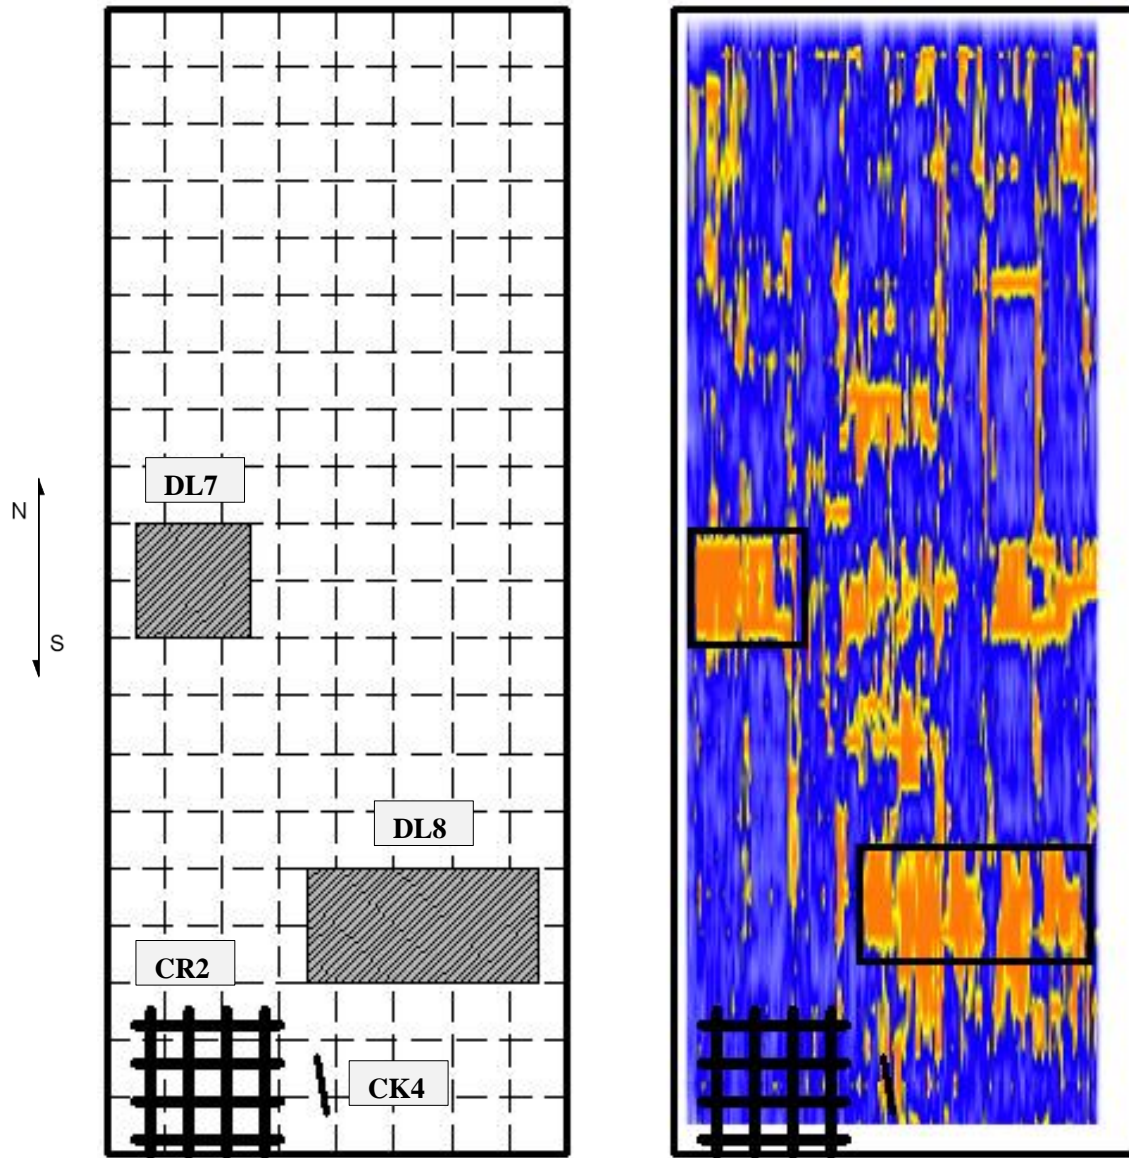
Fig. 13. C-scan at 6" depth: construction key (left) and UST results (right)

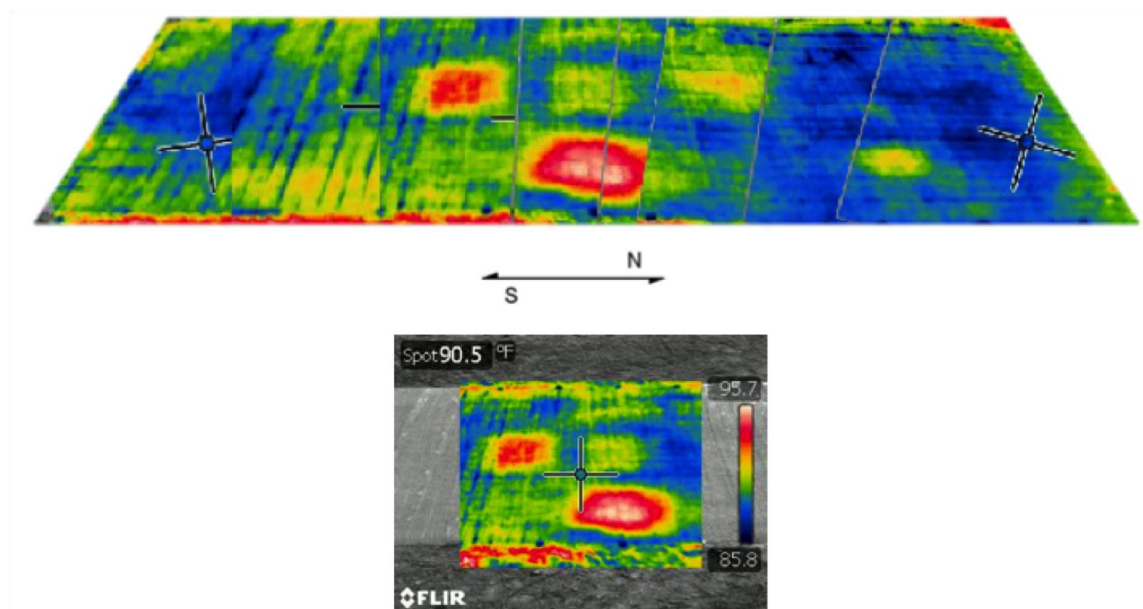
As can be seen from Fig. 21, the device revealed the more easily detectable delaminations but could not detect corrosion, cracks, or the deep foam delaminations (152 mm, or 6 in. deep) and shallow polyester delaminations (64 mm, or 2.5 in. deep). The lack of detection with these defects is due to the defect being too deep to locate temperature differences and too thin to produce a noticeable insulating effect. DL 5 and DL 6 (see Table 2) display higher thermal emissions than the thinner (1.0 mm, or 0.04 in. thick) defects DL 2 and DL 3, which have the same area and are located at the same depth as DL 5 and DL 6. This is consistent with the fact that DL 5 and DL 6 are constructed of 2 mm, or 0.08 in. thick material, allowing these delaminations to decrease

**Fig. 21. Infrared collage (above) and single image from camera (below) of the simulated bridge deck**

the rate of heat conduction. The same can be seen for the equally sized delaminations DL 1 and DL 4, which are also located at the same depth from the surface. While DL 1 is only vaguely discernible, DL 4 is substantially warmer. Comparisons should also be made between DL 8 and DL 7, which are discernible, but whose shape cannot be well defined. DL 9, the 0.25 mm (0.01 in.) polyester fabric, cannot be seen making a substantial change in surface temperature.

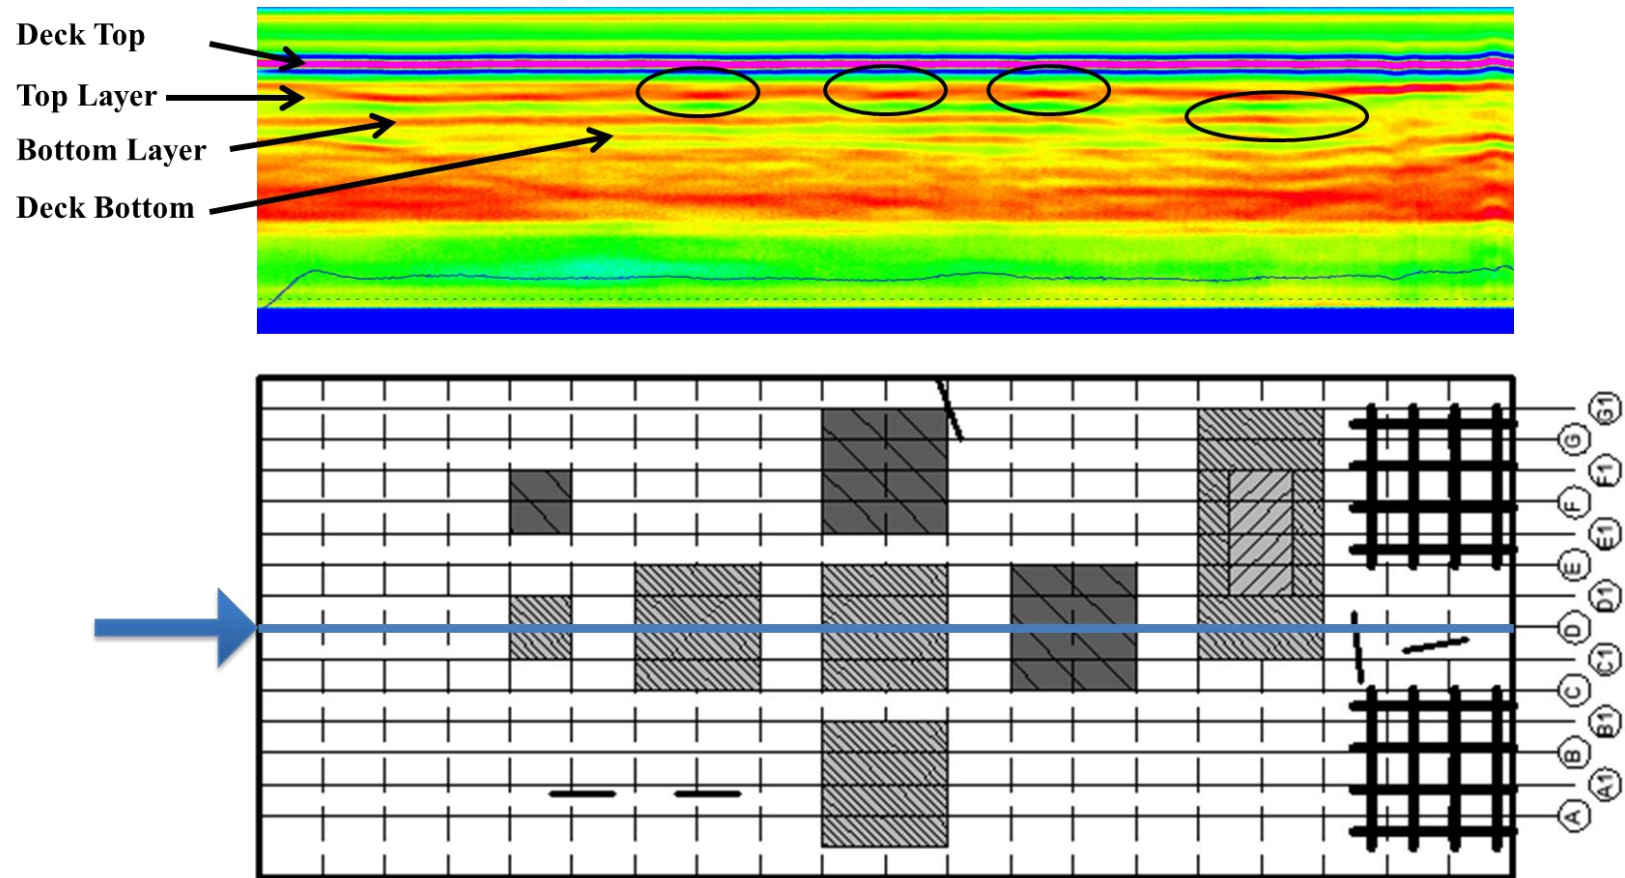
bridge deck, four areas consistent with the delaminations shown along Section D are circled (defects DL1, DL2, DL3, and DL8). Defects DL4 and DL7 are seen in a similar fashion. The only other defects detected by the GPR scans are the areas of possible corrosion indicated by the increase in dielectric (shown as a black line plot in the bottom of the GPR B-scan).

Fig. 22. GPR data indicating four areas of delamination within the top reinforcement

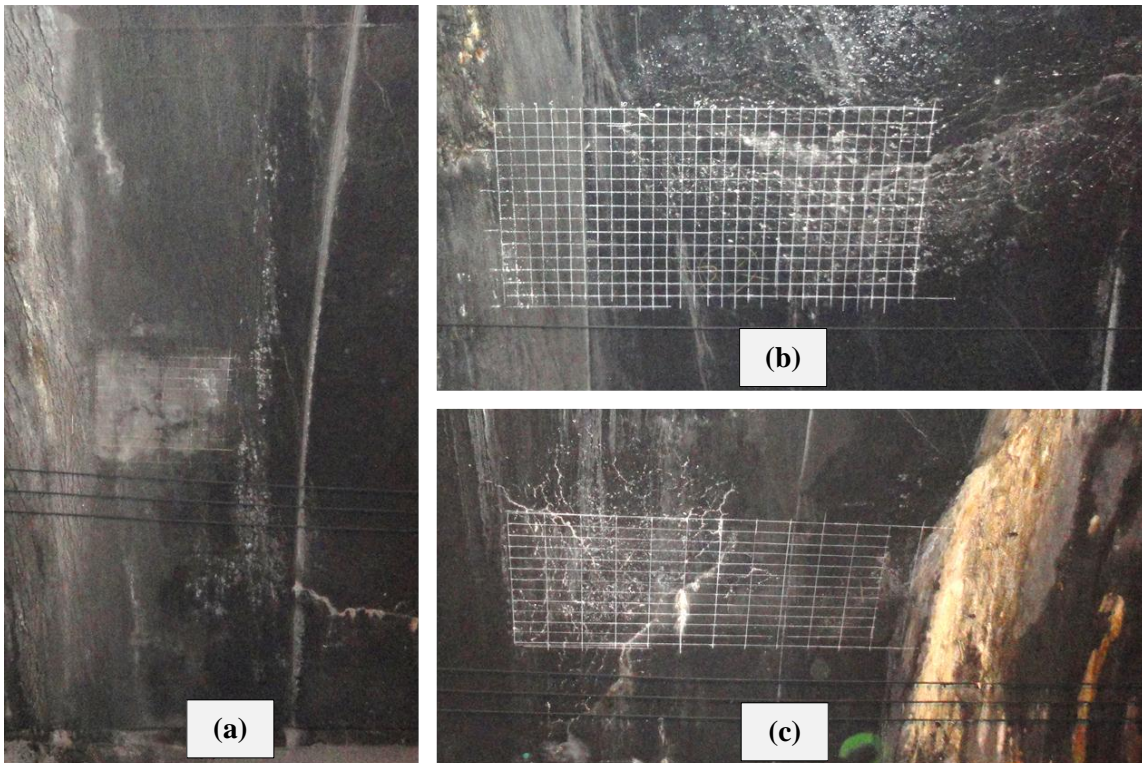
As would be expected, the “sound” concrete area (Map ET 10.4-1, 2 in Appendix B) showed no signs of significant delamination, but a clear interface was observed approximately 411 mm (16.2 in.) below the surface (~239 mm, or 9.4 in. wide).

**Fig. 26. Scanned areas within Eisenhower Tunnel: (a) “sound” concrete, (b) surface cracking and crazing near joint, and (c) surface cracking and crazing near joint and crack with stalactite formation**

As noted earlier, one of the two areas tested that displayed significant surface cracking and crazing occurred near a joint (Map ET 10.4-4, 5 in Appendix B). At this location, the structural reinforcement is again located approximately 409 mm (16.1 in.) below the surface (~343 mm, or 13.5 in. wide). B-, C-, and Volume-scans are shown in Fig. 28. In the B-scan (Fig. 28b), the longitudinal reinforcement is seen directly under the hoop reinforcement with multiple echoes observed in increments approximately the same as the depth of the longitudinal and hoop reinforcement. These echoes are suspected to be the effect of debonding of the longitudinal and hoop reinforcement. Interestingly, this supposed debonding also occurs directly below the lining joint. This may indicate moisture intrusion has corroded the reinforcement causing debonding. Unfortunately, no ground truth data has confirmed this observation.

In the second area that displayed significant surface cracking and crazing near a joint (Map ET 10.4-3 in Appendix B), a severe crack running vertically down the tunnel

lining is present. The map was built to the side of this crack (Fig. 26c), but due to the stalactite formation and grout Zerk fittings, could not extend over the crack. The same structural reinforcement (here approximately 437 mm [17.2 in.] deep and 310 mm [12.2 in.] wide) is present in both the B- and Volume-scans (Fig. 29). Also at this location, strong echoes under the region nearest the stalactite formation and crack indicate

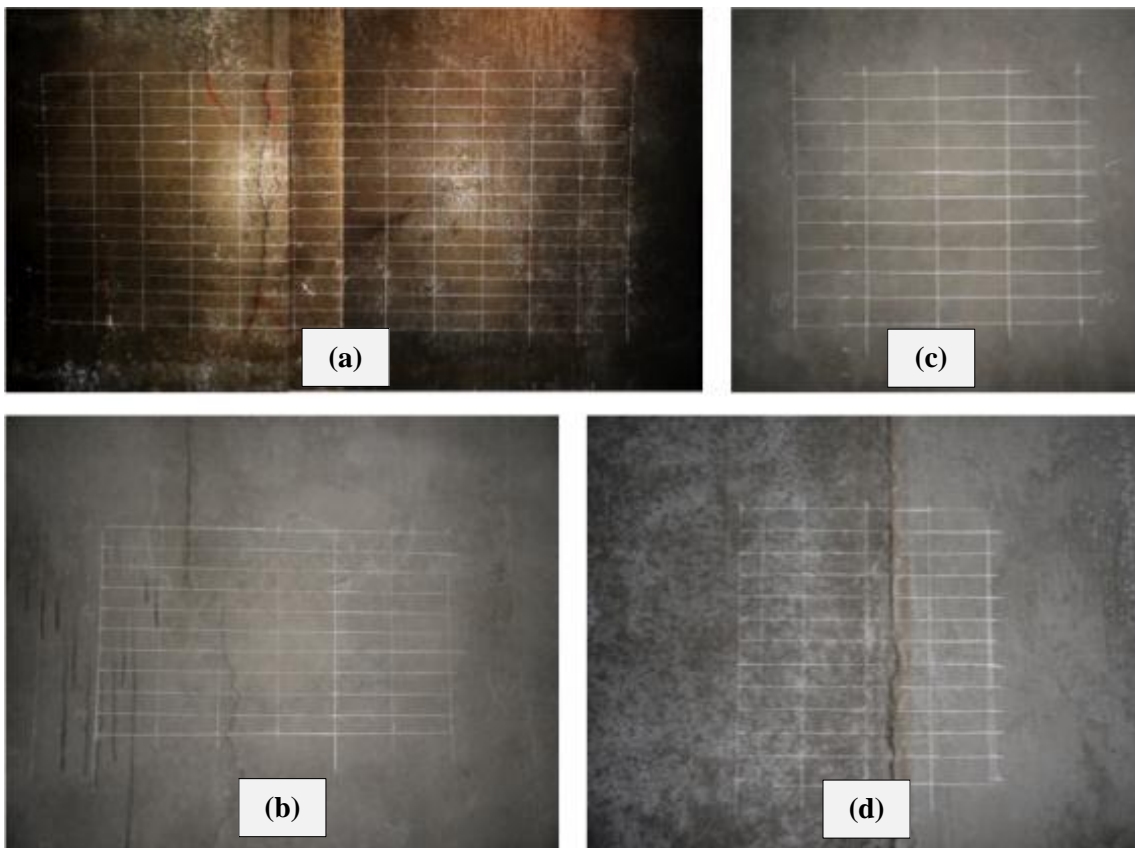
Areas of interest within the tunnel include a number of significant surface cracks (Fig. 32, a and b, as well as Fig. 33), some of which had been partially patched with a skim coat of some type of grout. Other areas include a standard “sound” concrete region (Fig. 32c), regions surrounding joints (Fig. 32d), and lastly, a region of tile in the eastbound lane (Fig. 34).

**Fig. 32. Images of areas tested at Hanging Lake Tunnel: (a-b) severe vertical cracks, (c) sound concrete, and (d) lining joint**

The “sound” concrete region (Fig. 32c, as well as Map HLT 10.5-5, 6, 7 in Appendix B) shows that the backwall reflection varies from 752-823 mm (29.6-32.4 in.)

The map tested over a joint (Fig. 32d, as well as Map HLT 10.5-4 in Appendix B) showed possible signs of debonding or the presence of voids and/or shallow delaminations at a maximum depth of 229 mm, or 9 in. (Fig. 38). Also, similar to the suspected debonding at Eisenhower Tunnel locations in Figs. 28 and 29, multiple reflections are seen at increments corresponding to the reinforcing steel depth. As noted before, these characteristic echoes are suspected to be present when debonding of the reinforcement occurs due to corrosion.

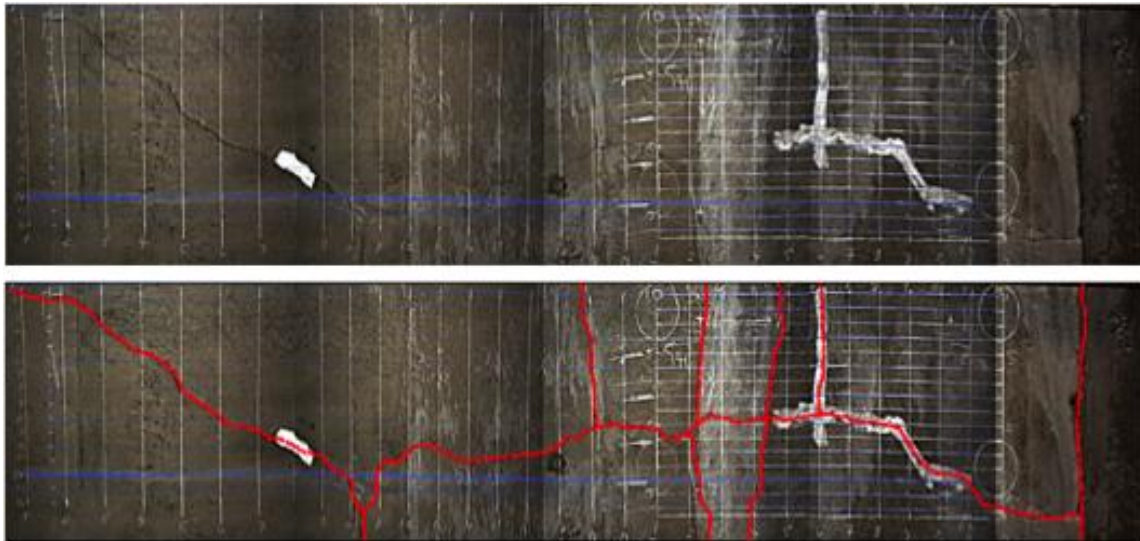
**Fig. 33. Image collage of extensive map with cracks (shown in red)**

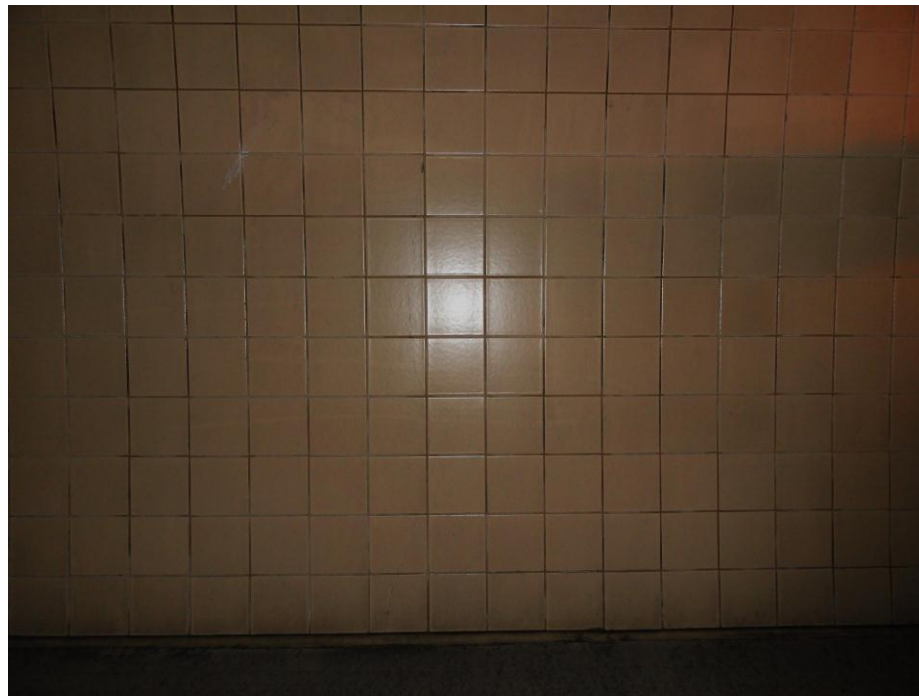
**Fig. 34. Image of tile surface that was evaluated**

The last area tested at the Hanging Lake Tunnel was a section of tile inside the eastbound lane along the outer wall (refer back to Fig. 34, as well as HLT 10.5-13 in Appendix B). Although no backwall surface was detectable, all reinforcement could be clearly seen.

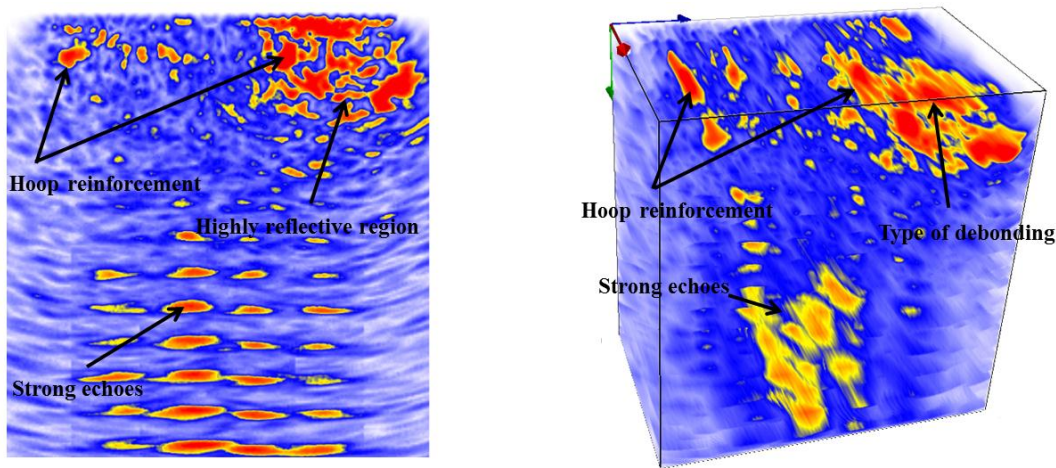
Fig. 38. UST images over lining joint: B-scan (left) and Volume-scan (right)

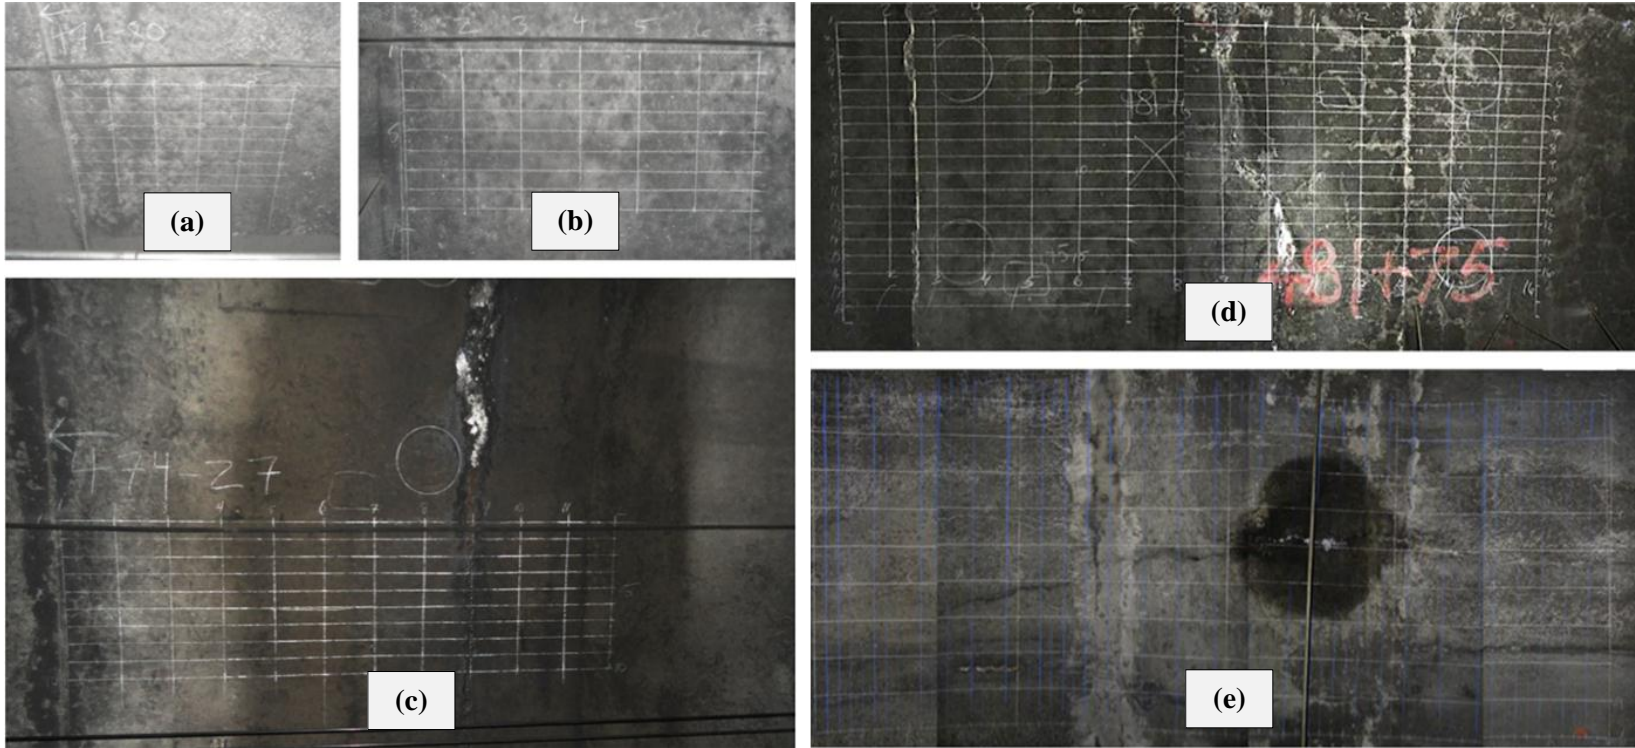
As testing began, a cart with an attached GPR antennae was wheeled throughout the entire length of the 1.6 km (1 mi) tunnel in various configurations. The data from the GPR evaluations revealed two significant features. The first was a change in steel layout. Within two segments of the entrance to the tunnel, the layer of reinforcement in the GPR scan showed a change, although specifics of the change were indiscernible. Two maps were built on what appeared to be a representation of “sound” concrete; one before the change shown in the GPR, and one after the change (Maps CBBT 10.11-1 through 4 in Appendix B). The first area, shown in Fig. 40a, revealed that the hoop reinforcement was approximately 61 mm (2.4 in.) in depth and 112 mm (4.4 in.) o.c., with the longitudinal reinforcement located directly beneath it. The backwall at this location was identified to be 627 mm (24.7 in.) from the surface. The second area, shown in Fig. 40b, revealed the hoop reinforcement to be 58 mm (2.3 in.) in depth and 300 mm (11.8 in.)

Fig. 40. Areas tested at Chesapeake Bay Tunnel

Another area of interest involved a circumferential crack that had only just begun to indicate signs of moisture intrusion (Fig. 40e, and Map CBBT 10.11-10 in Appendix B). A map was built around this crack, attempting to cover as much of the length of the crack as was possible from inside the plenum. Another feature that made this crack interesting was the presence of a longitudinal crack in that area between the stainless steel ceiling hangers (visible in Fig. 40e approximately one-third the distance from the left side of the image). The backwall surface was clearly distinguishable, and ranged from 577-658 mm (22.7-25.9 in.) below the surface (Fig. 45). The hoop reinforcement measured to be 69-81 mm (2.7-3.2 in.) in depth and 307 mm (12.1 in.) o.c., and the longitudinal reinforcement measured 434 mm (17.1 in.) o.c. This matches with the blueprint's details of 305 mm (12.0 in.) o.c. for the hoop reinforcement, but the plans do not indicate spacing for the longitudinal. As seen in Fig. 45 (top left B-scan), there appears to be two layers of hoop reinforcement, but as this is not indicated in the blueprints, it is possible that this could be an area of a splice. Light reflections, or echoes, are seen throughout the entire region of the crack, specifically surrounding the reinforcement nearest the moisture. Debonding of the reinforcement is suspected here due to corrosion.

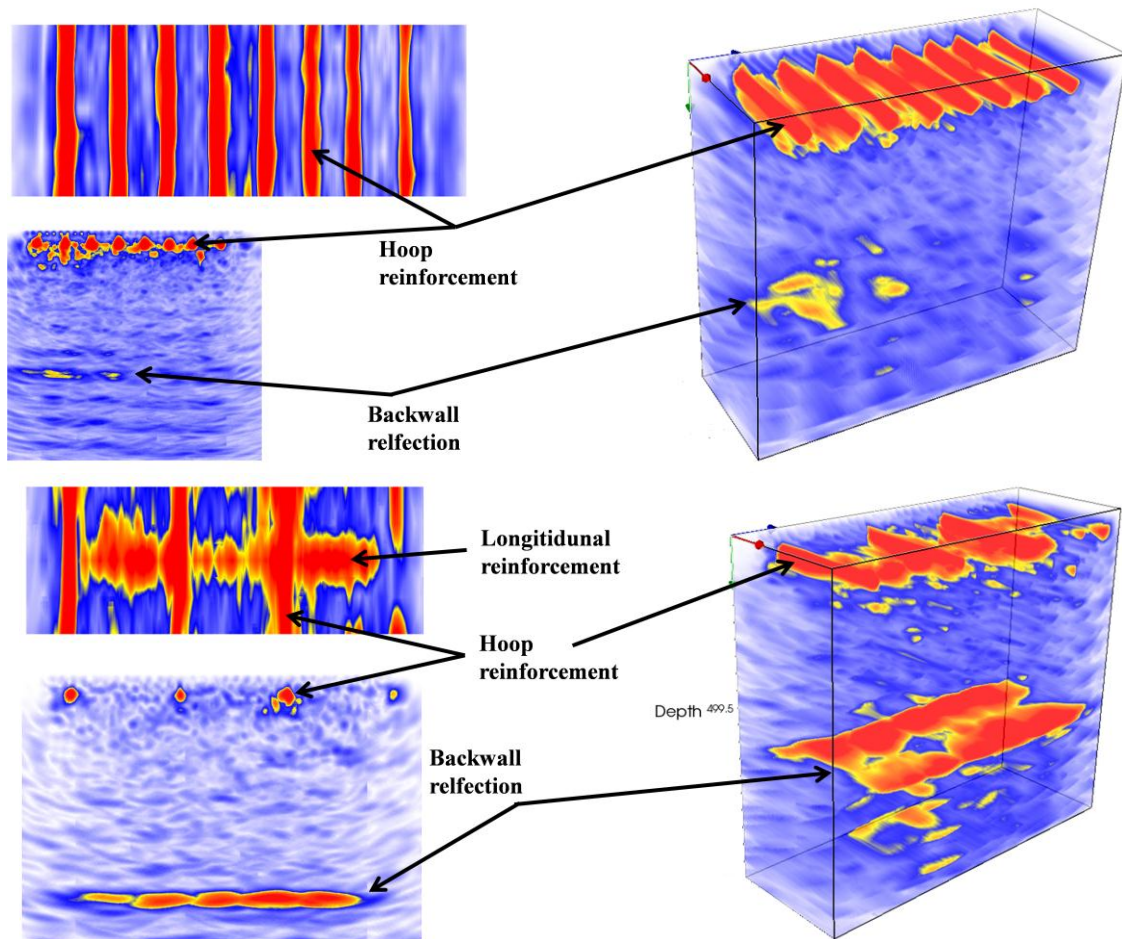
o.c., with the longitudinal reinforcement located directly beneath it. The backwall at this location was 620 mm (24.4 in.) from the surface. After consulting the blueprints for these two areas, it was verified that the first bridge section on both ends was constructed with the hoop reinforcement at 114 mm (4.5 in.) o.c., and the rest of the sections were constructed with the increase to 305 mm (12 in.) o.c. The plans also indicate all wall thicknesses were to be 610 mm (24 in.) in depth. Comparison of the two B-scans showing the difference in hoop rebar layout is shown in Fig. 41.

Fig. 41. Comparison of steel layout differences

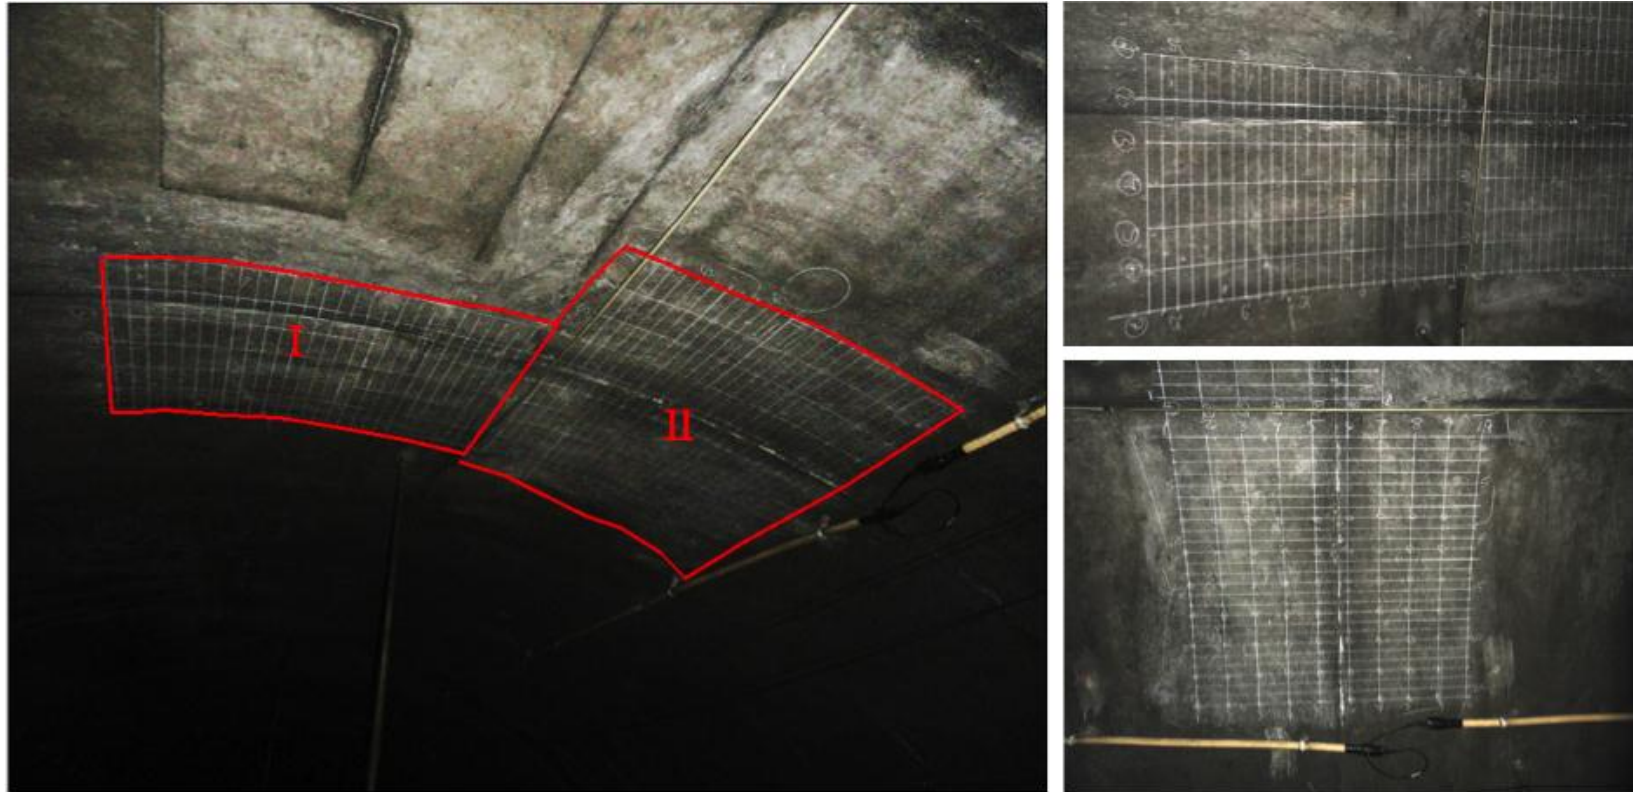
The last section tested within the plenum was a location detected by a high spike in GPR dielectric. Upon investigation, no live crack was found, but rather a dry seam. Although no visible signs of distress were apparent, hammer tapping revealed an extremely shallow delamination that appeared close to separating and falling. A grid was applied to this region surrounding the seam and shallow delamination and the area broken up into two sections, Region I (Map CBBT 10.11-9 in Appendix B) and Region II (Map CBBT 10.11-7, 8 in Appendix B), as shown in Fig. 46.

Fig. 46. Images depicting Region I (top right) and Region II (bottom right)

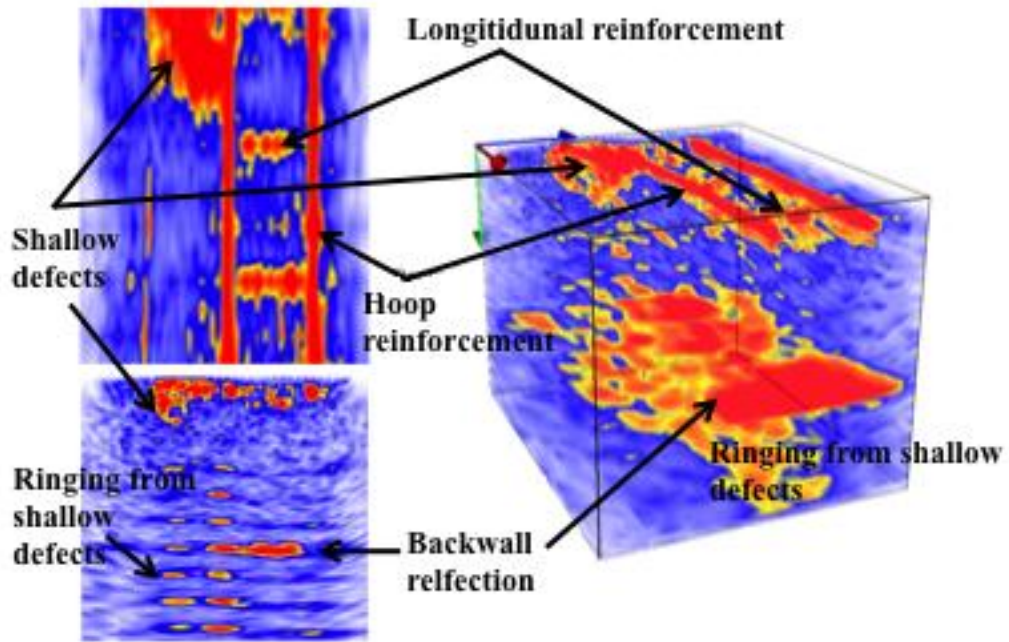
Region I UST evaluations reveal significant cracks and/or voids as deep as 218 mm, or 8.6 in. (Fig. 47, bottom left). The hoop reinforcement is shown to vary between 51-76 mm (2.0-3.0 in.) in depth at approximately 310 mm (12.2 in.) o.c., with the longitudinal reinforcement located directly beneath at 503 mm (19.8 in.) o.c. The backwall in this section varies from 617-660 mm (24.3-26.0 in.).

Fig. 47. Region I UST images

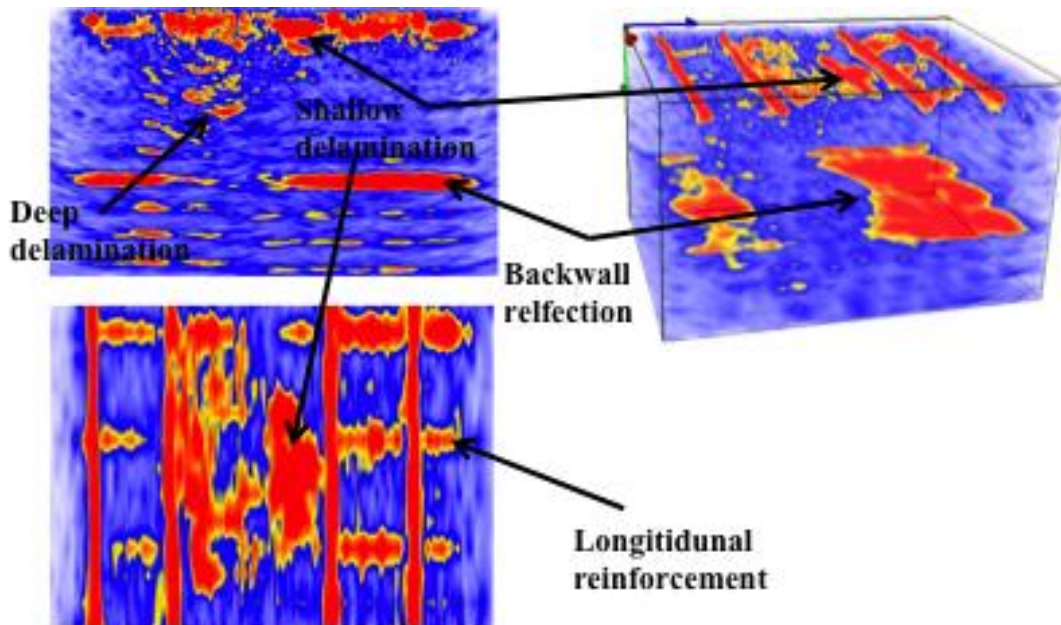
Region II UST evaluations, shown in Fig. 48, show the delaminated region (marked as “shallow delamination”) and also show the presence of cupped delaminations as deep as 488 mm (19.2 in.) below the surface, or approximately the same depth as the lower reinforcement closest to the tube skin. The backwall in this area ranged from 612-660 mm (24.1-26.0 in.). The hoop reinforcement at 56 mm (2.2 in.) deep was found to be 307 mm (12.1 in.) o.c., with the longitudinal rebars underneath at 411 mm (16.2 in.) o.c.

Fig. 48. Region II UST images

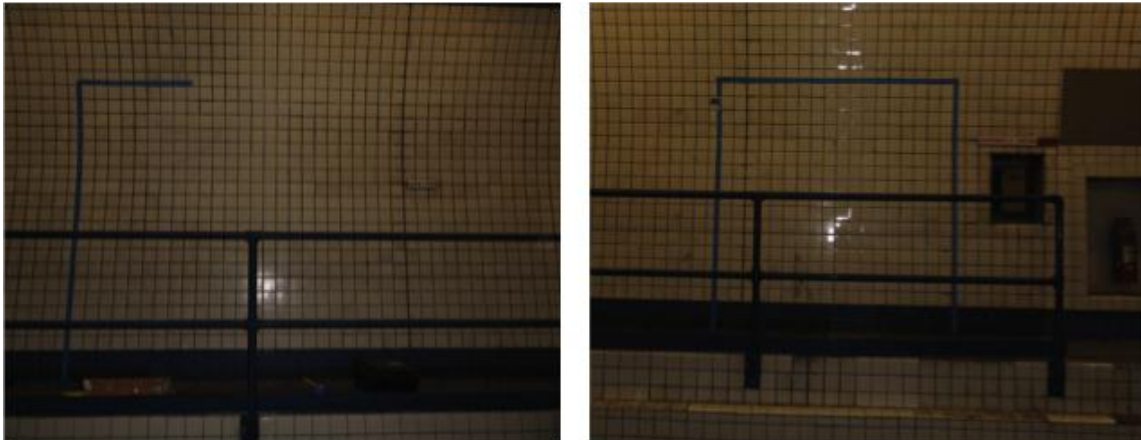
The last two areas tested within the Chesapeake Bay Tunnel were both located in the driving lane, along the tiled wall lining. One of these areas (Fig. 49, left) was discovered by using data from SPACETEC, a German company that utilizes a contact-free scanning system that provides detailed images, profiles, and thermal data for tunnel linings (<http://www.spacetec.de>). After evaluating the Chesapeake Bay Tunnel, SPACETEC’s analysis report revealed an area detected by the infrared scan, indicating possible debonding. When debonding occurs beneath tile, hammer sounding by ear or by microphone can readily differentiate bonded from debonded tile. Debonded tile can occur for two reasons: (1) improper installation (wrong type of thinset, disproportionate water ratios, improper mixing, and/or low standard of workmanship, i.e. not

**Fig. 49. Tile lining sections in Chesapeake Bay Tunnel**

backbuttering the tile) or (2) presence of degrading agent (typically water) behind the tile lining. If the debonding occurs for the first reason, reapplication of the tile lining can solve the problem. However, when debonding occurs due to cracks that facilitate the degradation of the thinset by moisture entrainment, NDT techniques can hopefully be used to determine the source of such moisture. Therefore, it became a goal to search for a damaged area that was not verifiable by sounding techniques. In other words, we wanted to determine the beginning stages of tile debonding before the tile debonding actually occurred to a noticeable extent. SPACETEC's data served this purpose very well by determining an area (Fig. 49, left) that showed signs of possible delamination but was not detectable via hammer sounding. Fig. 49, right, details a damaged area that includes debonded tile detectable by hammer sounding. The UST results from scanning the area determined by SPACETEC's data are shown in Fig. 50 below. The three B-scans (Fig. 50, left images) indicate the backwall reflection varies between 714-787 mm (28.1-31.0 in.). This variance can be seen in the D-scan in Fig. 50 (far right image- the dark blue curved strip on the right of the figure), which shows the curvature of the tube's

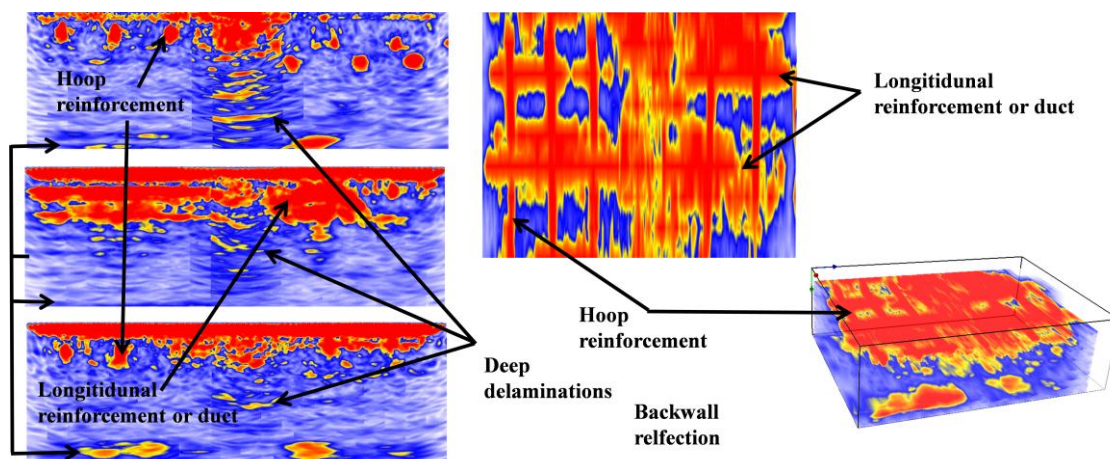
The UST results from the second area tested (Fig. 49, right) are shown in Fig. 51. The region of debonded tile correlated greatly with a joint in the tube lining, as can also be supported by the extensive delamination noted mid-image in the B-scans (Fig. 51, left images). The backwall in this region varied from 635-762 mm (25.0-30.0 in.), due to the same reasons of tube curvature discussed in the previous map. The hoop reinforcement is 109-196 mm (4.3-7.7 in.) in depth, and approximately 307 mm (12.1 in.) o.c. As in the previous map, the longitudinal reinforcement is hard to distinguish from the 51 mm (2 in.) dia. electrical ducts present. It is suspected that the top left image is evidence of a lap splice (notice two distinct layers of steel rebar to the right of the joint, where different tube sections could have different splice locations). During the assembly of the tubes underwater, as noted beforehand, steel skins are connected by bolting and welding overlapped “hoods” (Kozel n.d.). After this mechanical lock connection is complete, concrete is poured surrounding the joint location to make the interior steel-reinforced concrete continuous and waterproof. Although no detailed plans

Fig. 51. Second tile lining area tested

show the width of this “scratch joint”, it remains a question as to whether the deep delaminations seen in the B-scans could be a result of degrading concrete joints.
