ULTRASONIC TOMOGRAPHY FOR DETECTING AND LOCATING DEFECTS IN  
CONCRETE STRUCTURES

A Thesis

JOSHUA BENJAMIN WHITE

Submitted to the Office of Graduate Studies of  
Texas A&M University  
in partial fulfillment of the requirements for the degree of  
MASTER OF SCIENCE

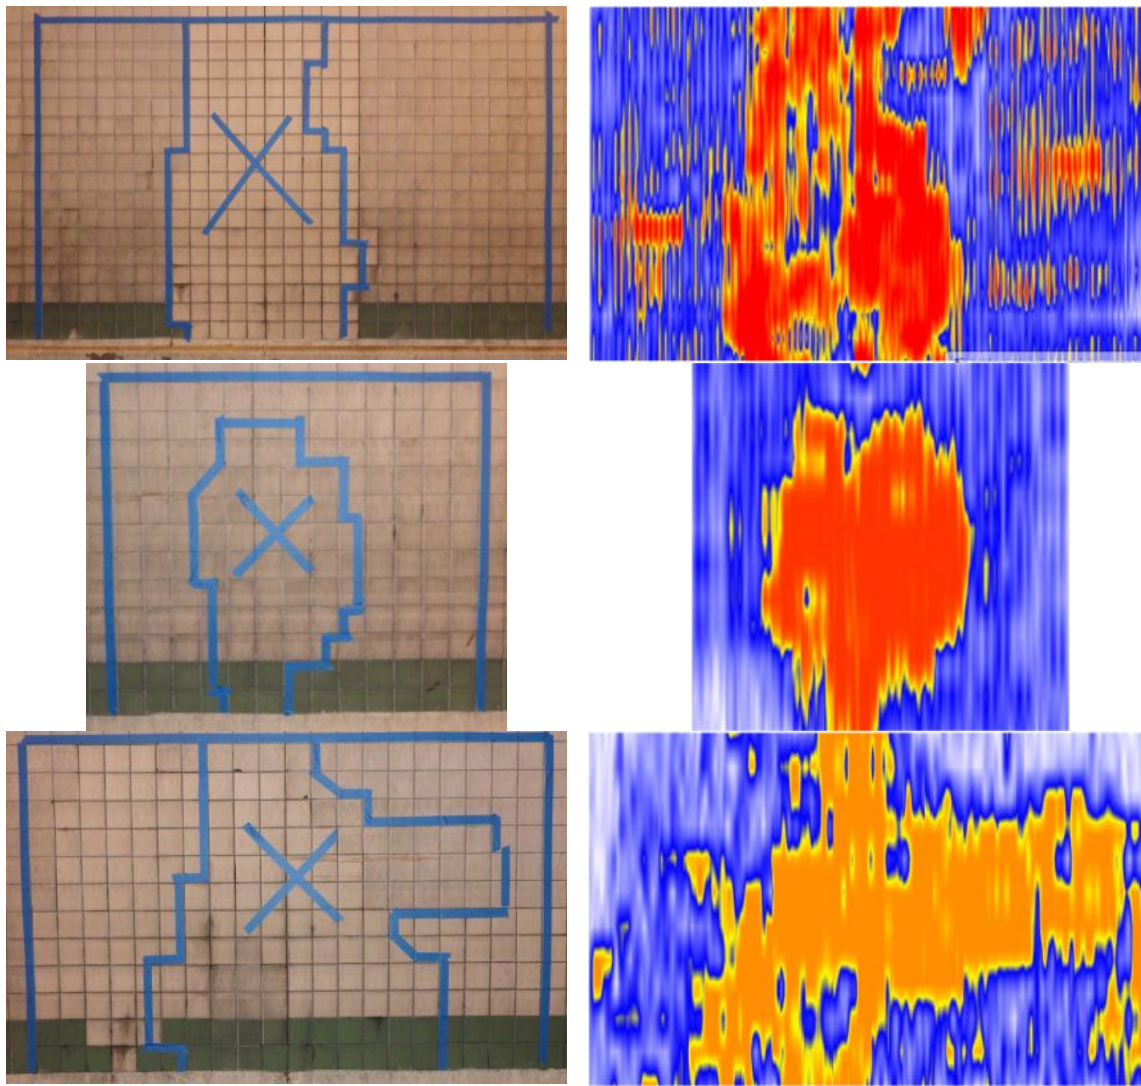
**Fig. 53. Tile linings via UST (left) paired with the associated C-scans (right)**

The first three sections are shown in Fig. 53. The images shown here have blue painters tape that outline debonded areas (by hammer sounding), and are paired with the associated C-scan that shows shallow delaminations ranging from 16 – 103 mm (0.63 – 4.1 in.) deep. It can be seen that the area marked off by hammer sounding closely matches the region of shallow debonding.

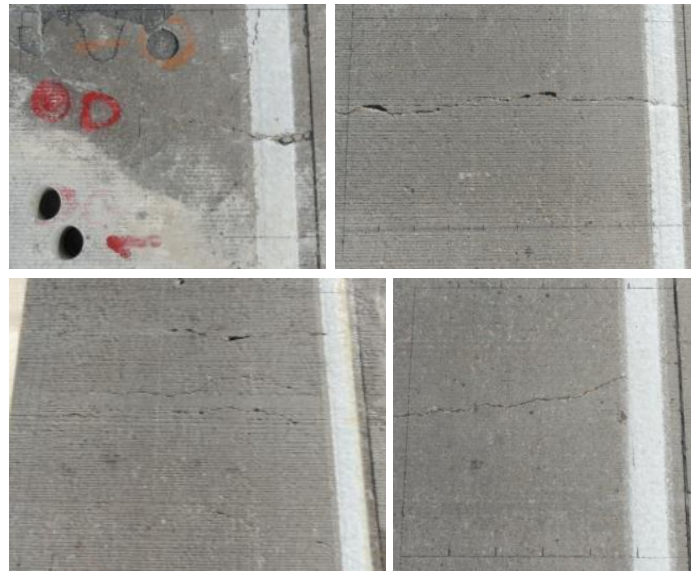
any delamination within the overlay. The four areas tested are shown in Fig. 57. Each area was tested using a 50 mm x 150 mm (2 in. x 6 in.) grid. After scanning the section, cores were taken to verify the predicted overlay depth, reinforcement cover, and delamination depth.

**Fig. 57. Four areas tested on I-20 in Ft. Worth, TX**

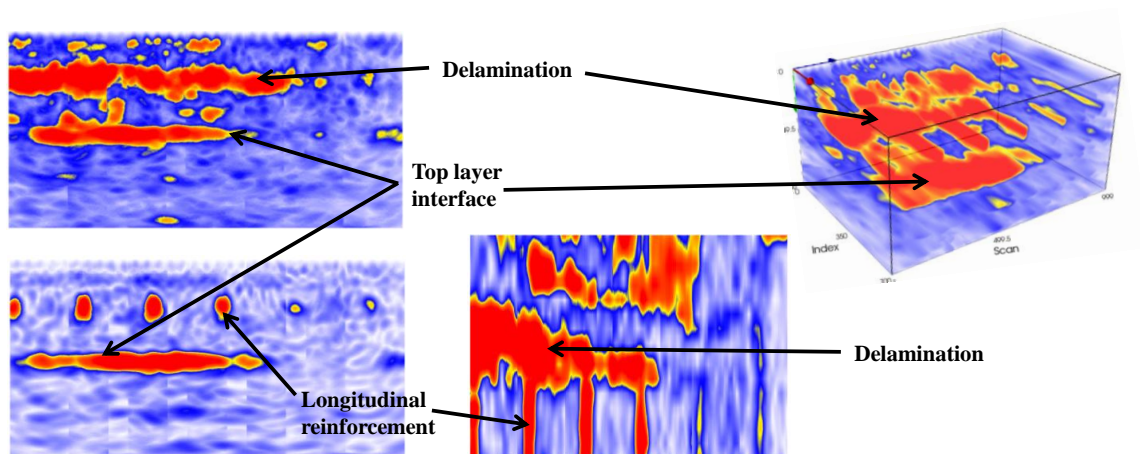
The UST results of the first area tested (Fig. 57, top left), are shown in Fig. 58. These are typical B-, C-, and Volume-scans that are seen in the other scanned areas, and all full reports can be found in Appendix A. The two B-scans in Fig. 58 (left) show an area with delamination at the level of longitudinal reinforcement (top B-scan) and an area with no delamination, but a backwall reflection at the top layer interface

**Fig. 58. Typical UST results for I-20 scanning**

(bottom B-scan). The C-scan (Fig. 58, center) shows the width of the delamination at the level of reinforcement.

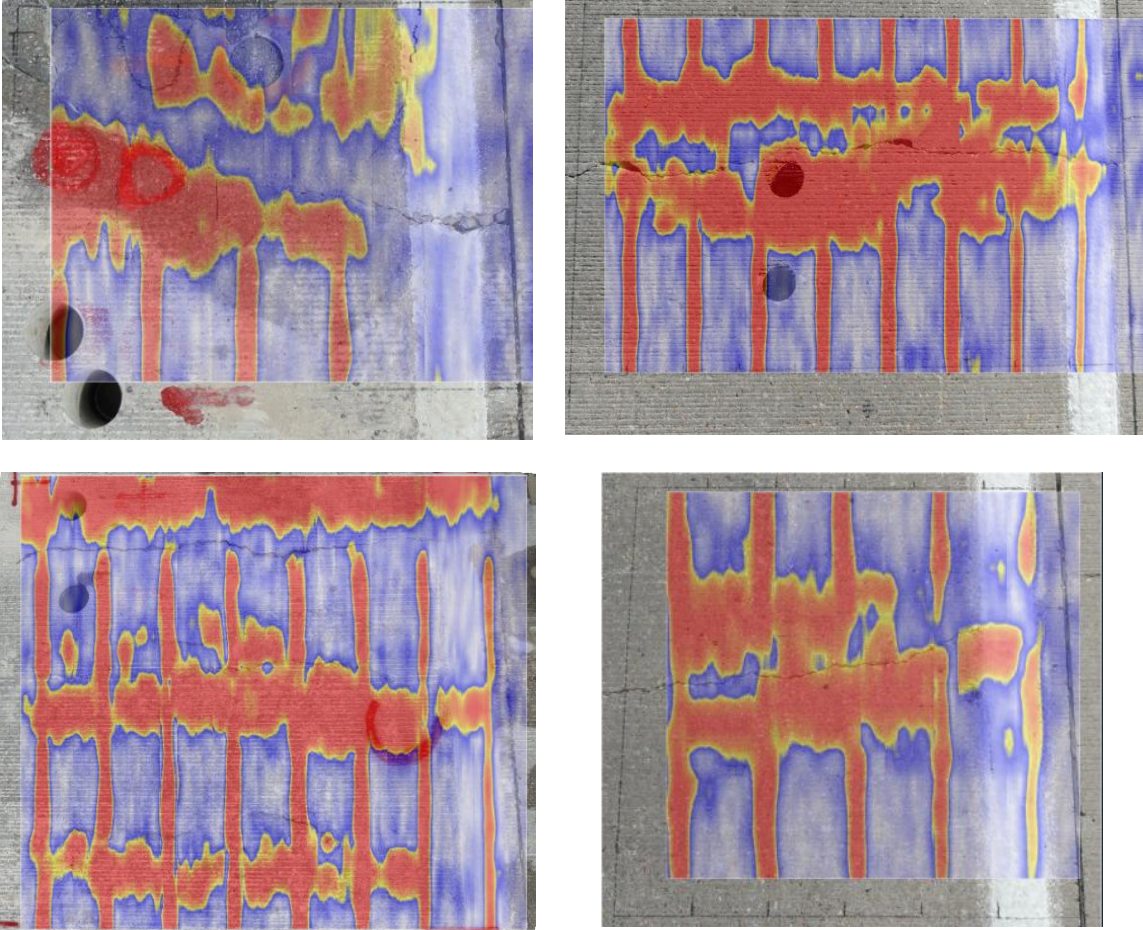
Fig. 59 below shows all four areas scanned with their appropriate C-scans overlaid on the image. All delaminations in these figures are at the level of reinforcement (see Tables 3-6 for details).

**Fig. 59. UST C-scans overlaid on I-20 images: Section A (top left), Section B (top right), Section C (bottom left), and Section D (bottom right)**

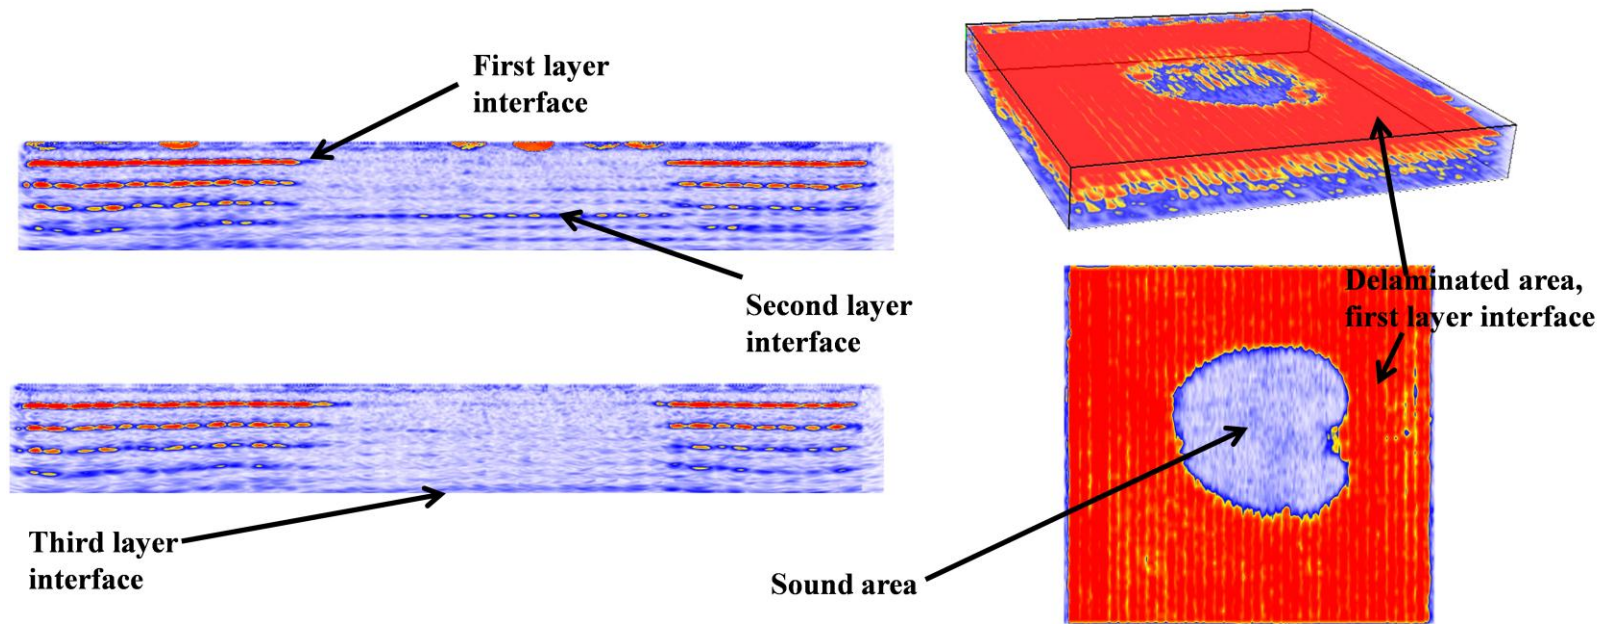
cracks on the bonded concrete overlay (BCO) instigated an evaluation on the source of these cracks. Using a grid spacing of 100 mm x 200 mm (4 in. x 7.9 in.), UST was used to completely scan two entire sections of the runway (two 7.6 m x 7.6 m, or 25 ft x 25 ft slabs) to evaluate the extent of damage present. The UST results are shown in Figs. 57 and 58. The first runway tested shows over 70 % of the area delaminated at the first layer interface (Fig. 61, C-scan at bottom right, Volume-scan at top right). The B-scans on the left of this figure show the first layer interface at 193-206 mm (7.6-8.1 in.) deep, the second layer interface at 683 mm (26.9 in.) deep, and the third layer interface at 958 mm (37.7 in.) deep. The second area tested shows approximately 15% of the total area

Fig. 61. First segment tested at IAH: B-scans (left), Volume-scan (top right), and C-scan (bottom right)

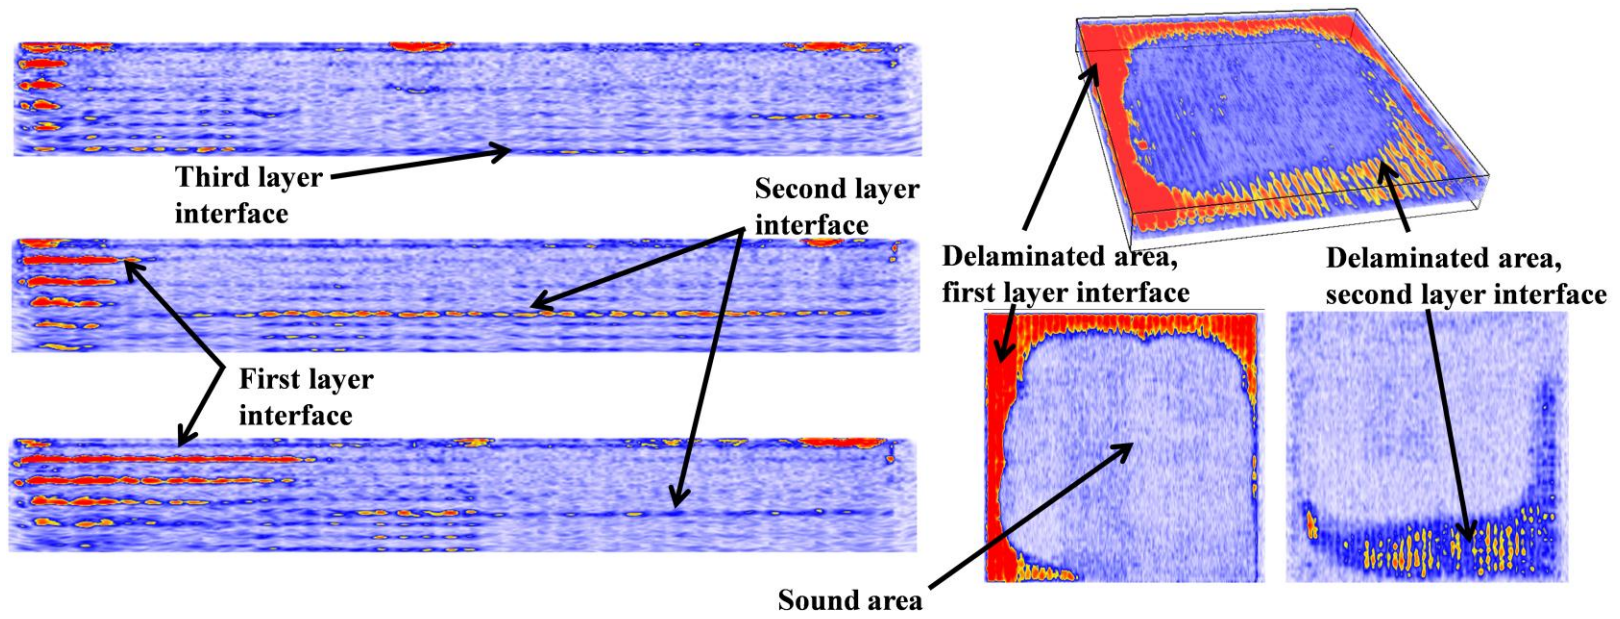
Fig. 62. Second segment tested at IAH: B-scans (left), Volume-scan (top right), and C-scans (bottom right)

debonded at the first layer interface (Fig. 61, C-scans at bottom right, Volume-scan at top right). It is also easy to see the partially bonded region at the second layer interface.

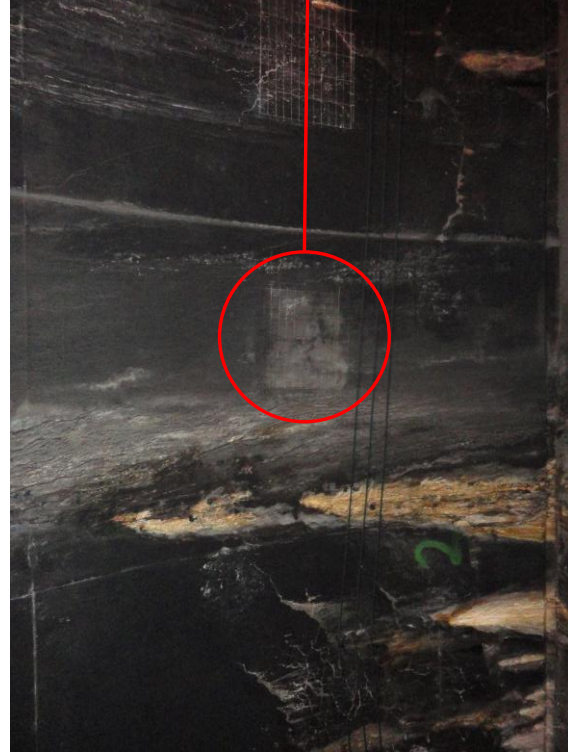
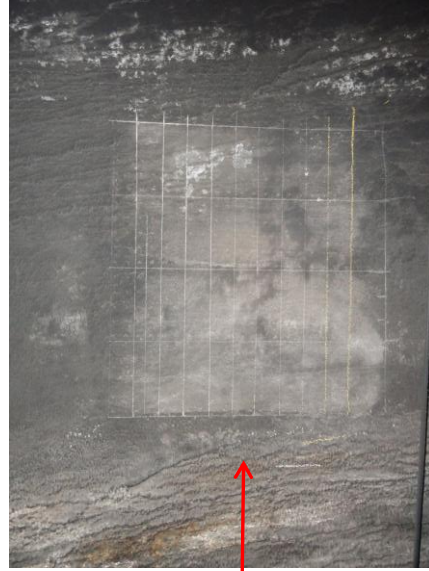
## Eisenhower Memorial Tunnel, Dillon, CO

Defects	Notes	Backsurface	Reinf. Detail	Test Parameters
No significant defect noticed, except for "strip" of area (~9.4" wide, 16.2" deep) consistently found in other maps. Possibly structural reinforcement: wood or steel?	Area tested as representative of "sound" concrete.	Not discernible	Hoop Reinf. ~4.2" deep @ ~9.9" O.C. Longitudinal Reinf: On bottom	$V_{shear} = 2751 \text{ m/s}$ X-step: 150 mm Y-step: 50 mm Max Depth: 1000 mm Frequency: 50 kHz
Dillon, CO Eisenhower Tunnel ET 10.4-1, 2 Segment 8 TAMU/TTI 10/2011

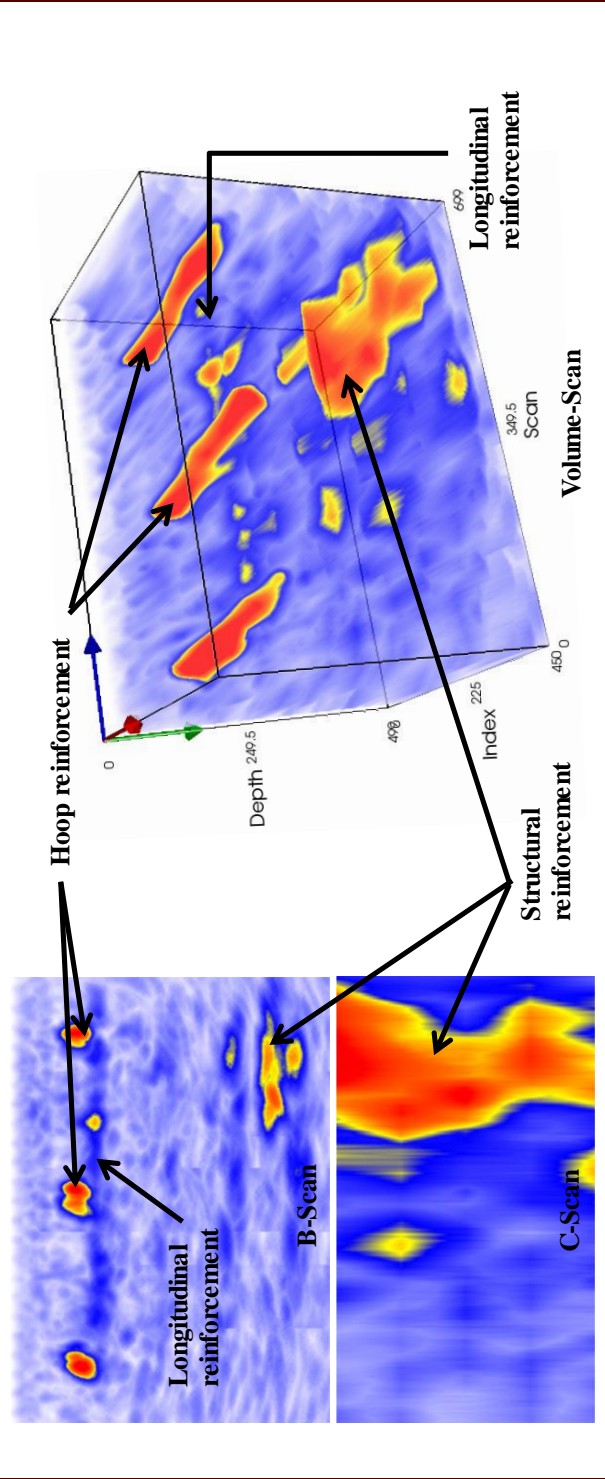
## Eisenhower Memorial Tunnel, Dillon, CO

Defects	Notes	Backsurface	Reinf. Detail	$V_{shear} = 2751$ m/s X-step: 150 mm Y-step: 50 mm Max Depth: 1000 mm Frequency: 50 kHz Dillon, CO Eisenhower Tunnel ET 10.4-1, 2 Segment 8 TAMU/TTI 10/2011
No significant defect noticed, except for "strip" of area (~9.4" wide, 16.2" deep) consistently found in other maps. Possibly structural reinforcement: wood or steel?	Area tested as representative of "sound" concrete.	Not discernible	Hoop Reinf. ~4.2" deep @ ~9.9" O.C. Longitudinal Reinf: On bottom

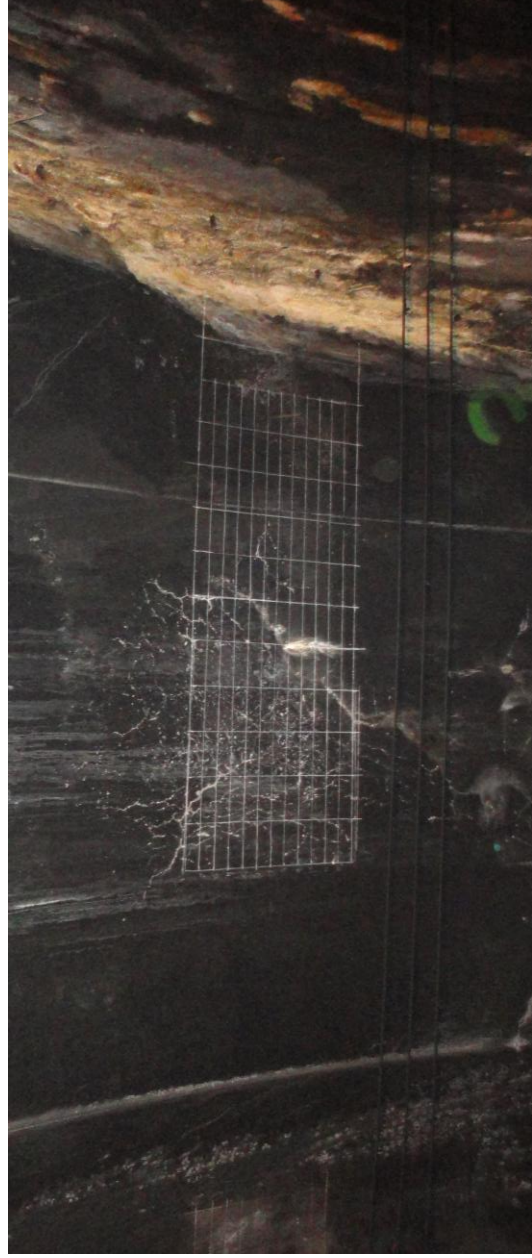
## Eisenhower Memorial Tunnel, Dillon, CO

Defects	Notes	Backsurface	Reinf. Detail	$V_{shear} = 2751 \text{ m/s}$ X-step: 150 mm Y-step: 50 mm Max Depth: 750 mm Frequency: 50 kHz
No significant defect noticed, except for "strip" of area (~12.2" wide, 17.2" deep) consistently found in other maps. Possibly structural reinforcement: wood or steel?	Area tested because of surface cracking and crazing, nearby stalactite formation (Could not test over stalactite crack due to obtrusions).	Not discernible	Hoop Reinf: ~3.7"-5.1" deep @ ~10.1" O.C. Longitudinal Reinf: On bottom	Dillon, CO Eisenhower Tunnel ET 10.4-3 Segment 8 TAMU/TTI 10/2011

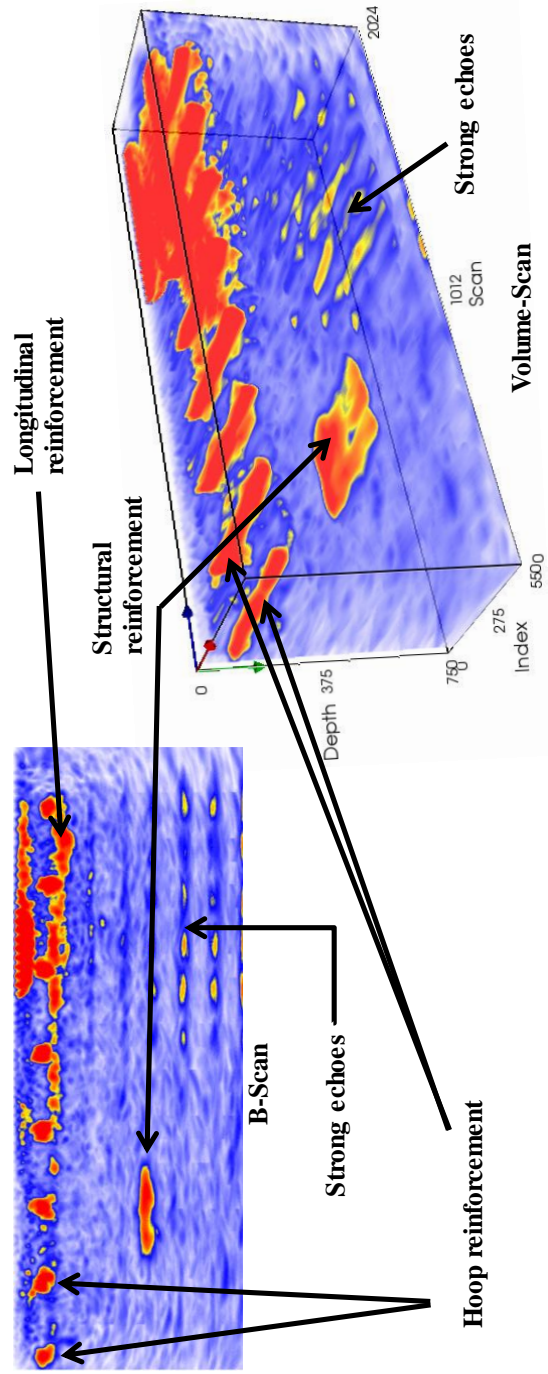
## Eisenhower Memorial Tunnel, Dillon, CO

Defects	Notes	Backsurface	Reinf. Detail	$V_{shear} = 2751$ m/s X-step: 150 mm Y-step: 50 mm Max Depth: 750 mm Frequency: 50 kHz Dillon, CO Eisenhower Tunnel ET 10.4-3 Segment 8 TAMU/TTI 10/2011
No significant defect noticed, except for "strip" of area (~12.2" wide, 17.2" deep) consistently found in other maps. Possibly structural reinforcement: wood or steel?	Area tested because of surface cracking and crazing, nearby stalactite formation (Could not test over stalactite crack due to obtrusions).	Not discernible	Hoop Reinf: ~3.7"-5.1" deep @ ~10.1" O.C. Longitudinal Reinf: On bottom

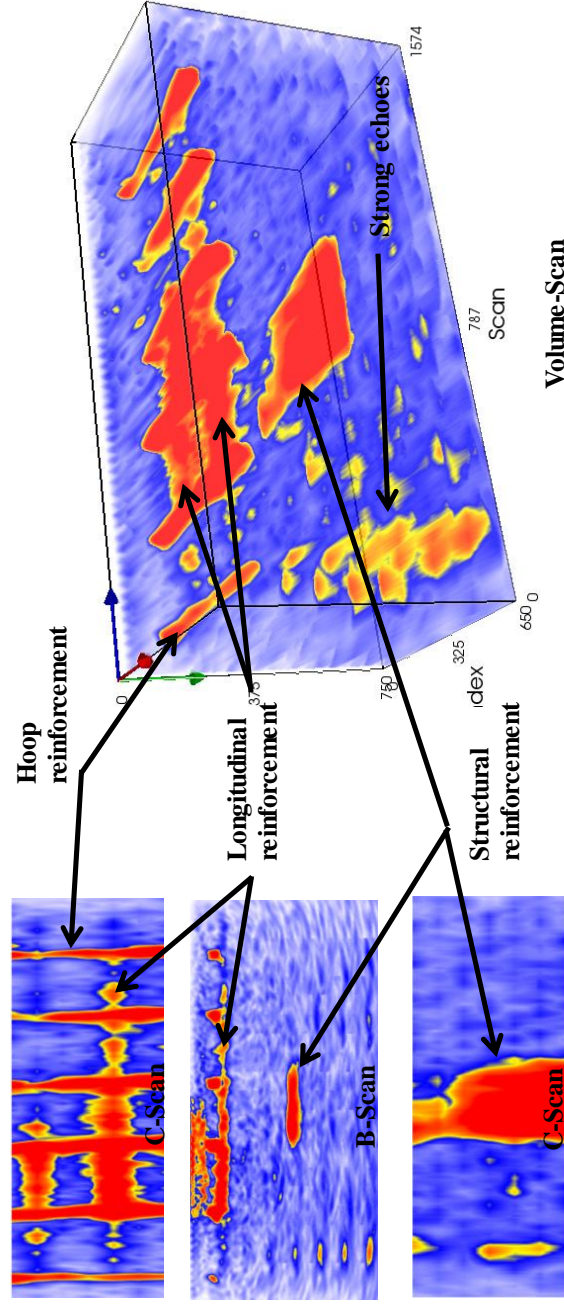
## Hanging Lake Tunnel, Glenwood Springs, CO

Defects	Notes	Backsurface	Reinf. Detail	$V_{shear} = 2751$ m/s X-step: 150 mm Y-step: 50 mm Max Depth: 750 mm Frequency: 50 kHz Dillon, CO Eisenhower Tunnel ET 10.4-4, 5 Segment 10 TAMU/TTI 10/2011
No significant defect noticed, except for "strip" of area (~13.5" wide, 16.1" deep) consistently found in other maps. Possibly structural reinforcement: wood or steel?	Area tested because of surface cracking and crazing, nearby joint.	Not discernible	Hoop Reinf. ~4.1" deep @ ~10.1" O.C. Longitudinal Reinf: On bottom

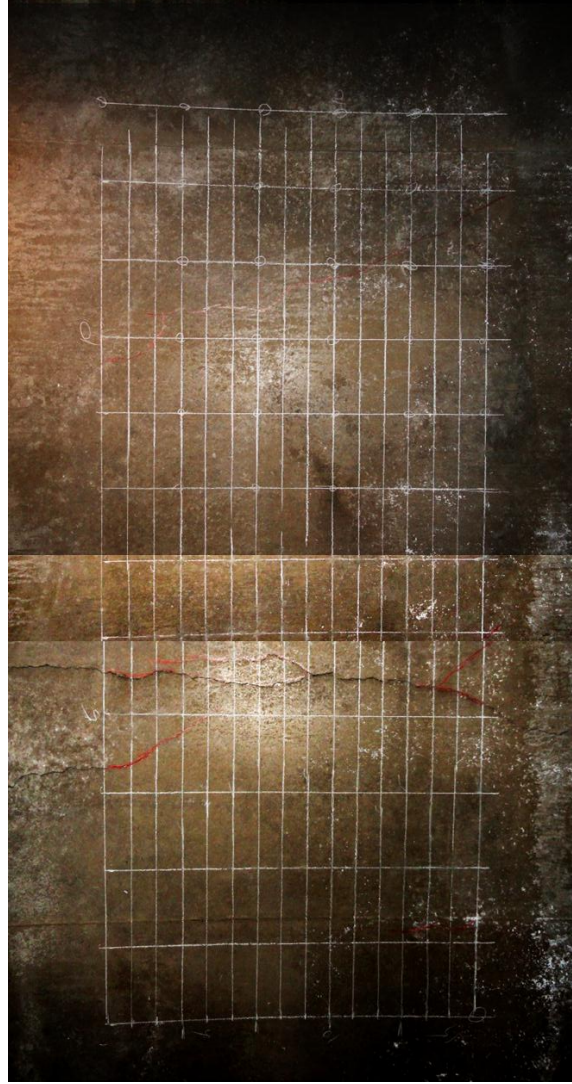
# Hanging Lake Tunnel, Glenwood Springs, CO

Defects	Notes	Backsurface	Reinf. Detail	V <sub>shear</sub> = 2159 m/s X-step: 150 mm Y-step: 50 mm Max Depth: 2500 mm Frequency: 50 kHz
Apparent delamination extending 12.3" deep, originating from surface crack; possibly trying to meet another crack located approximately 35" east (right) of surface crack.	Severe cracking. Area also tested by BAM.	Possibly 27.6"	Hoop Reinf: 4.6"- 6.2" deep @ 15.7" O.C. Longitudinal Reinf: On top (and below?) HR @ 14.1" O.C.	Glenwood Springs, CO Hanging Lake Tunnel HLT 10.5-1, 2, 3 Segment 57 TAMU/TTI 10/2011

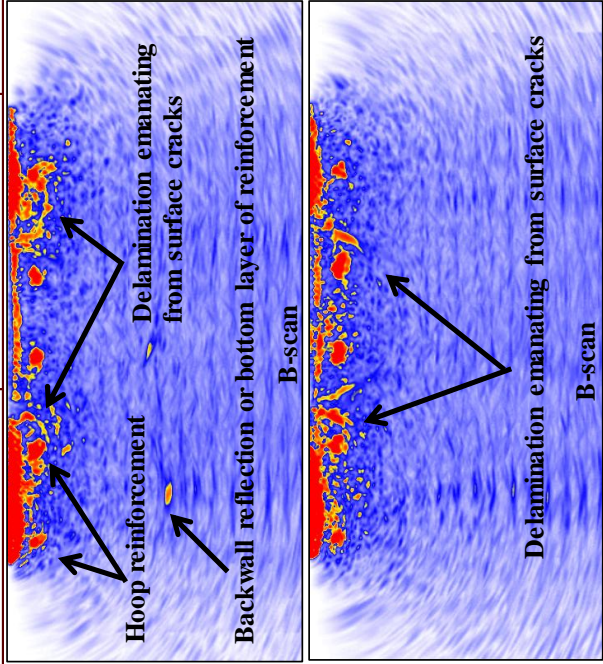
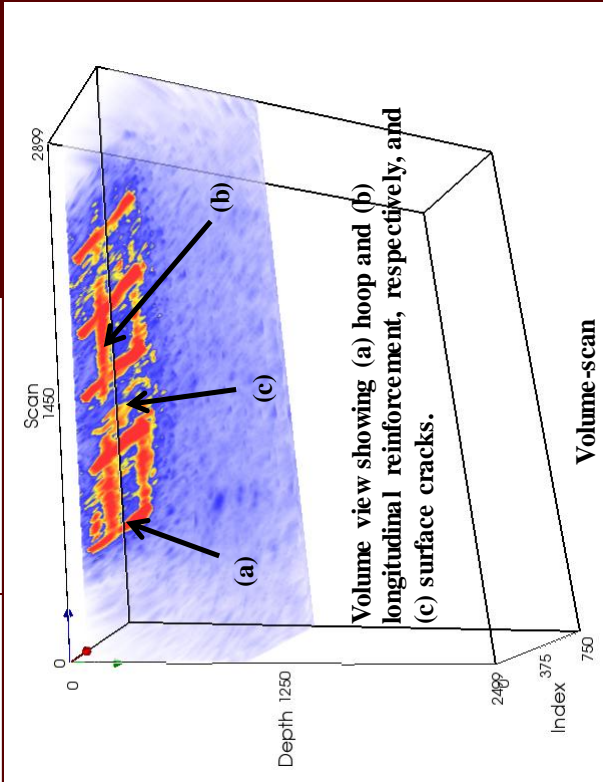
## Hanging Lake Tunnel, Glenwood Springs, CO

Defects	Notes	Backsurface	Reinf. Detail	$V_{shear} = 2159 \text{ m/s}$ X-step: 150 mm Y-step: 50 mm Max Depth: 2500 mm Frequency: 50 kHz Glenwood Springs, CO Hanging Lake Tunnel HLT 10.5-1, 2, 3 Segment 57 TAMU/TTI 10/2011
Apparent delamination extending 12.3" deep, originating from surface crack; possibly trying to meet another crack located approximately 35" east (right) of surface crack.	Severe cracking. Area also tested by BAM.	Possibly 27.6"	Hoop Reinf: 4.6"- 6.2" deep @ 15.7" O.C. Longitudinal Reinf: On top (and below?) HR @ 14.1" O.C.

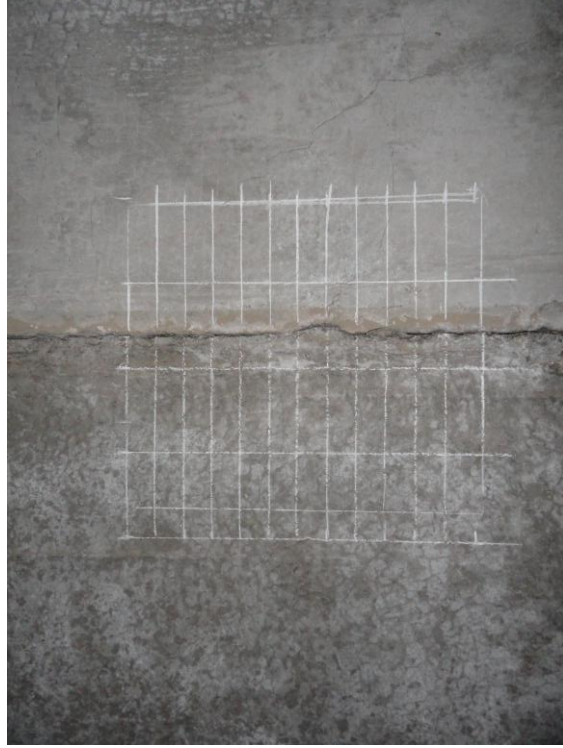
# Hanging Lake Tunnel, Glenwood Springs, CO

Defects	Notes	Backsurface	Reinf. Detail	V <sub>shear</sub> = 2159 m/s X-step: 150 mm Y-step: 50 mm Max Depth: 1000 mm Frequency: 50 kHz
<p>Suspected debonding around east (right) side of joint. Surface crack around area might support this.</p> <p>Suspected debonding extends a maximum of 9" deep.</p>	<p>Area tested because of natural joint. This map should be extended east to detail more of possible debonding.</p>	<p>Not detectable</p>	<p>Hoop Reinf. ~3.6" deep</p>	<p>Glenwood Springs, CO Hanging Lake Tunnel HLT 10.5-4 Segments 54/55 Joint TAMU/TTI 10/2011</p>

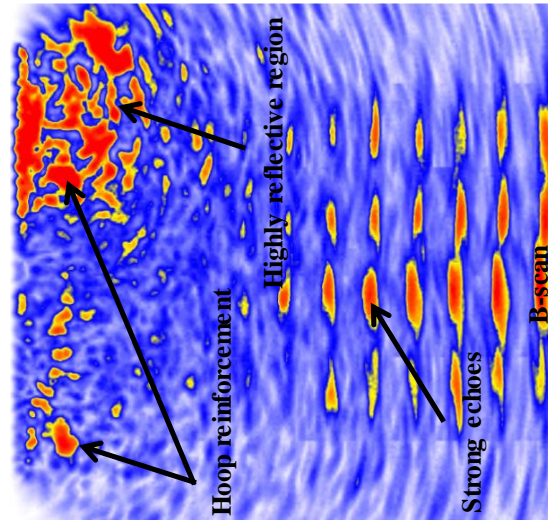
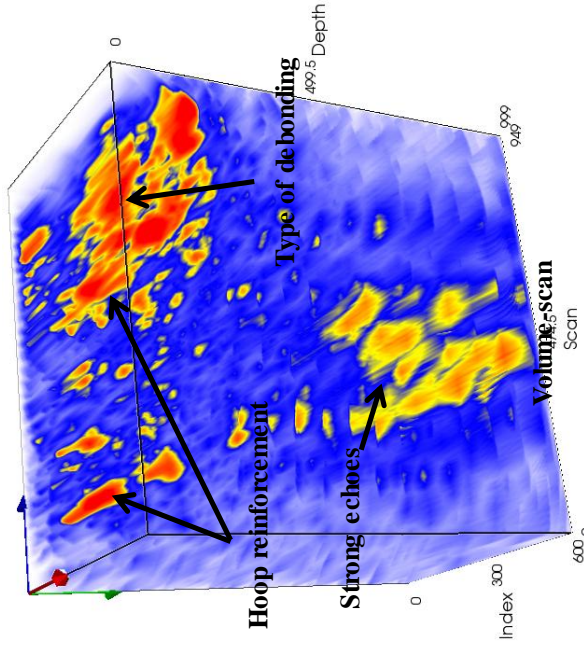
## Hanging Lake Tunnel, Glenwood Springs, CO

Defects	Notes	Backsurface	Reinf. Detail	$V_{shear} = 2159 \text{ m/s}$ X-step: 150 mm Y-step: 50 mm Max Depth: 1000 mm Frequency: 50 kHz
Suspected debonding around east (right) side of joint. Surface crack around area might support this. Suspected debonding extends a maximum of 9" deep.	Area tested because of natural joint. This map should be extended east to detail more of possible debonding.	Not detectable	Hoop Reinf. ~3.6" deep	Glenwood Springs, CO Hanging Lake Tunnel HLT 10.5-4 Segments 54/55 Joint TAMU/TTI 10/2011

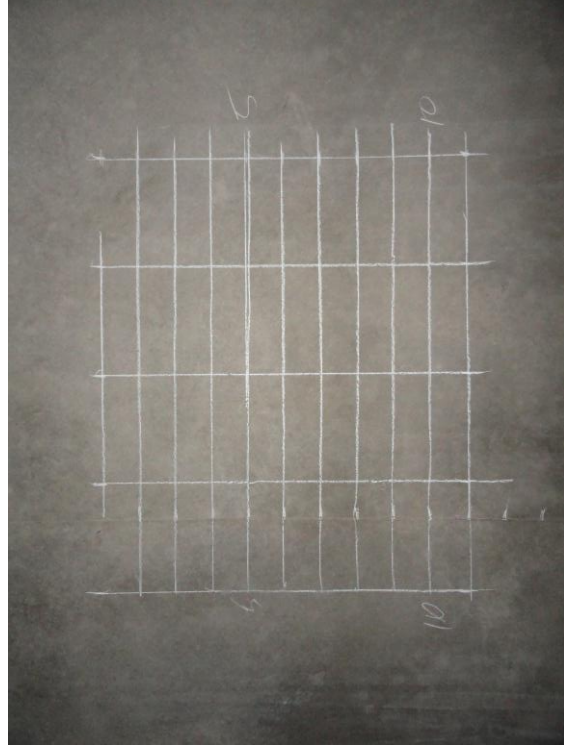
Defects	Notes	Backsurface	Reinf. Detail	V <sub>shear</sub> = 2159 m/s X-step: 150 mm Y-step: 50 mm Max Depth: 2500 mm Frequency: 50 kHz
No significant defect noticeable. Backwall reflection varies 2-3" in depth, so this may be lower reinforcement reflection or backwall delamination (see HLT 10.5-8,9)	Area tested as a representation of "sound concrete" - no apparent cracks, defects.	Possibly 29.6" - 32.4"	Hoop Reinf: ~4.3"-5.1" deep @ 16.6" O.C. Longitudinal Reinf: On top	Glenwood Springs, CO Hanging Lake Tunnel HLT 10.5-5, 6, 7 Segment 49 TAMU/TTI 10/2011

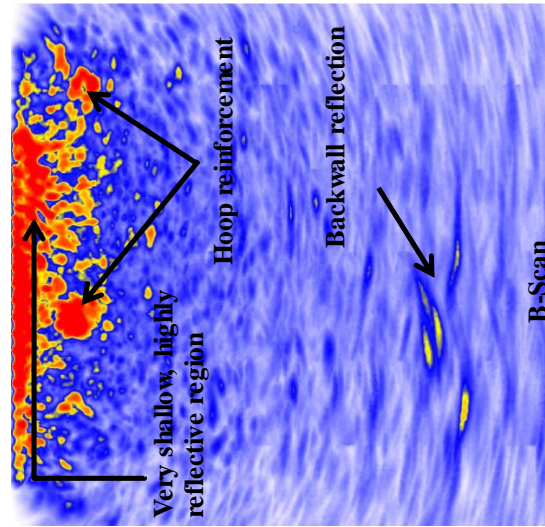
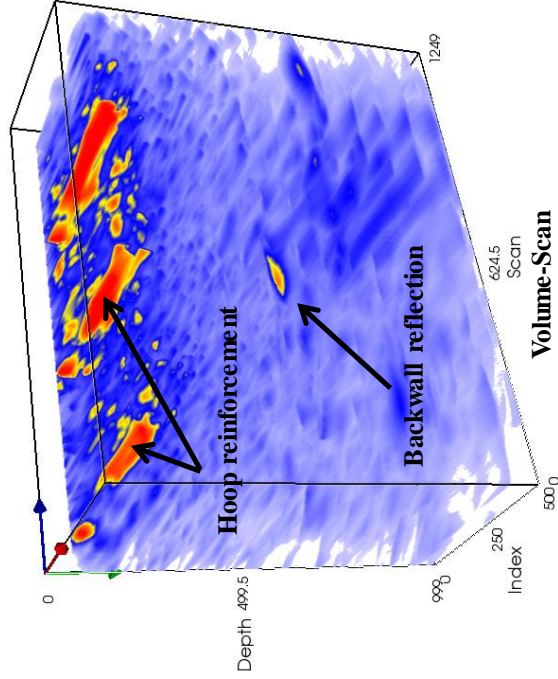
## Hanging Lake Tunnel, Glenwood Springs, CO

Defects	Notes	Backsurface	Reinf. Detail	$V_{shear} = 2159 \text{ m/s}$ X-step: 150 mm Y-step: 50 mm Max Depth: 2500 mm Frequency: 50 kHz
No significant defect noticeable. Backwall reflection varies 2-3" in depth, so this may be lower reinforcement reflection or backwall delamination (see HLT 10.5-8,9)	Area tested as a representation of "sound concrete" - no apparent cracks, defects.	Possibly 29.6" - 32.4"	Hoop Reinf: ~4.3"-5.1" deep @ 16.6" O.C. Longitudinal Reinf: On top	Glenwood Springs, CO Hanging Lake Tunnel HLT 10.5-5, 6, 7 Segment 49 TAMU/TTI 10/2011

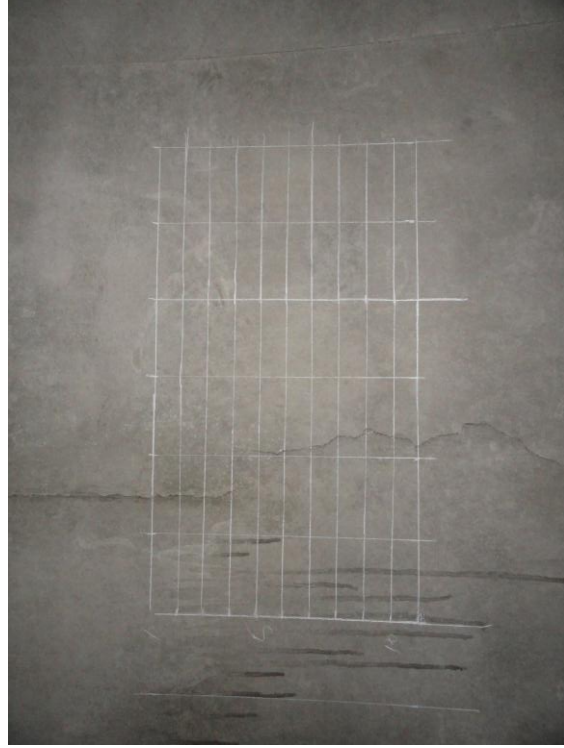
# Hanging Lake Tunnel, Glenwood Springs, CO

Defects	Notes	Backsurface	Reinf. Detail
No significant defect noticeable. Backwall reflection varies 2-3" in depth, so this may be lower reinforcement reflection or backwall delamination (see HLT 10.5-8,9).	Area tested because of single surface crack. Note strong echoes emanating from region of reinforcement. Sign of debonding?	Possibly 24.5" - 29.6"	Hoop Reinf. ~3.7" deep @ 15.9" O.C. Longitudinal Reinf: On bottom
		$V_{shear} = 2159 \text{ m/s}$ X-step: 150 mm Y-step: 50 mm Max Depth: 2500 mm Frequency: 50 kHz Glenwood Springs, CO Hanging Lake Tunnel HLT 10.5-8, 9 Segment 49 TAMU/TTI 10/2011

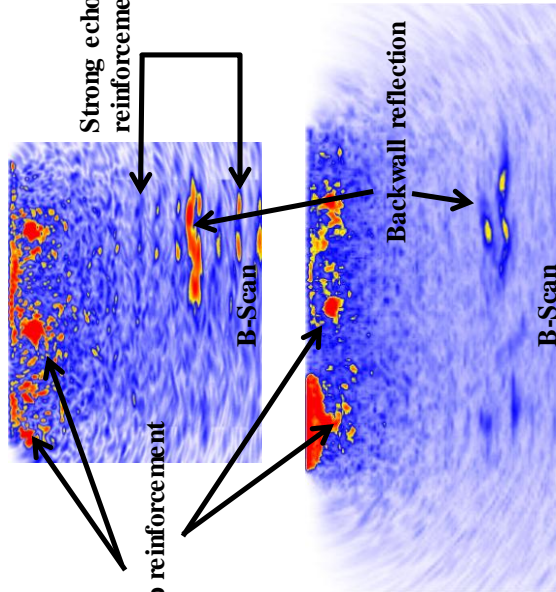
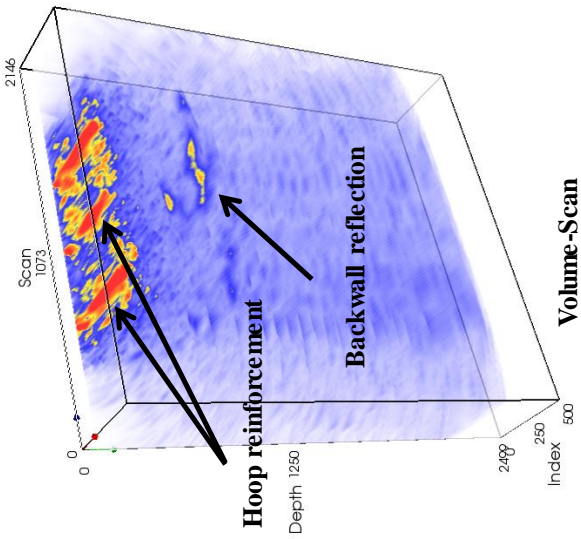
# Hanging Lake Tunnel, Glenwood Springs, CO

<p><b>Defects</b></p> <p>No significant defect noticeable. Backwall reflection varies 2-3" in depth, so this may be lower reinforcement reflection or backwall delamination (see HLT 10.5-8,9).</p>	<p><b>Notes</b></p> <p>Area tested because of single surface crack. Note strong echoes emanating from region of reinforcement. Sign of debonding?</p>	<p><b>Backsurface</b></p> <p>Possibly 24.5" - 29.6"</p>	<p><b>Reinf. Detail</b></p> <p>Hoop Reinf. ~3.7" deep @ 15.9" O.C. Longitudinal Reinf: On bottom</p>	<p><math>V_{shear} = 2159</math> m/s          X-step: 150 mm          Y-step: 50 mm          Max Depth: 2500 mm          Frequency: 50 kHz          Glenwood Springs, CO          Hanging Lake Tunnel          HLT 10.5-8, 9          Segment 49          TAMU/TTI 10/2011</p>
---	---	---	--	--

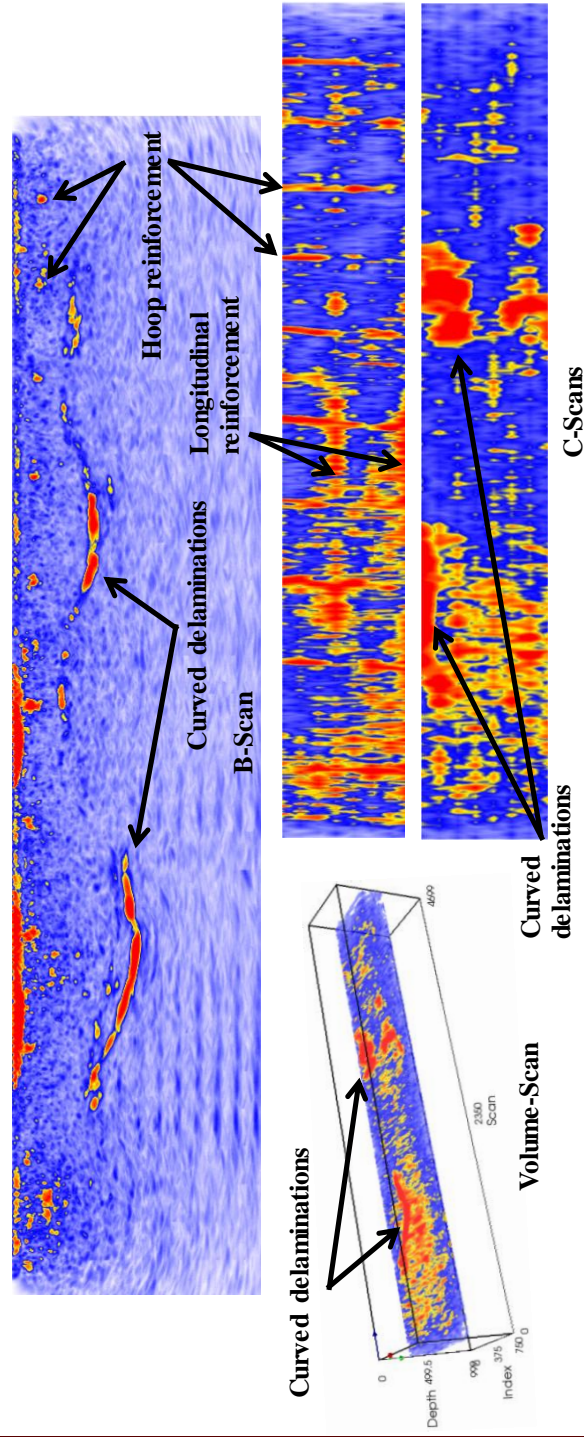
# Hanging Lake Tunnel, Glenwood Springs, CO

Defects	Notes	Backsurface	Reinf. Detail	Test Parameters
Significant delaminations discovered which stretched over 11', ranging from 8"-20" below the surface.	Area tested because of severe cracking. The B-scan below shows variance in depth and the C-scans show the planar nature of the delaminations.	Not discernible due to high presence of delaminations.	Hoop Reinf: ~2.9"-5.1" deep @ ~16.4" O.C. Longitudinal Reinf: On top	$V_{shear} = 2159 \text{ m/s}$ X-step: 150 mm Y-step: 50 mm Max Depth: 1000 mm Frequency: 50 kHz
Glenwood Springs, CO Hanging Lake Tunnel HLT 10.5-10, 11, 12 Segment 55 TAMU/TTI 10/2011

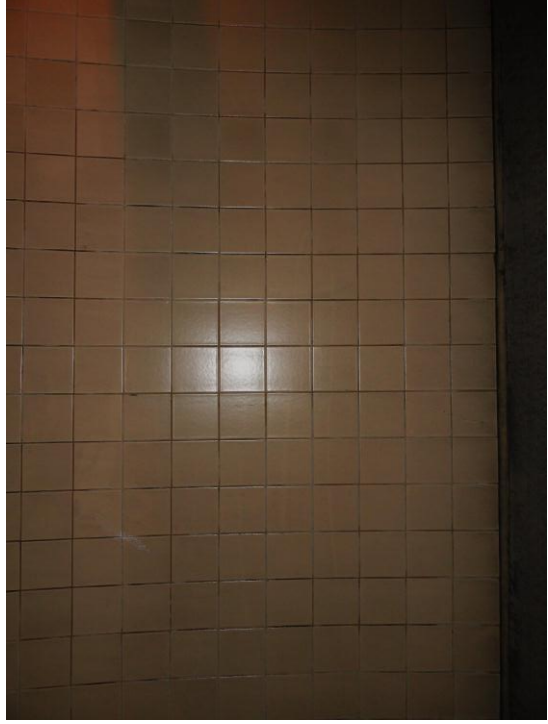
## Hanging Lake Tunnel, Glenwood Springs, CO

Defects	Notes	Backsurface	Reinf. Detail	$V_{shear} = 2159$ m/s X-step: 150 mm Y-step: 50 mm Max Depth: 1000 mm Frequency: 50 kHz
No significant defect noticed.	Area tested on surface of tile; hair-line crack.	Not discernible	Hoop Reinf. ~5.1" deep @ ~16.3" O.C. Longitudinal Reinf: On bottom (possibly on top as well) @ ~14.0" O.C.	Glenwood Springs, CO Hanging Lake Tunnel HLT 10.5-13 Interior Tile Lining TAMU/TTI 10/2011

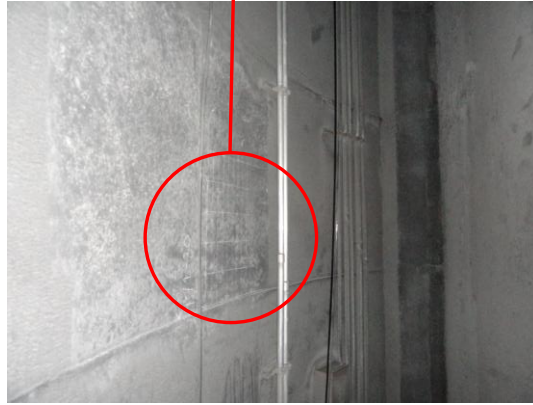
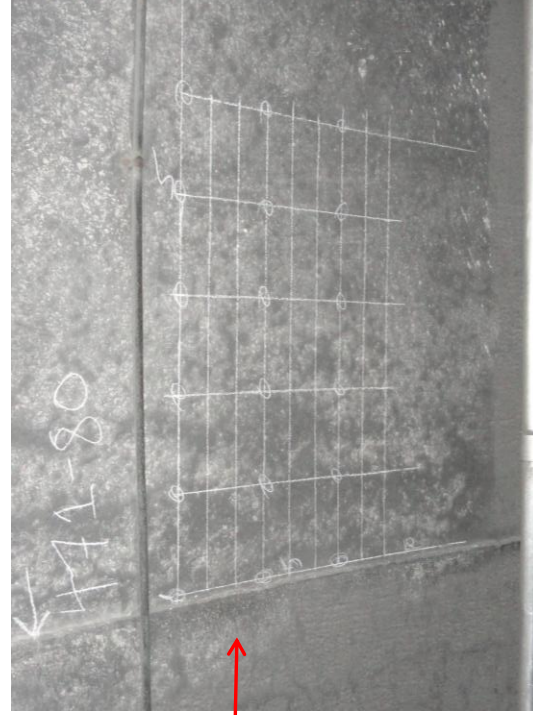
Defects	Notes	Backsurface	Reinf. Detail	V <sub>shear</sub> = 2710 m/s X-step: 150 mm Y-step: 50 mm Max Depth: 1000 mm Frequency: 50 kHz
No significant defect noticed.	Area tested as representative of "sound" concrete. Also, GPR data revealed different steel composition (c.f. with CBBT 10.11-3,4).	~24.7"	Hoop Reinf. ~2.4" deep @ ~4.4" O.C. Longitudinal Reinf: On bottom	Norfolk, VA Chesapeake Tunnel CBBT 10.11-1, 2 Sta. 471+80 TAMU/TTI 10/2011

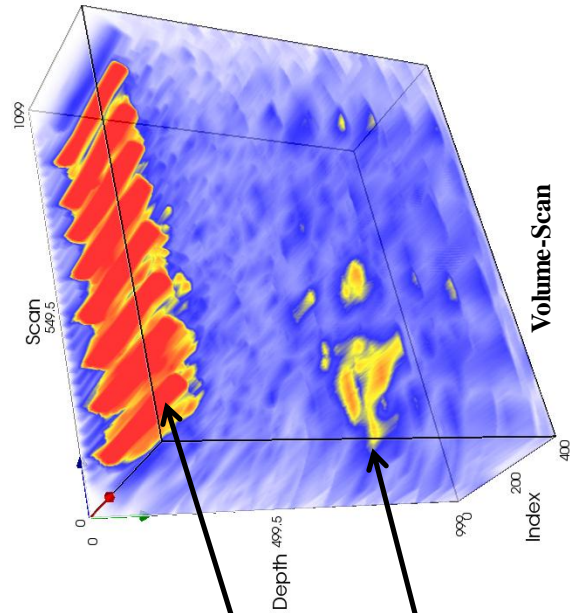
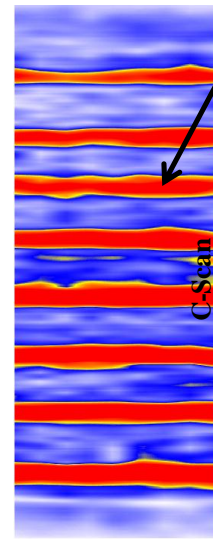
Defects	Notes	Backsurface	Reinf. Detail	$V_{shear} = 2710 \text{ m/s}$ X-step: 150 mm Y-step: 50 mm Max Depth: 1000 mm Frequency: 50 kHz Norfolk, VA Chesapeake Tunnel CBBT 10.11-1, 2 Sta. 471+80 TAMU/TTI 10/2011
No significant defect noticed.	Area tested as representative of "sound" concrete. Also, GPR data revealed different steel composition (c.f. with CBBT 10.11-3,4).	~24.7"	Hoop Reinf. ~2.4" deep @ ~4.4" O.C. Longitudinal Reinf: On bottom

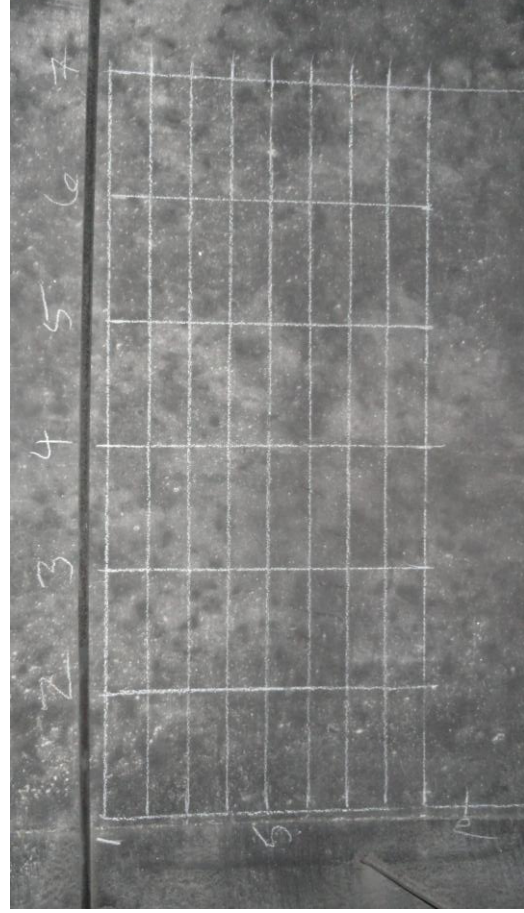
Defects	Notes	Backsurface	Reinf. Detail
<p>No significant defect noticed.</p>	<p>Area tested as representative of "sound" concrete. Also, GPR data revealed different steel composition (c.f. with CBBT 10.11-1, 2).</p>	<p>~24.4"</p>	<p>Hoop Reinf. ~2.3" deep @ ~11.8" O.C. Longitudinal Reinf: On bottom</p>

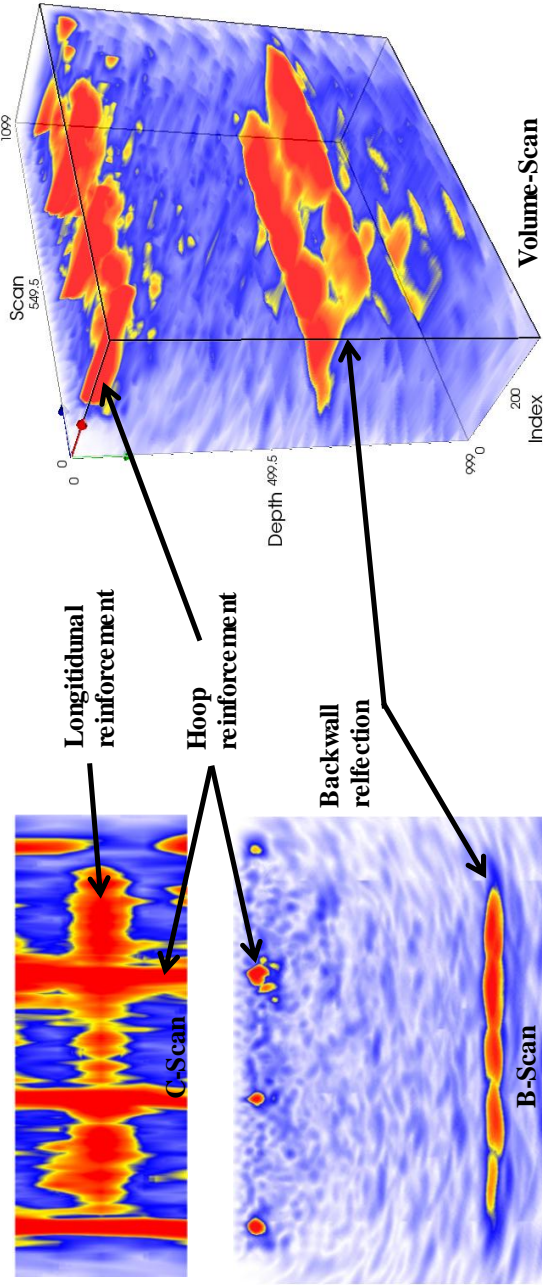
<p>Defects</p> <p>No significant defect noticed.</p>	<p>Notes</p> <p>Area tested as representative of "sound" concrete. Also, GPR data revealed different steel composition (c.f. with CBBT 10.11-1, 2).</p>	<p>Backsurface</p> <p>~24.4"</p>	<p>Reinf. Detail</p> <p>Hoop Reinf. ~2.3" deep @ ~11.8" O.C. Longitudinal Reinf: On bottom</p>	<p><math>V_{shear} = 2710</math> m/s  X-step: 150 mm  Y-step: 50 mm  Max Depth: 1000 mm  Frequency: 50 kHz  Norfolk, VA  Chesapeake Channel Tunnel  CBBT 10.11-3, 4  Sta. 473+56  TAMU/TTI 10/2011</p>
--	---	----------------------------------	--	--

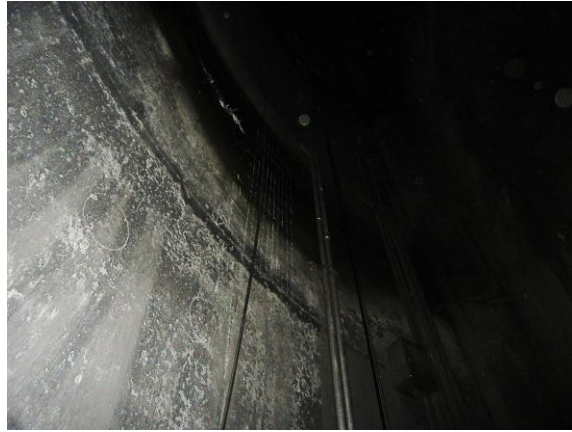
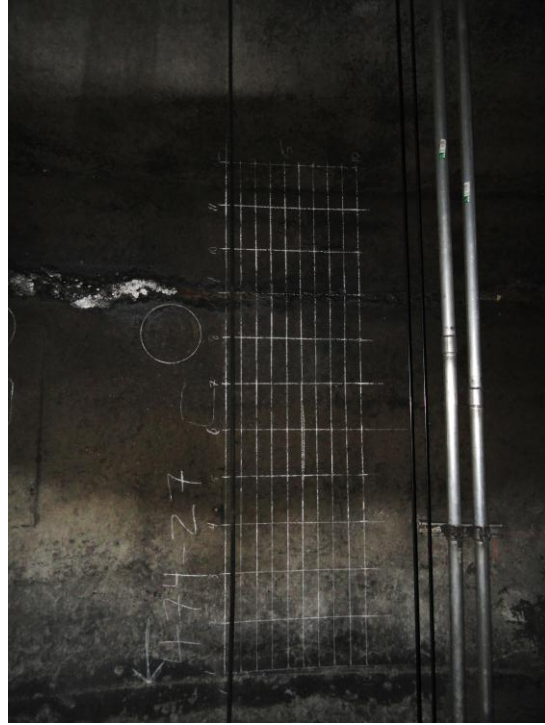
Defects	Notes	Backsurface	Reinf. Detail	$V_{shear} = 2710 \text{ m/s}$ X-step: 150 mm Y-step: 50 mm Max Depth: 1000 mm Frequency: 50 kHz Norfolk, VA Chesapeake Channel Tunnel CBBT 10.11-5 Sta. 474+27 TAMU/TTI 10/2011
Significant shallow defects, such as shallow cracks (~9" deep) and possibly shallow delaminations (~2" deep), which seem to produce the ringing.	Area tested because of "five" crack. Significant ringing may suggest debonding of longitudinal reinforcement.	~24.1"	Hoop Reinf: ~2.0"-2.6" deep @ ~12.0" O.C. Longitudinal Reinf: On bottom

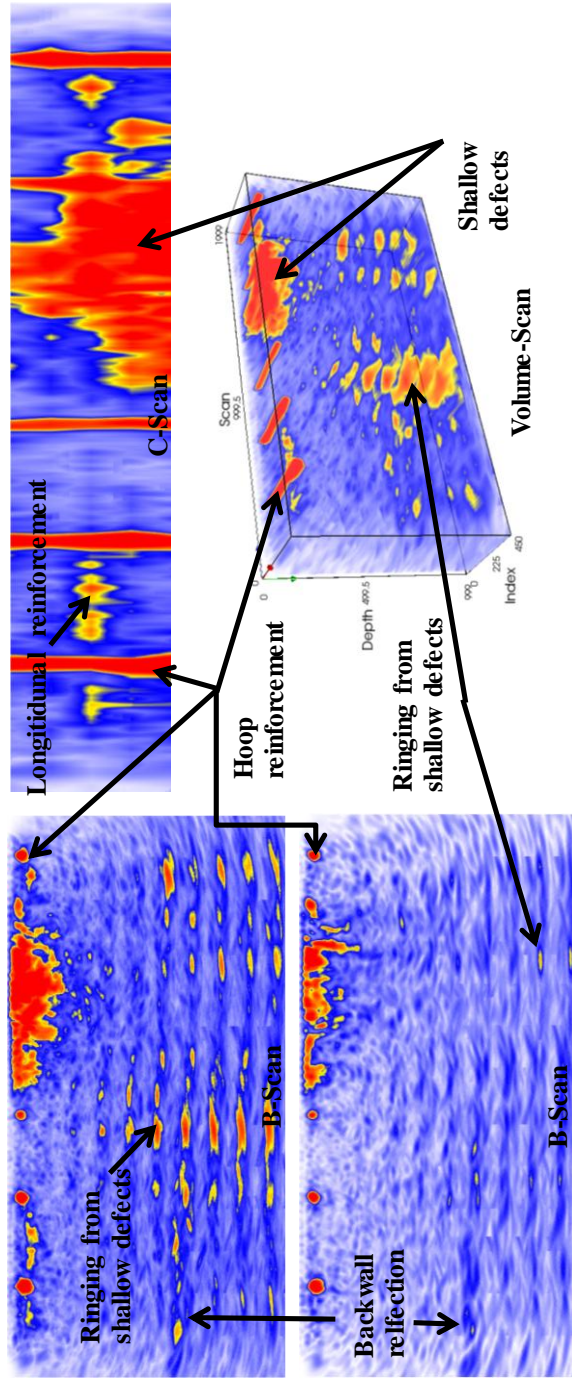
Defects	Notes	Backsurface	Reinf. Detail	$V_{shear} = 2710 \text{ m/s}$ X-step: 150 mm Y-step: 50 mm Max Depth: 1000 mm Frequency: 50 kHz Norfolk, VA Chesapeake Channel Tunnel CBBT 10.11-5 Sta. 474+27 TAMU/TTI 10/2011
Significant shallow defects, such as shallow cracks (~9" deep) and possibly shallow delaminations (~2" deep), which seem to produce the ringing.	Area tested because of "five" crack. Significant ringing may suggest debonding of longitudinal reinforcement.	~24.1"	Hoop Reinf: ~2.0"-2.6" deep @ ~12.0" O.C. Longitudinal Reinf: On bottom
