ULTRASONIC TOMOGRAPHY FOR DETECTING AND LOCATING DEFECTS IN  
CONCRETE STRUCTURES

A Thesis

JOSHUA BENJAMIN WHITE

Submitted to the Office of Graduate Studies of  
Texas A&M University  
in partial fulfillment of the requirements for the degree of  
MASTER OF SCIENCE

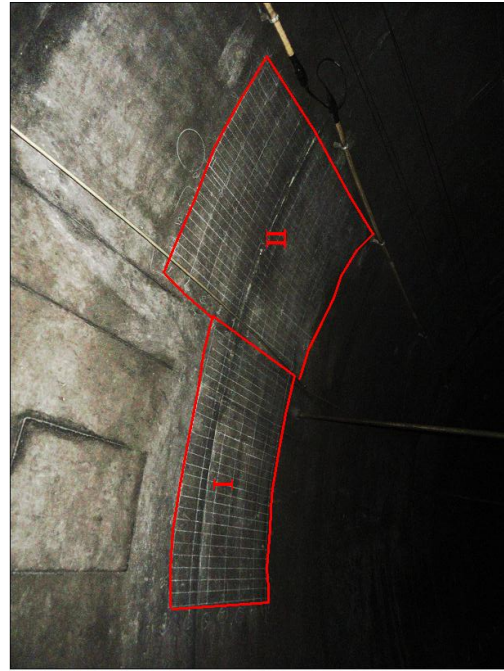
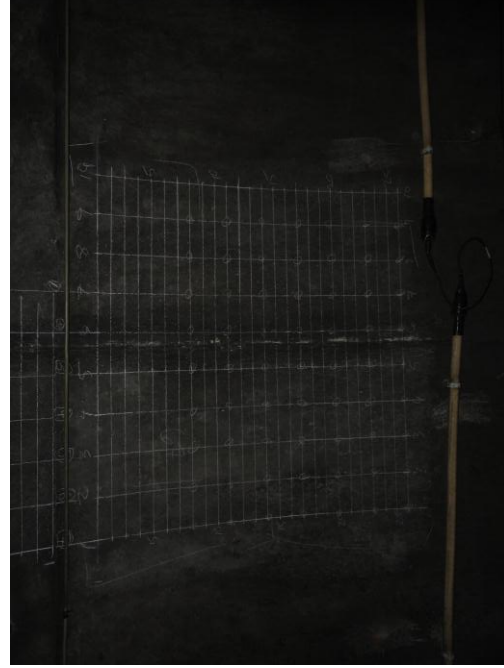
Defects	Notes	Backsurface	Reinf. Detail	$V_{shear} = 2710 \text{ m/s}$ X-step: 150 mm Y-step: 50 mm Max Depth: 1000 mm Frequency: 50 kHz Norfolk, VA Chesapeake Channel Tunnel CBBT 10.11-7, 8 (Region II) Sta. 486+67 TAMU/TTI 10/2011
Hammer tapping revealed hollow region as shown by shallow reflective region in the C and B-scans. Significant cupped-shaped delaminations as deep as 19.2"	Area tested because of high dielectric reading from GPR scan. No significant visual distress noticeable, but hammer sounding revealed shallow delamination in Region II.	24.1-26.0"	Hoop Reinf. ~2.2" deep @ ~12.1" O.C. Longitudinal Reinf: On bottom @ 16.2" O.C.

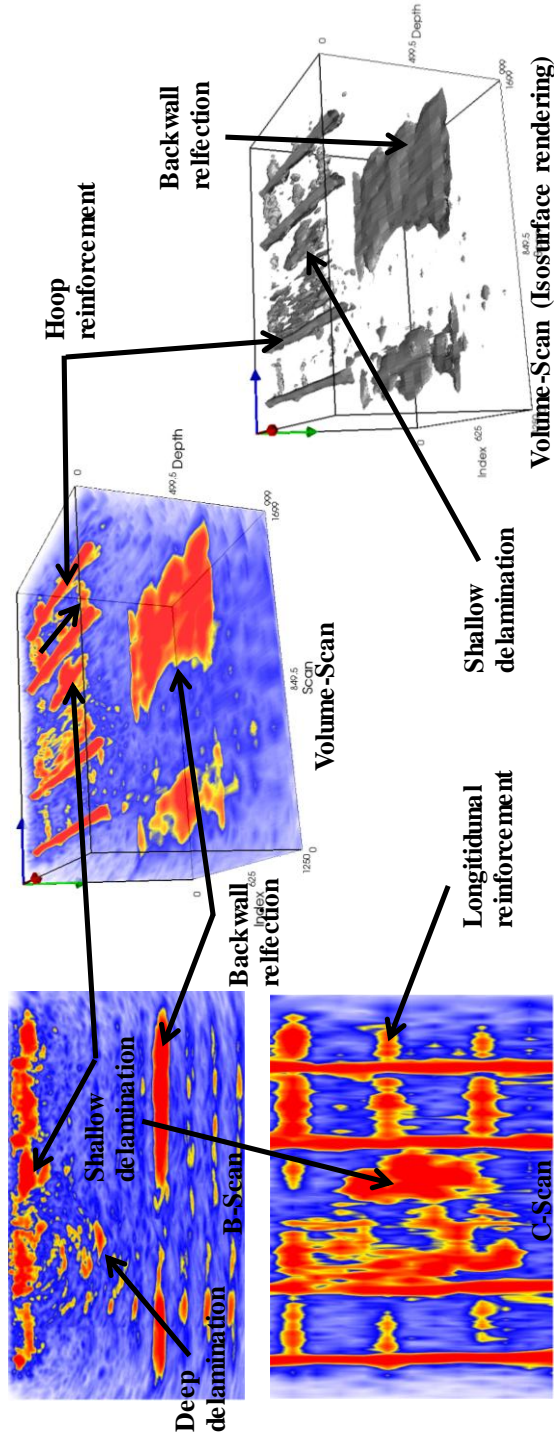
Defects	Notes	Backsurface	Reinf. Detail	$V_{shear} = 2710 \text{ m/s}$ X-step: 150 mm Y-step: 50 mm Max Depth: 1000 mm Frequency: 50 kHz Norfolk, VA Chesapeake Channel Tunnel CBBT 10.11-7, 8 (Region II) Sta. 486+67 TAMU/TTI 10/2011
Hammer tapping revealed hollow region as shown by shallow reflective region in the C and B-scans. Significant cupped-shaped delaminations as deep as 19.2"	Area tested because of high dielectric reading from GPR scan. No significant visual distress noticeable, but hammer sounding revealed shallow delamination in Region II.	24.1-26.0"	Hoop Reinf. ~2.2" deep @ ~12.1" O.C. Longitudinal Reinf: On bottom @ 16.2" O.C.

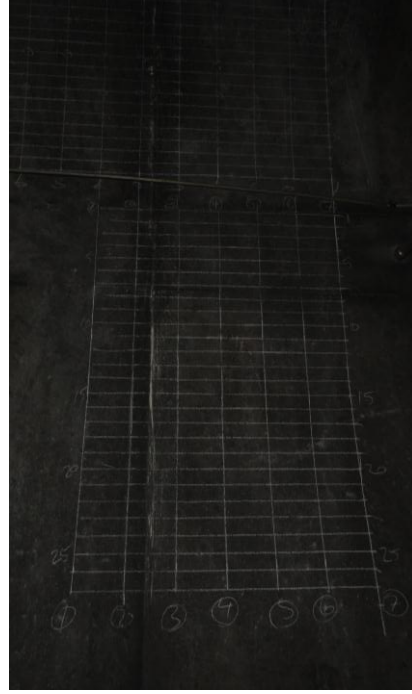
Defects	Notes	Backsurface	Reinf. Detail	$V_{shear} = 2710 \text{ m/s}$ X-step: 150 mm Y-step: 50 mm Max Depth: 1000 mm Frequency: 50 kHz Norfolk, VA Chesapeake Channel Tunnel CBBT 10.11-9 (Region I) Sta. 486+67 TAMU/TTI 10/2011
Significant cracks as deep as 8.6" deep.	Area tested because of high dielectric reading from GPR scan. No significant visual distress noticeable.	24.3-26.0"	Hoop Reinf: ~2.0"-3.0" deep @ ~12.2" O.C. Longitudinal Reinf: On bottom @ 19.8" O.C.

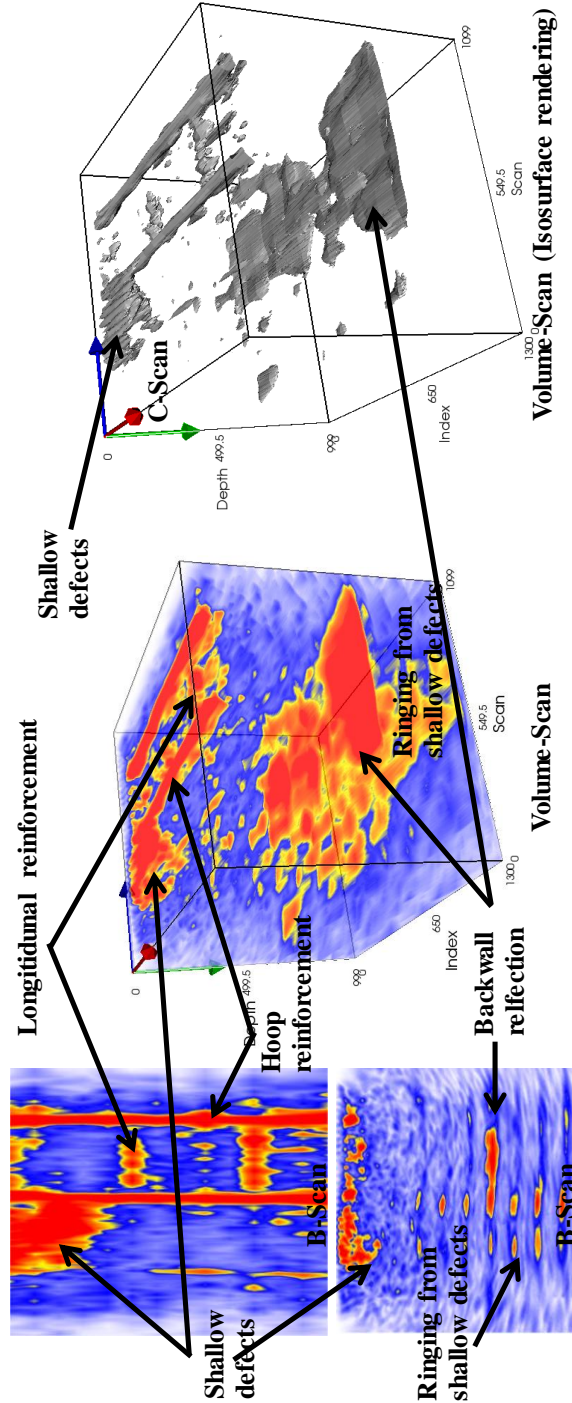
Defects	Notes	Backsurface	Reinf. Detail	$V_{shear} = 2710 \text{ m/s}$ X-step: 150 mm Y-step: 50 mm Max Depth: 1000 mm Frequency: 50 kHz Norfolk, VA Chesapeake Channel Tunnel CBBT 10.11-9 (Region I) Sta. 486+67 TAMU/TTI 10/2011
Significant cracks as deep as 8.6" deep.	Area tested because of high dielectric reading from GPR scan. No significant visual distress noticeable.	24.3-26.0"	Hoop Reinf: ~2.0"-3.0" deep @ ~12.2" O.C. Longitudinal Reinf: On bottom @ 19.8" O.C.

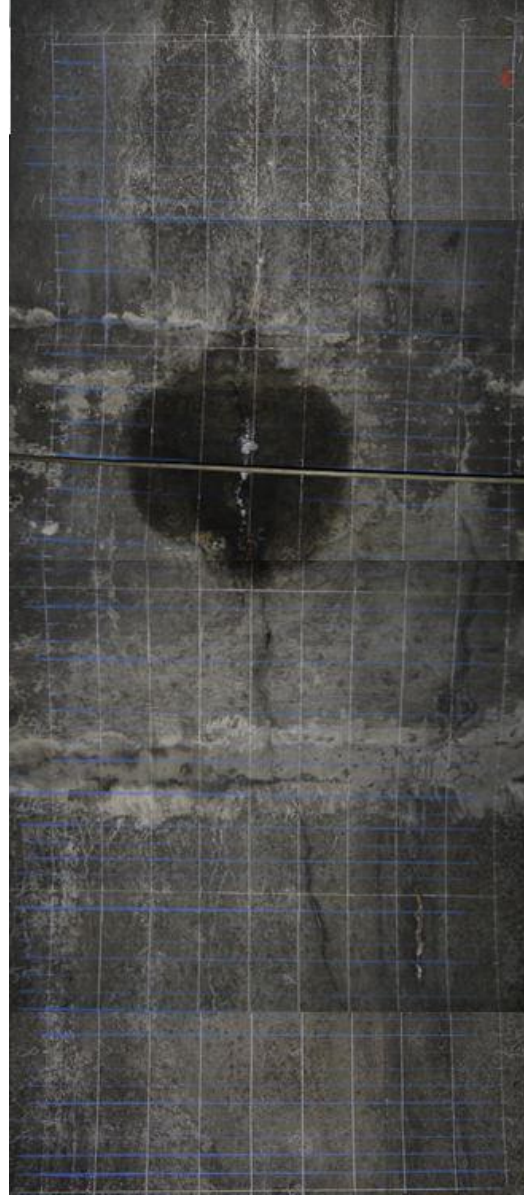
Defects	Notes	Backsurface	Reinf. Detail	$V_{shear} = 2710 \text{ m/s}$ X-step: 150 mm Y-step: 50 mm Max Depth: 1000 mm Frequency: 50 kHz Norfolk, VA Chesapeake Channel Tunnel CBBT 10.11-10 Sta. 491+25 TAMU/TTI 10/2011
Heavy ringing made internal inspection difficult. Possible deep delamination (~17.7" deep and possibly 19" wide) and evidence of surface crack extending ~9.8" deep.	Area tested because of large surface crack and small area of water intrusion.	22.7-25.9"	Hoop Reinf: ~2.7"-3.2" deep @ ~11.7"-12.4" O.C. 2nd Layer of Hoop reinf. directly beneath top layer. Longitudinal Reinf: On bottom @ ~17.1" O.C.

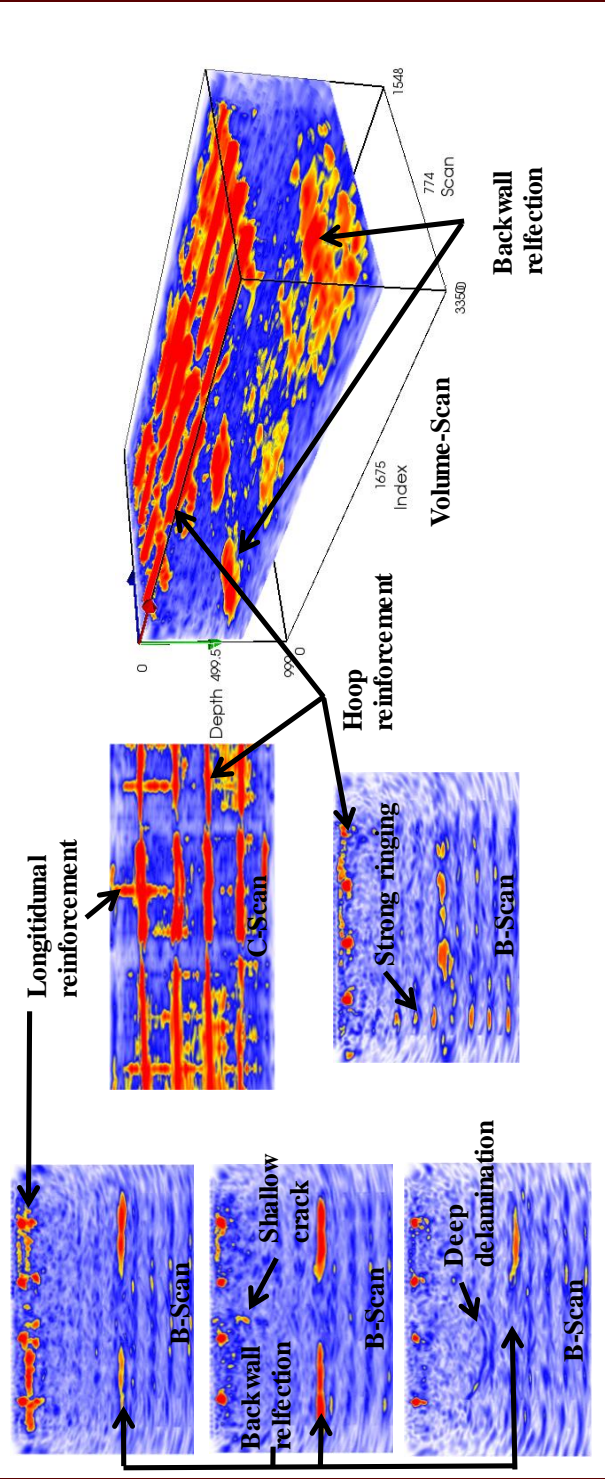
<b>Defects</b> Heavy ringing made internal inspection difficult. Possible deep delamination (~17.7" deep and possibly 19" wide) and evidence of surface crack extending ~9.8" deep.	<b>Notes</b> Area tested because of large surface crack and small area of water intrusion.	<b>Backsurface</b> 22.7'-25.9"	<b>Reinf. Detail</b> Hoop Reinf: ~2.7"-3.2" deep @ ~11.7"-12.4" O.C. 2nd Layer of Hoop reinf. directly beneath top layer. Longitudinal Reinf: On bottom @ ~17.1" O.C.	V <sub>shear</sub> = 2710 m/s X-step: 150 mm Y-step: 50 mm Max Depth: 1000 mm Frequency: 50 kHz Norfolk, VA Chesapeake Channel Tunnel CBBT 10.11-10 Sta. 491+25 TAMU/TTI 10/2011
--	---	-----------------------------------	--	---

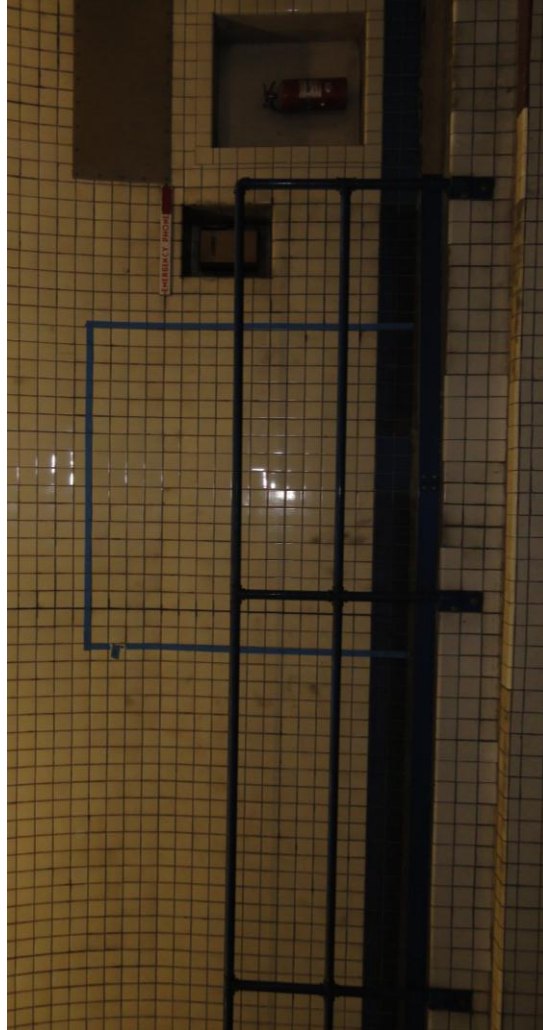
Defects	Notes	Backsurface	Reinf. Detail	V <sub>shear</sub> = 2710 m/s X-step: 110 mm Y-step: 110 mm Max Depth: 750 mm Frequency: 50 kHz Norfolk, VA Chesapeake Channel Tunnel CBBT TILE 10.11-11 Approx. Sta. 488 TAMU/TTI 10/2011
Heavy ringing made internal inspection difficult. Possible deep delamination (~15.7" deep and possibly 20.3" wide).	Area tested was tiled lining, over a joint where tile has debonded. Determined area via hammer sounding.	25.0-30.0"	Hoop Reinf: ~4.3"-7.7" deep @ ~12.1" O.C. 2nd layer of hoop reinf. seen briefly beneath top layer in one location, but this may be splice area. Longitudinal Reinf: On bottom @ ~13.0" O.C.

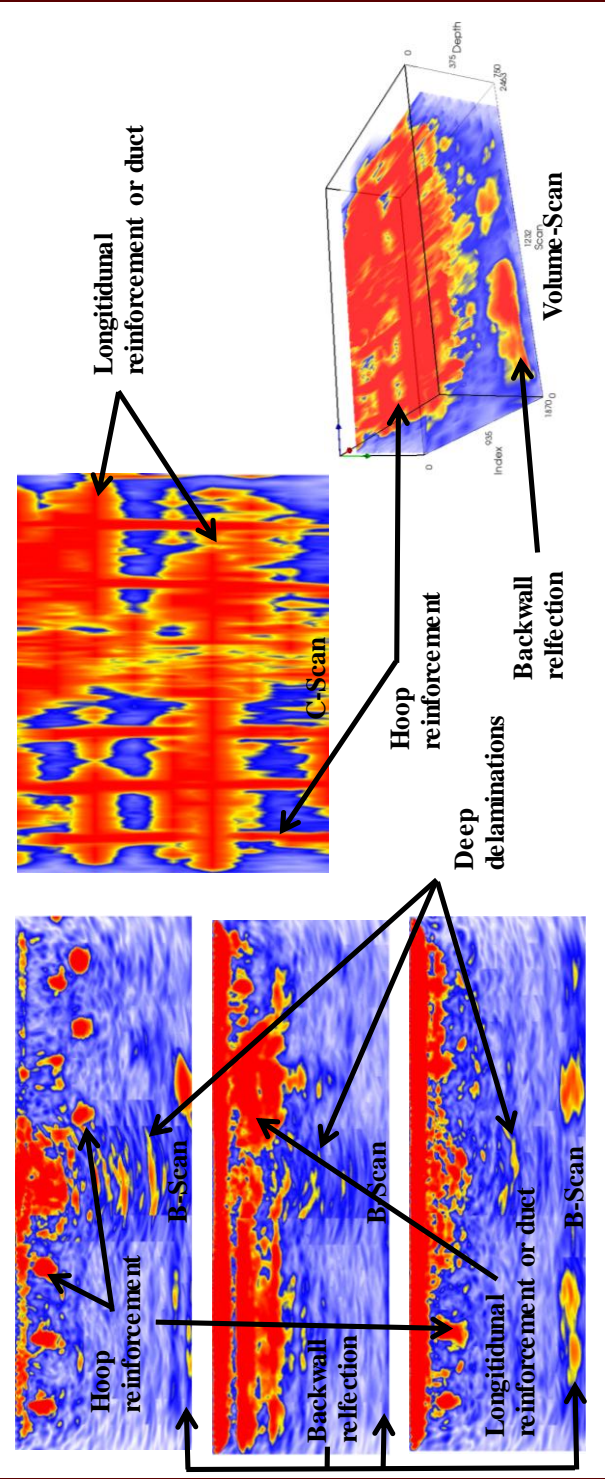
<b>Defects</b> Heavy ringing made internal inspection difficult. Possible deep delamination (~15.7" deep and possibly 20.3" wide).	<b>Notes</b> Area tested was tiled lining, over a joint where tile has debonded. Determined area via hammer sounding.	<b>Backsurface</b> 25.0-30.0"	<b>Reinf. Detail</b> Hoop Reinf: ~4.3"-7.7" deep @ ~12.1" O.C. 2nd layer of hoop reinf. seen briefly beneath top layer in one location, but this may be splice area. Longitudinal Reinf: On bottom @ ~13.0" O.C.	$V_{shear} = 2710 \text{ m/s}$ X-step: 110 mm Y-step: 110 mm Max Depth: 750 mm Frequency: 50 kHz Norfolk, VA Chesapeake Channel Tunnel CBBT TILE 10.11-11 Approx. Sta. 488 TAMU/TTI 10/2011
---	--	----------------------------------	---	--

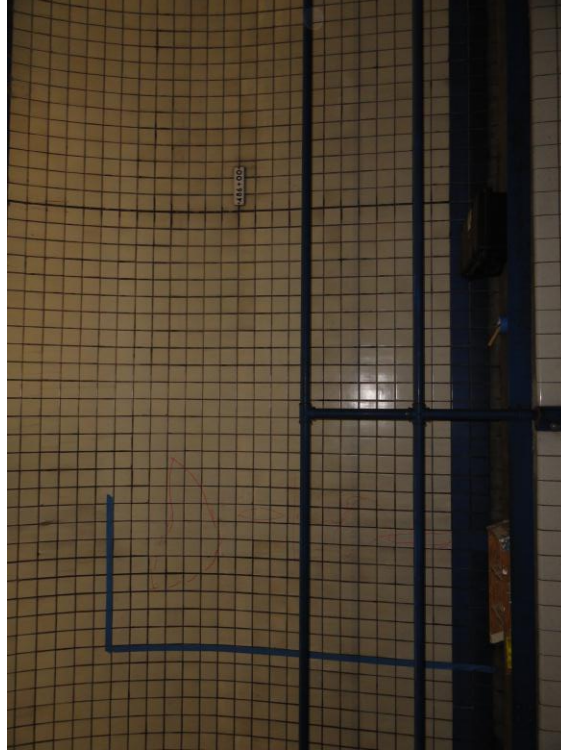
Defects	Notes	Backsurface	Reinf. Detail	V <sub>shear</sub> = 2710 m/s X-step: 110 mm Y-step: 110 mm Max Depth: 1000 mm Frequency: 50 kHz Norfolk, VA Chesapeake Channel Tunnel CBBT TILE 10.11-12 Sta. 486-09 TAMU/TTI 10/2011
Heavy ringing made internal inspection difficult. Possibly multiple cracks as deep as 8.6".	Area tested was tiled lining. Hammer sounding did not indicate debonding, but SPACETEC infrared scans showed area of question.	28.1-31.0"	Hoop Reinf: ~4.8"-9.4" deep @ ~11.7" O.C. Longitudinal Reinf: On bottom, possibly top as well, but may be duct.

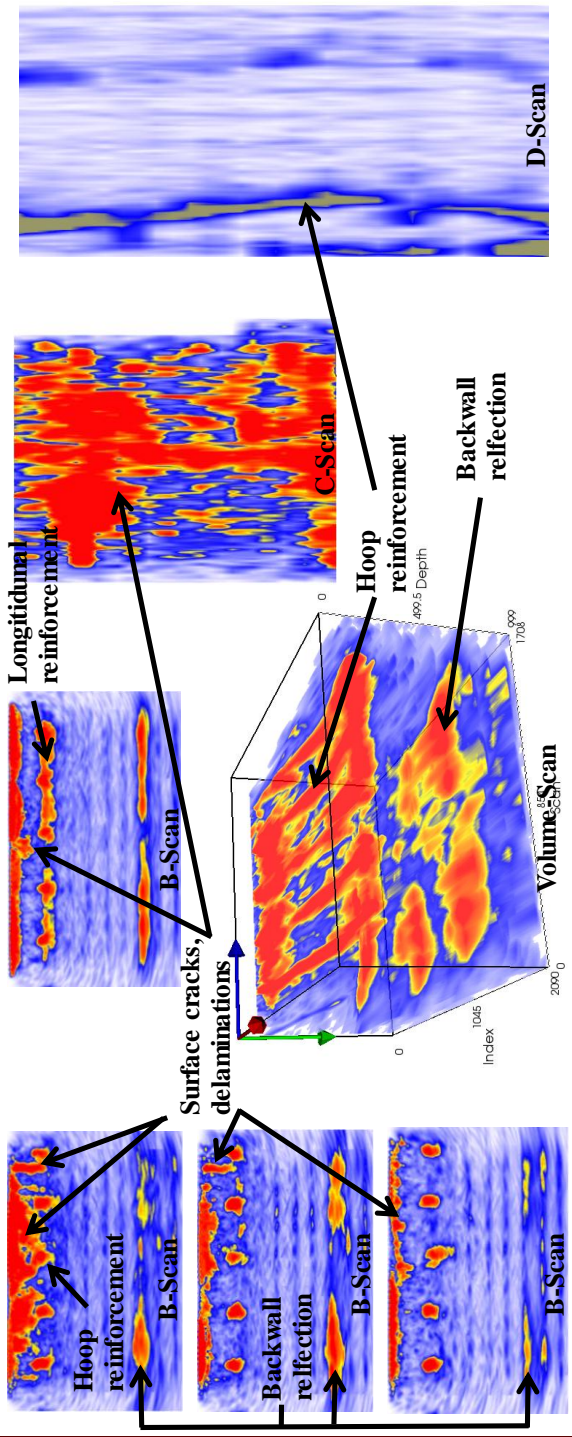
<b>Defects</b> Heavy ringing made internal inspection difficult. Possibly multiple cracks as deep as 8.6".	<b>Notes</b> Area tested was tiled lining. Hammer sounding did not indicate debonding, but SPACETEC infrared scans showed area of question.	<b>Backsurface</b> 28.1-31.0"	<b>Reinf. Detail</b> Hoop Reinf: ~4.8"-9.4" deep @ ~11.7" O.C. Longitudinal Reinf: On bottom, possibly top as well, but may be duct.	$V_{shear} = 2710 \text{ m/s}$ X-step: 110 mm Y-step: 110 mm Max Depth: 1000 mm Frequency: 50 kHz Norfolk, VA Chesapeake Channel Tunnel CBBT TILE 10.11-12 Sta. 486-09 TAMU/TTI 10/2011
---	--	----------------------------------	--	--

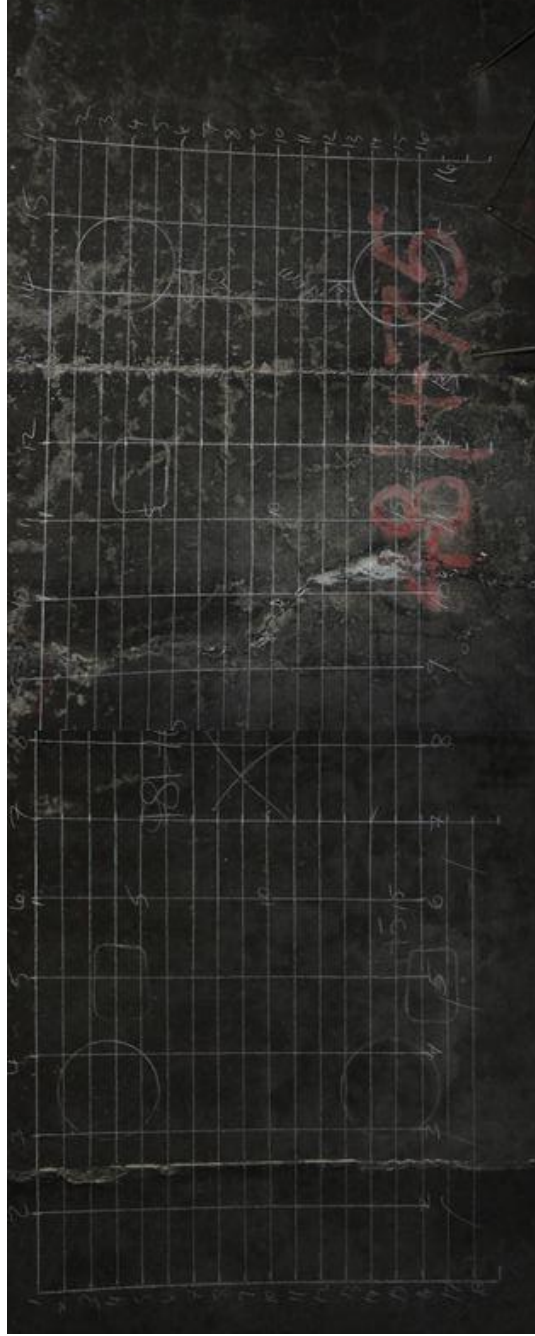
Defects	Notes	Backsurface	Reinf. Detail
Apparent delamination 20.2" deep, and 27.4" wide.	Area tested because of surface crack and varying backwall reflections from single-point evaluations.	26.6"-28.4"	Hoop Reinf: ~2.0"-3.6" deep @ 12.1" O.C. Longitudinal Reinf: On bottom.
$V_{shear} = 2710 \text{ m/s}$ X-step: 150 mm Y-step: 50 mm Max Depth: 1000 mm Frequency: 50 kHz Norfolk, VA Chesapeake Channel Tunnel CBBT 10.11-13 Sta. 481-76 TAMU/TTI 10/2011

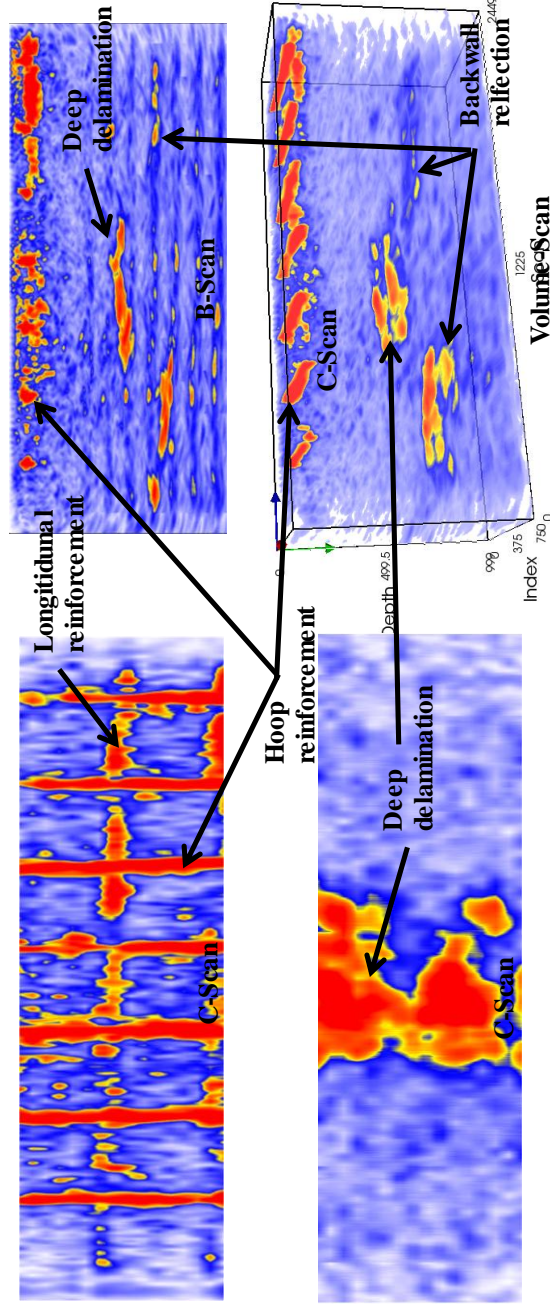
Defects	Notes	Backsurface	Reinf. Detail	V <sub>shear</sub> = 2710 m/s X-step: 150 mm Y-step: 50 mm Max Depth: 1000 mm Frequency: 50 kHz Norfolk, VA
Apparent delamination 20.2" deep, and 27.4" wide.	Area tested because of surface crack and varying backwall reflections from single-point evaluations.	26.6"-28.4"	Hoop Reinf: ~2.0"-3.6" deep @ 12.1" O.C. Longitudinal Reinf: On bottom.	Chesapeake Channel Tunnel CBBT 10.11-13 Sta. 481-76 TAMU/TTI 10/2011

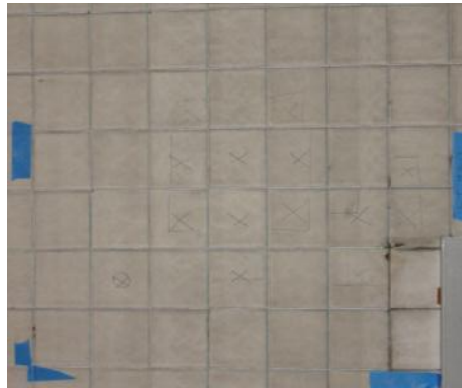
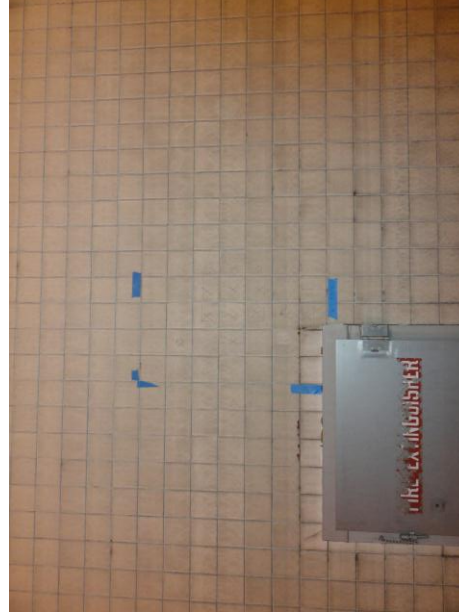
Defects	Notes	Backsurface	Reinf. Detail	$V_{shear} = 2710 \text{ m/s}$ X-step: 110 mm Y-step: 110 mm Max Depth: 500 mm Frequency: 50 kHz
Significant shallow debonding/delamination. Deep delamination approximately 1.3" deep (B-scan image)	Area tested because of debonding located via hammer sounding.	Not discernible	Hoop Reinf. ~6.8" deep	Houston, TX Washburn Tunnel WT 9.16-1 West Side TAMU/TTI 9/2011

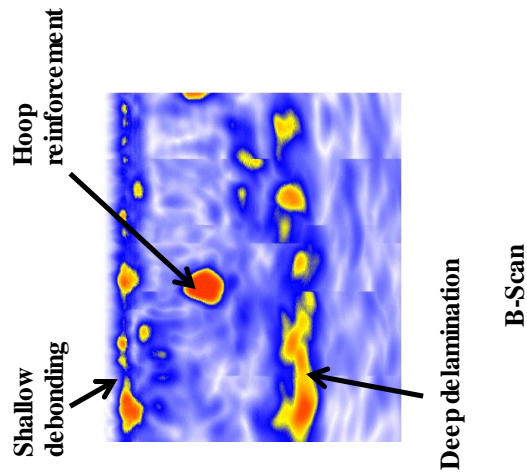
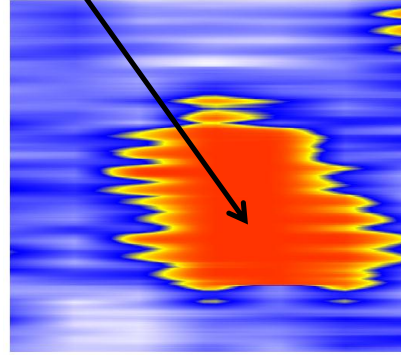
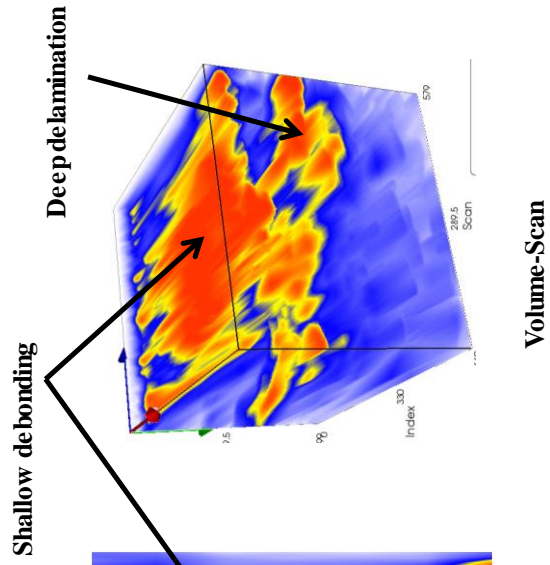
Defects	Notes	Backsurface	Reinf. Detail	V <sub>shear</sub> = 2710 m/s X-step: 110 mm Y-step: 110 mm Max Depth: 500 mm Frequency: 50 kHz
Significant shallow debonding/delamination. Deep delamination approximately 13" deep (B-scan image)	Area tested because of debonding located via hammer sounding.	Not discernible	Hoop Reinf. ~6.8" deep	Houston, TX Washburn Tunnel WT 9.16-1 West Side TAMU/TTI 9/2011

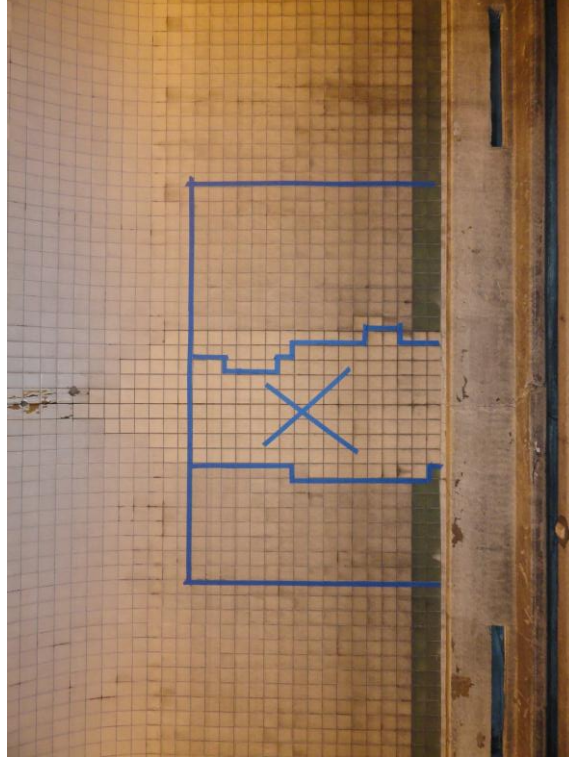
Defects	Notes	Backsurface	Reinf. Detail
<p>Significant shallow and deep debonding/delamination. Delaminations as deep as approximately 18" deep (B-scan image).</p>	<p>Area tested because of debonding located via hammer sounding.</p>	<p>Not discernible</p>	<p>Hoop Reinf: ~4.8"-5.2" deep @ 12.2 O.C. Longitudinal Reinf: On bottom</p>

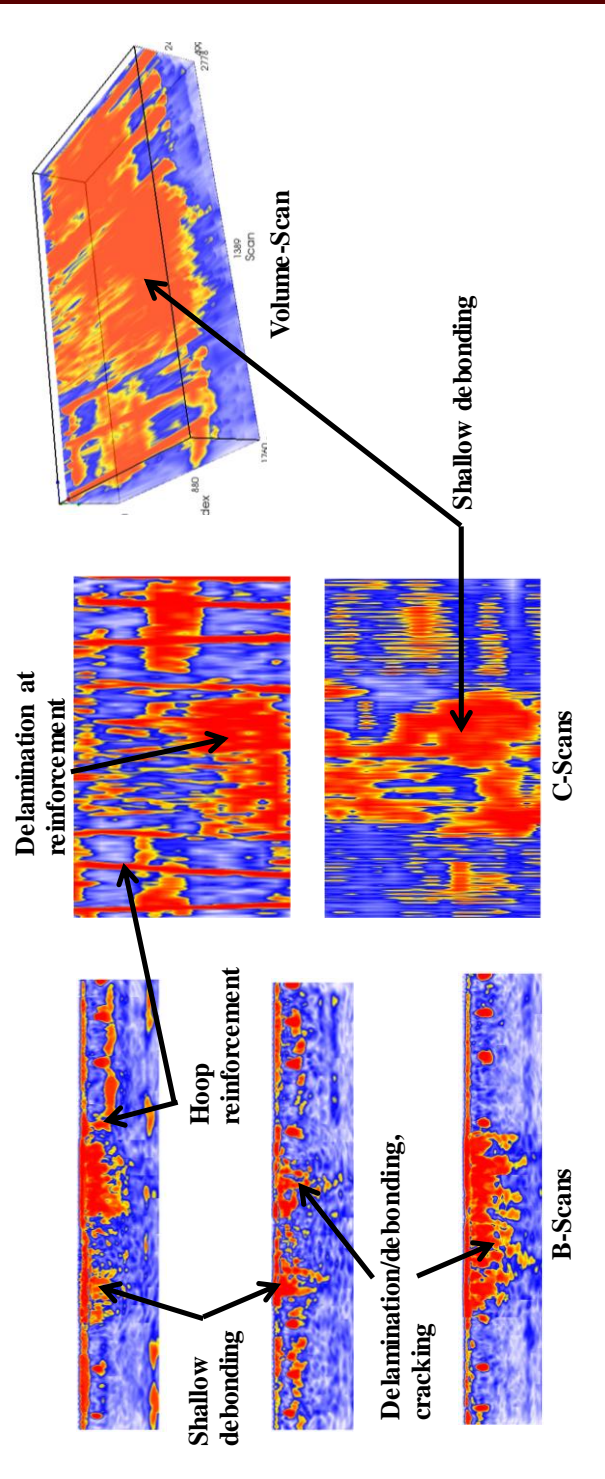
Defects	Notes	Backsurface	Reinf. Detail	$V_{shear} = 2710 \text{ m/s}$ X-step: 110 mm Y-step: 110 mm Max Depth: 500 mm Frequency: 50 kHz
Significant shallow and deep debonding/delamination. Delaminations as deep as approximately 18" deep (B-scan image).	Area tested because of debonding located via hammer sounding.	Not discernible	Hoop Reinf: ~4.8"-5.2" deep @ 12.2 O.C. Longitudinal Reinf: On bottom	Houston, TX Washburn Tunnel WT 9.16-2 West Side TAMU/TTI 9/2011

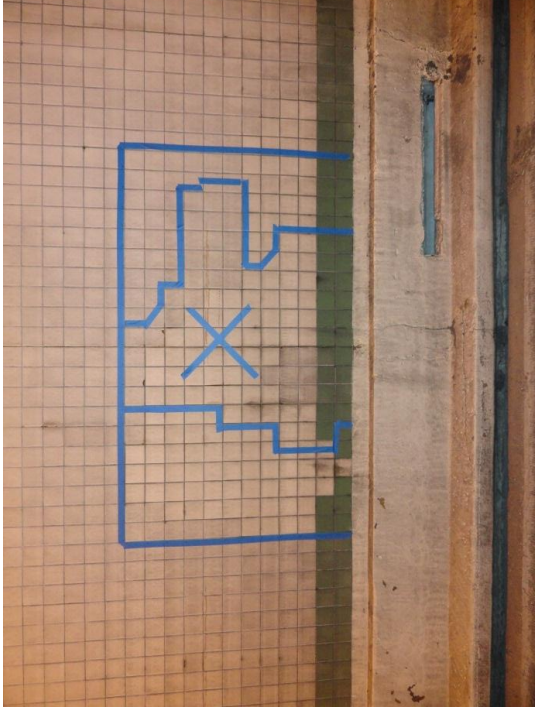
<b>Washburn Tunnel, Houston, TX</b>			
Defects	Notes	Backsurface	Reinf. Detail
<p>Significant delaminations/debonding throughout. Delaminations as deep as 10.7" below surface.</p>	<p>Area tested because of delaminations determined by hammer sounding.</p>	<p>Not discernible</p>	<p>Hoop Reinf. ~4.9" deep @ 13.4" O.C. Longitudinal Reinf: On bottom</p>
		<p> <math>V_{shear} = 2710 \text{ m/s}</math>                      X-step: 110 mm                      Y-step: 110 mm                      Max Depth: 500 mm                      Frequency: 50 kHz                      Houston, TX                      Washburn Tunnel                      WT 9.16-3                      West Side                      TAMU/TTI 9/2011                 </p>

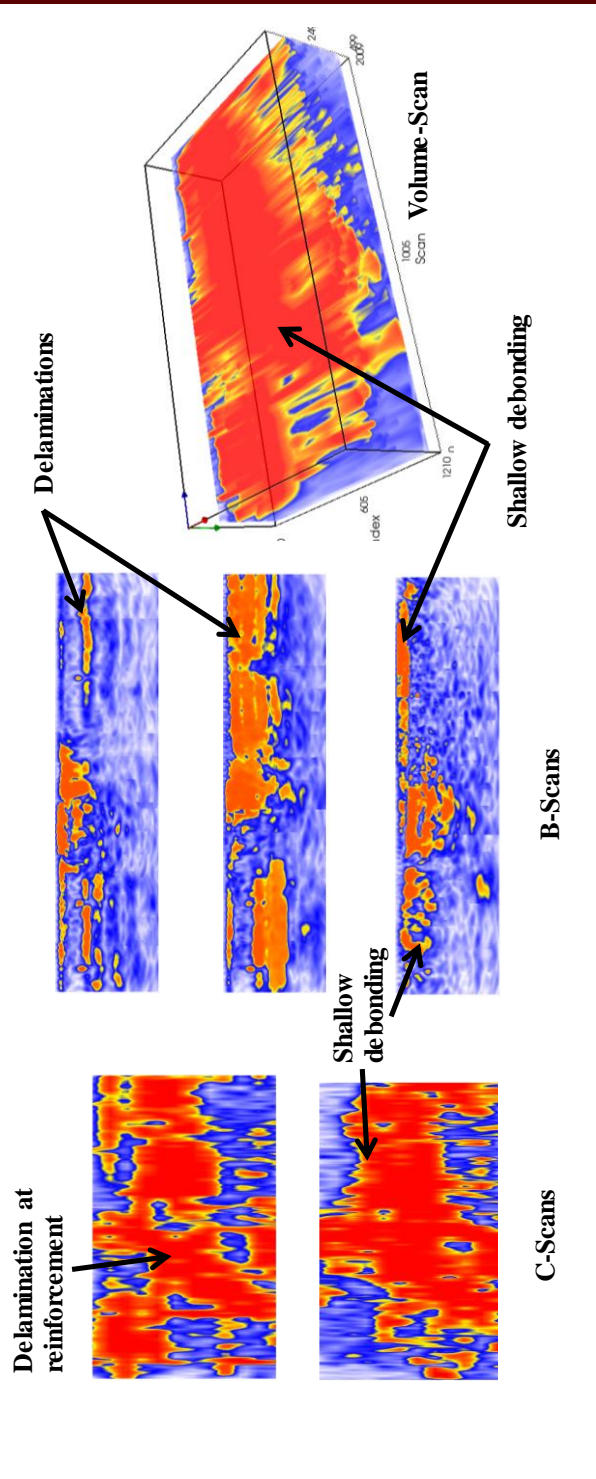
Defects	Notes	Backsurface	Reinf. Detail	$V_{shear} = 2710 \text{ m/s}$ X-step: 110 mm Y-step: 110 mm Max Depth: 500 mm Frequency: 50 kHz
Significant delaminations/debonding throughout. Delaminations as deep as 10.7" below surface.	Area tested because of delaminations determined by hammer sounding.	Not discernible	Hoop Reinf. ~4.9" deep @ 13.4" O.C. Longitudinal Reinf: On bottom	Houston, TX Washburn Tunnel WT 9.16-3 West Side TAMU/TTI 9/2011

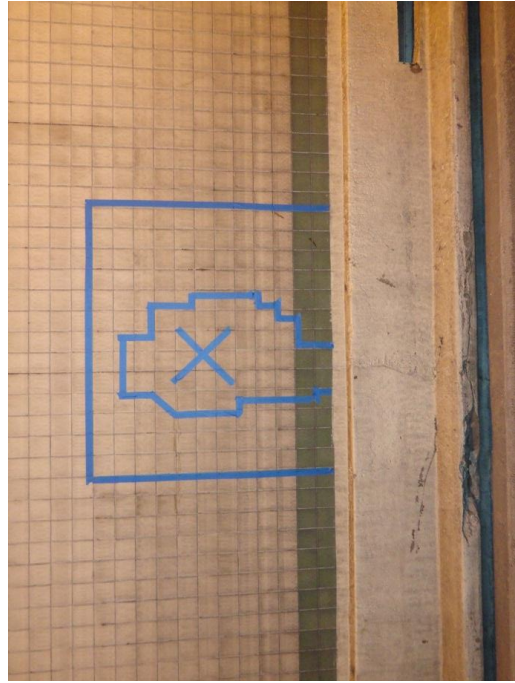
Defects	Notes	Backsurface	Reinf. Detail
Significant delaminations/debonding throughout. Possible delaminations 11.7" deep.	Area tested because of delaminations determined by hammer sounding.	Not discernible	Hoop Reinf. ~4.7" deep @ 11.7" O.C. Longitudinal Reinf: On bottom
		$V_{shear} = 2710 \text{ m/s}$ X-step: 110 mm Y-step: 110 mm Max Depth: 500 mm Frequency: 50 kHz Houston, TX Washburn Tunnel WT 9.16-4 West Side TAMU/TTI 9/2011

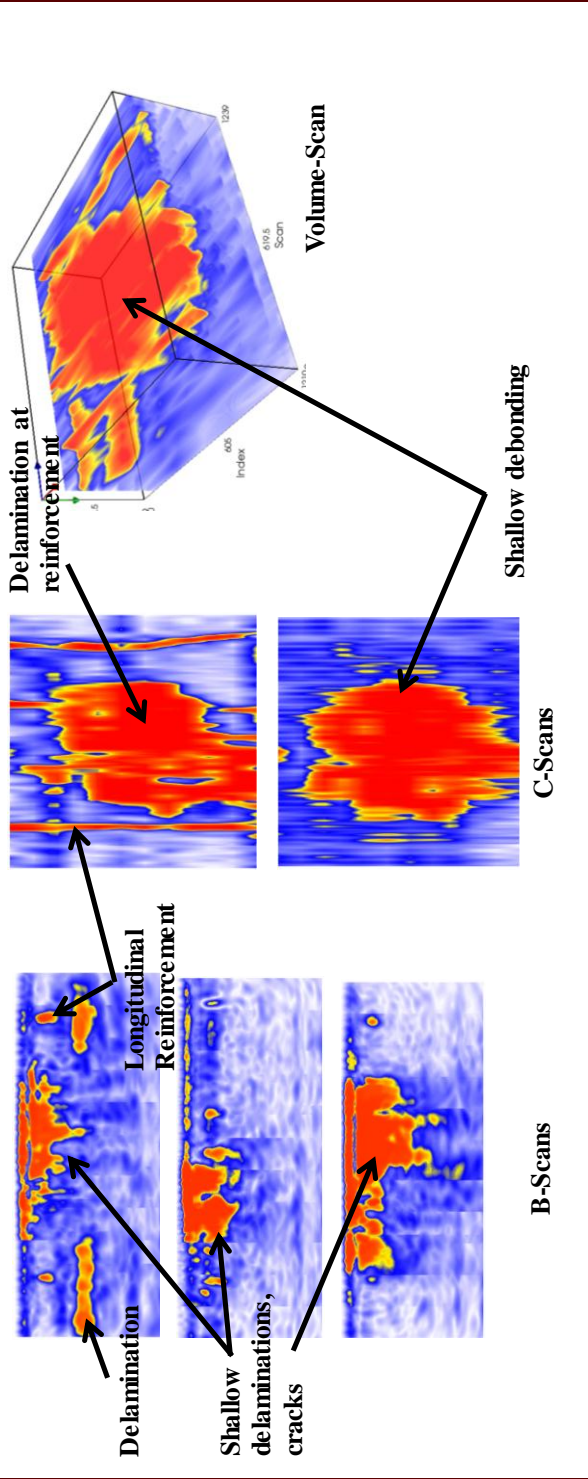
Defects	Notes	Backsurface	Reinf. Detail	$V_{shear} = 2710 \text{ m/s}$ X-step: 110 mm Y-step: 110 mm Max Depth: 500 mm Frequency: 50 kHz
Significant delaminations/debonding throughout. Possible delaminations 11.7" deep.	Area tested because of delaminations determined by hammer sounding.	Not discernible	Hoop Reinf. ~4.7" deep @ 11.7" O.C. Longitudinal Reinf: On bottom	Houston, TX Washburn Tunnel WT 9.16-4 West Side TAMU/TTI 9/2011

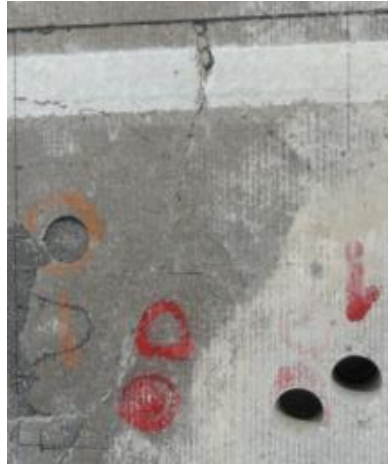
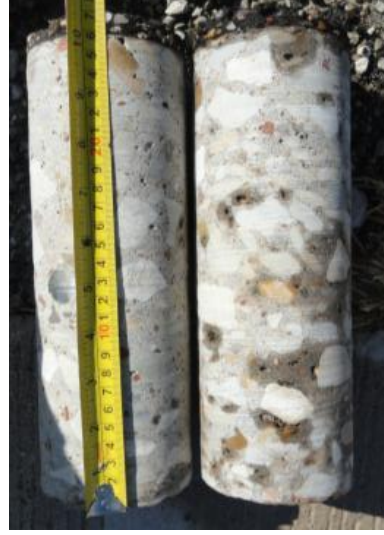
Defects	Notes	Backsurface	Reinf. Detail	V <sub>shear</sub> = 2770 m/s X-step: 150 mm Y-step: 50 mm Max Depth: 500 mm Frequency: 50 kHz Ft. Worth, TX I-20 IH20 9.27-1 MP 426 + 0.5, RM 2871 TAMU/TTI 9/2011
Significant delamination on both sides of surface crack, ranging from 4.2" - 5.0" from top surface.	Area tested because of transverse surface cracking. Pavement depth confirmed by 2 cores, both indicating 10.2" thickness and one indicating 5.0" reinf. depth.	Top layer of pavement approximately 10.2" below surface.	Longitudinal Reinf.: ~4.6" - 5.0" deep @ 5.6" O.C. No transverse reinforcement located in this area.

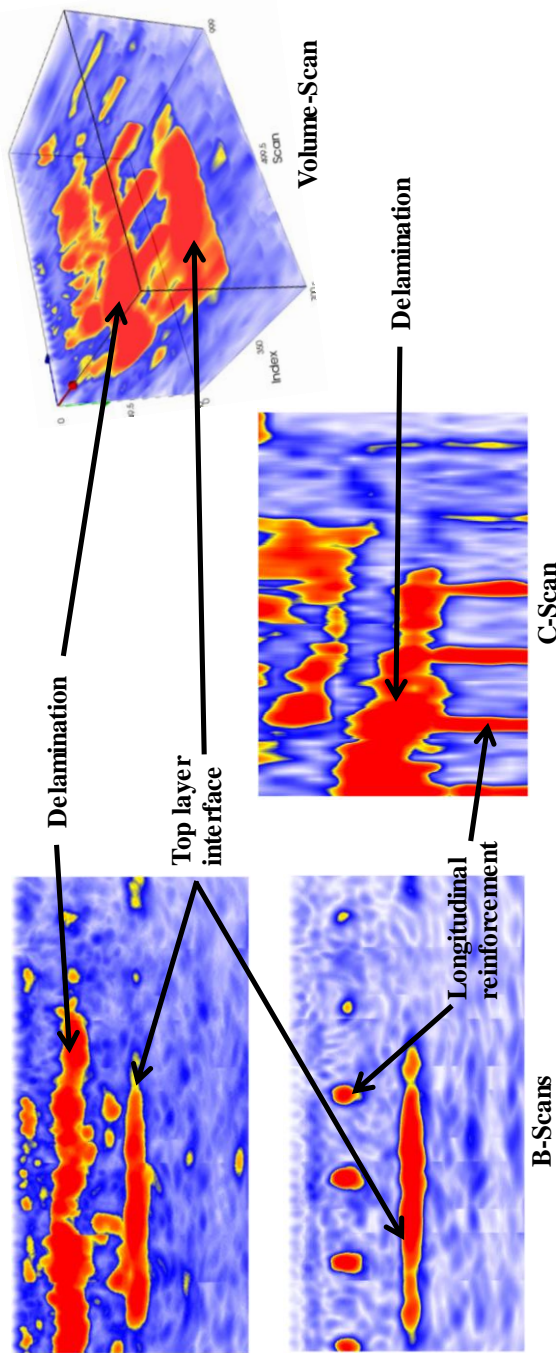
Defects	Notes	Backsurface	Reinf. Detail	V <sub>shear</sub> = 2770 m/s X-step: 150 mm Y-step: 50 mm Max Depth: 500 mm Frequency: 50 kHz
Significant delamination on both sides of surface crack, ranging from 4.2" - 5.0" from top surface.	Area tested because of transverse surface cracking. Pavement depth confirmed by 2 cores, both indicating 10.2" thickness and one indicating 5.0" reinf. depth.	Top layer of pavement approximately 10.2" below surface.	Longitudinal Reinf.: ~4.6" - 5.0" deep @ 5.6" O.C. No transverse reinforcement located in this area.	Ft. Worth, TX I-20 IH20 9.27-1 MP 426 + 0.5, RM 2871 TAMU/TTI 9/2011

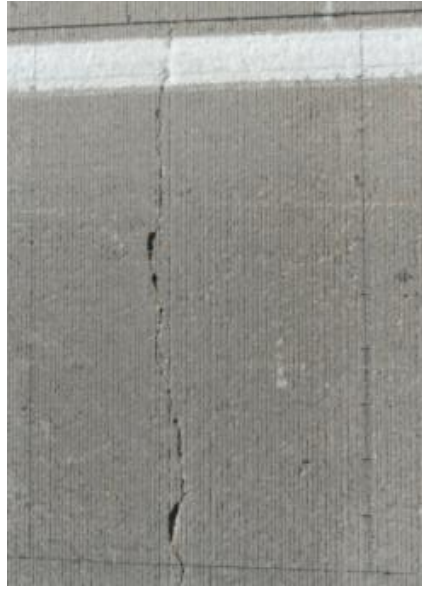
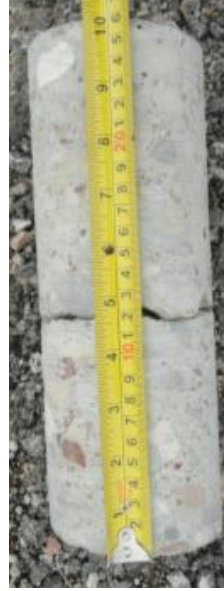
Defects	Notes	Backsurface	Reinf. Detail	$V_{shear} = 2770$ m/s X-step: 150 mm Y-step: 50 mm Max Depth: 500 mm Frequency: 50 kHz Ft. Worth, TX I-20 IH20 9.27-2 MP 426 + 0.5, RM 2871 TAMU/TTI 9/2011
Significant delamination on both sides of surface crack, ranging from 4.5" - 5.3" from top surface.	Area tested because of transverse surface cracking. Pavement depth confirmed by 2 cores, indicating 9.4" - 10.4" thickness.	Top layer of pavement approximately 10.4" below surface.	Longitudinal Reinf.: ~4.5" - 5.2" deep @ 7.1" O.C. No transverse reinforcement located in this area.

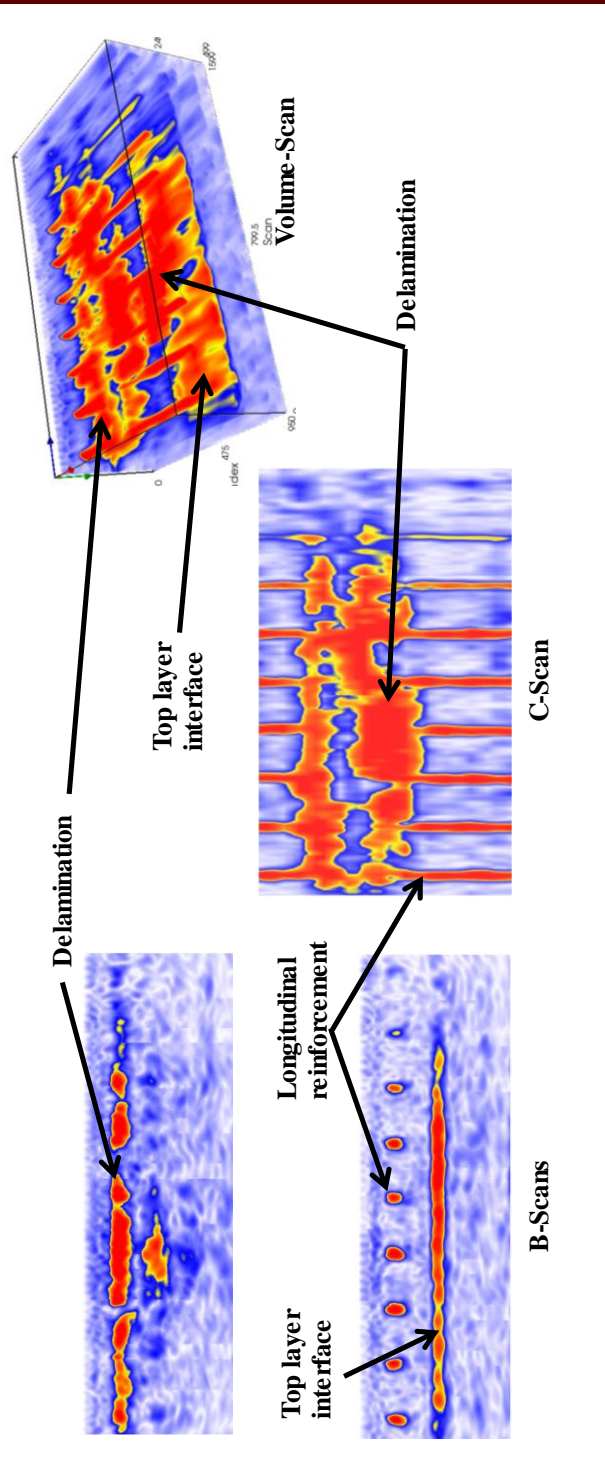
Defects	Notes	Backsurface	Reinf. Detail	$V_{shear} = 2770 \text{ m/s}$ X-step: 150 mm Y-step: 50 mm Max Depth: 500 mm Frequency: 50 kHz Ft. Worth, TX I-20 IH20 9.27-2 MP 426 + 0.5, RM 2871 TAMU/TTI 9/2011
Significant delamination on both sides of surface crack, ranging from 4.5" - 5.3" from top surface.	Area tested because of transverse surface cracking. Pavement depth confirmed by 2 cores, indicating 9.4" - 10.4" thickness.	Top layer of pavement approximately 10.4" below surface.	Longitudinal Reinf.: ~4.5" - 5.2" deep @ 7.1" O.C. No transverse reinforcement located in this area.

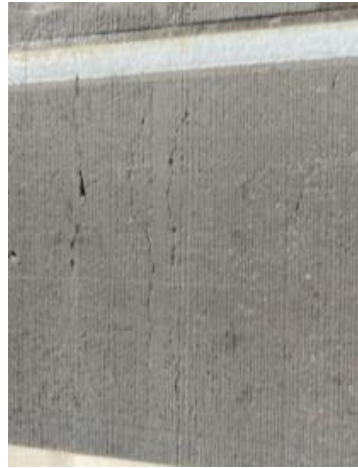
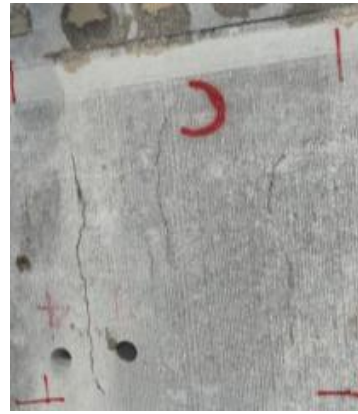
Defects	Notes	Backsurface	Reinf. Detail	V <sub>shear</sub> = 2770 m/s X-step: 150 mm Y-step: 50 mm Max Depth: 500 mm Frequency: 50 kHz Ft. Worth, TX I-20 IH20 9.27-3 MP 426 + 0.5, RM 2871 TAMU/TTI 9/2011
Significant delamination on both sides of surface crack, ranging from 4.6" - 5.1" from top surface.	Area tested because of transverse surface cracking. Pavement depth confirmed by 2 cores, indicating 10.2" thickness.	Top layer of pavement approximately 10.2" below surface.	Longitudinal Reinf.: ~4.8" - 5.0" deep @ 7.2" O.C. No transverse reinforcement located in this area.

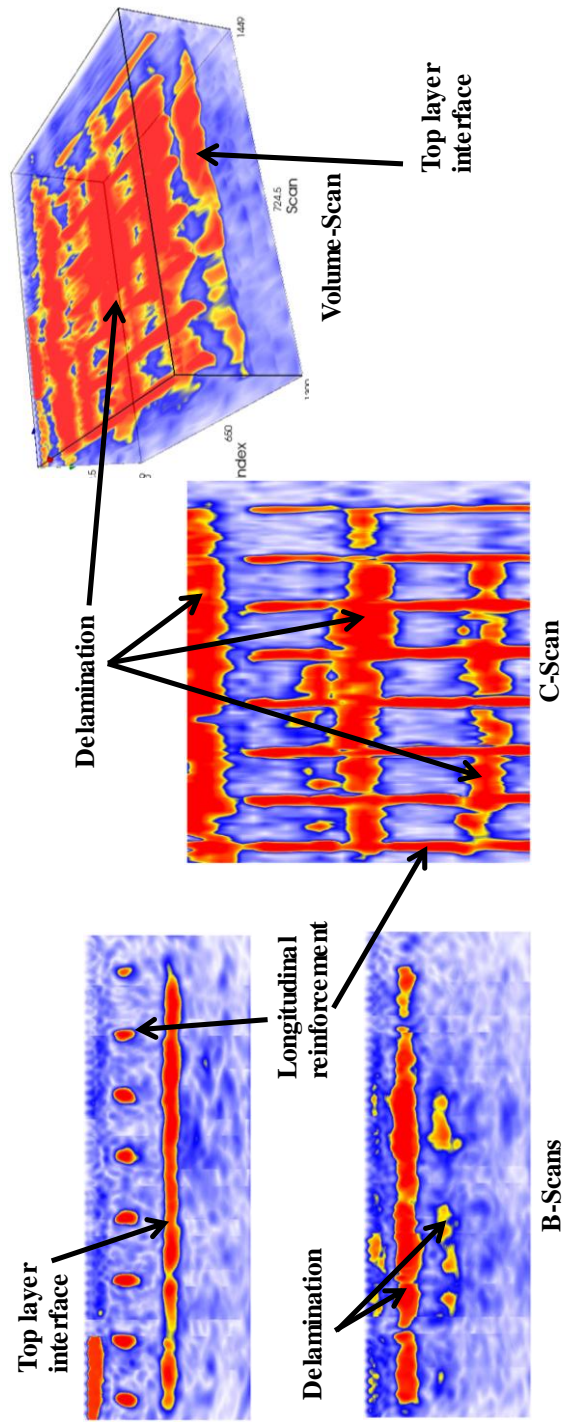
Defects	Notes	Backsurface	Reinf. Detail	V <sub>shear</sub> = 2770 m/s X-step: 150 mm Y-step: 50 mm Max Depth: 500 mm Frequency: 50 kHz
Significant delamination on both sides of surface crack, ranging from 4.6" - 5.1" from top surface.	Area tested because of transverse surface cracking. Pavement depth confirmed by 2 cores, indicating 10.2" thickness.	Top layer of pavement approximately 10.2" below surface.	Longitudinal Reinf.: ~4.8" - 5.0" deep @ 7.2" O.C. No transverse reinforcement located in this area.	Ft. Worth, TX I-20 IH20 9.27-3 MP 426 + 0.5, RM 2871 TAMU/TTI 9/2011

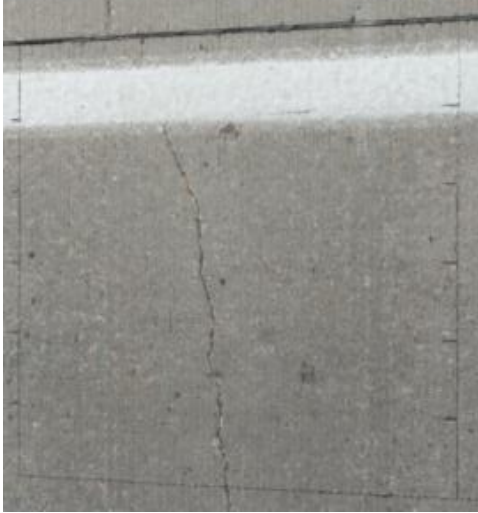
<b>Interstate 20, Ft. Worth, TX</b>	
<b>Defects</b> Significant delamination on both sides of surface crack, approximately 5.0" from top surface.	<b>Notes</b> Area tested because of transverse surface cracking. No cores taken in this location.	<b>Backsurface</b> Top layer of pavement approximately 10.1" below surface.	<b>Reinf. Detail</b> Longitudinal Reinf.: ~4.6"-5.2" deep @ 7.0" O.C. No transverse reinforcement located in this area.

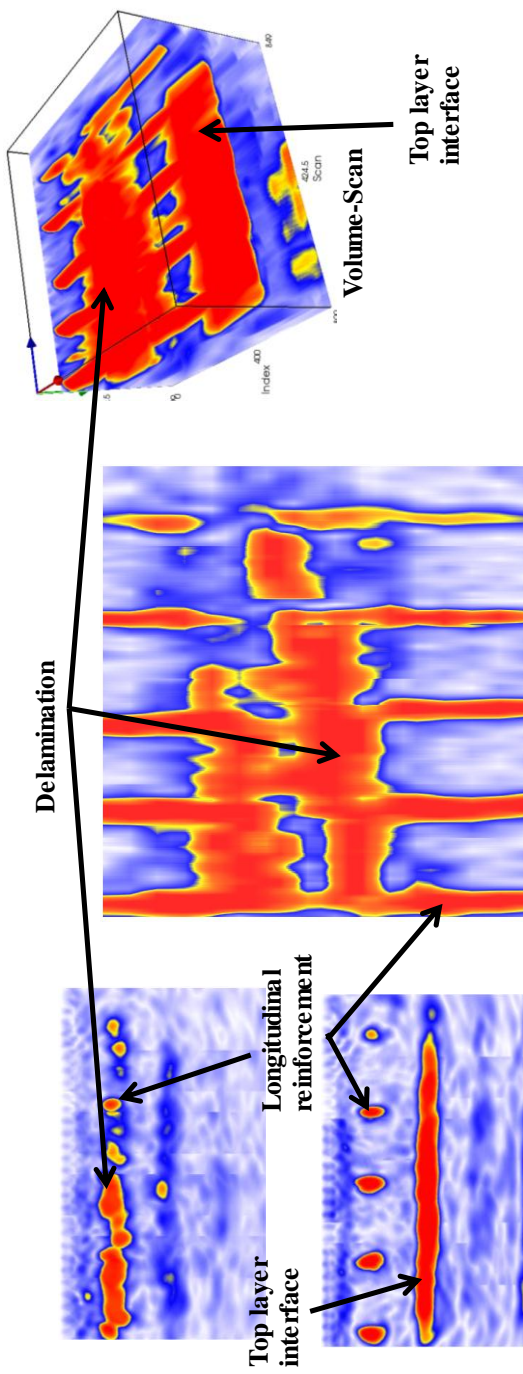
Defects	Notes	Backsurface	Reinf. Detail	V <sub>shear</sub> = 2770 m/s X-step: 150 mm Y-step: 50 mm Max Depth: 500 mm Frequency: 50 kHz Ft. Worth, TX I-20 IH20 9.27-5 MP 426 + 0.5, RM 2871 TAMU/TTI 9/2011
Significant delamination on both sides of surface crack, approximately 5.0" from top surface.	Area tested because of transverse surface cracking. No cores taken in this location.	Top layer of pavement approximately 10.1" below surface.	Longitudinal Reinf.: ~4.6"-5.2" deep @ 7.0" O.C. No transverse reinforcement located in this area.

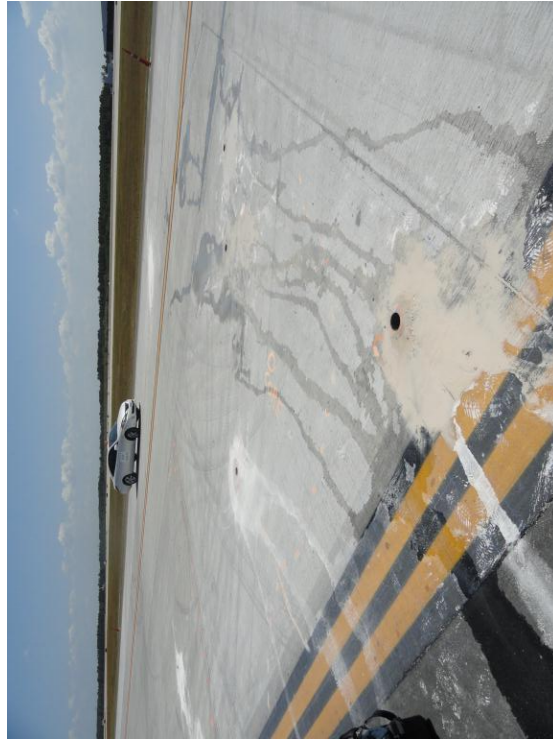
Defects	Notes	Backsurface	Reinf. Detail	V <sub>shear</sub> = 2885 m/s X-step: 200 mm Y-step: 100 mm Max Depth: 1000 mm Frequency: 50 kHz
Significant debonding at at runway/subbase (7.6"-8.1" deep), verified by coring. Possible further debonding in deeper layers (26.9" and 37.7" deep).	Area tested because of surface cracking, hammer sounding revealing possible delaminations. Image is of typical runway segment.	Top layer of pavement approximately 7.6"-8.1" below surface, second layer 26.9" below surface, third layer 37.7" below surface.	None	Houston, TX IAH IAH 6.9-1 Sta 83+00 T/W W A E TAMU/TTI 6/2011
