ULTRASONIC TOMOGRAPHY FOR DETECTING AND LOCATING DEFECTS IN  
CONCRETE STRUCTURES

A Thesis

JOSHUA BENJAMIN WHITE

Submitted to the Office of Graduate Studies of  
Texas A&M University  
in partial fulfillment of the requirements for the degree of  
MASTER OF SCIENCE

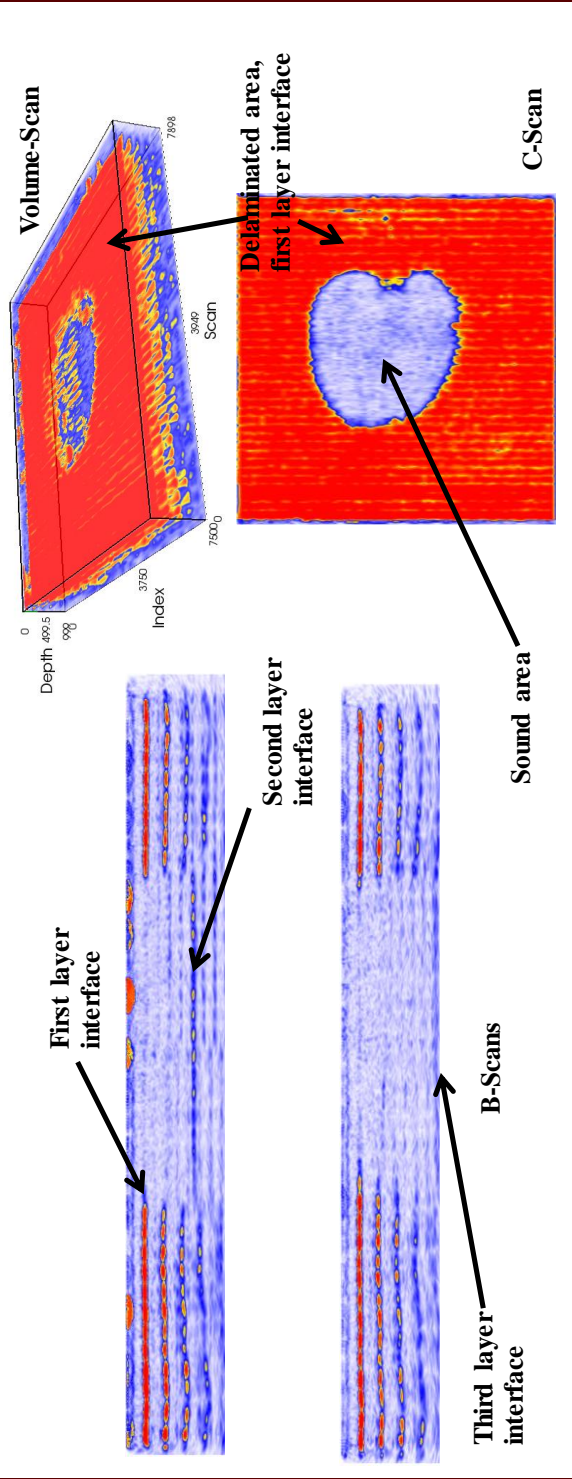
Defects	Notes	Backsurface	Reinf. Detail	V <sub>shear</sub> = 2885 m/s X-step: 200 mm Y-step: 100 mm Max Depth: 1000 mm Frequency: 50 kHz
Significant debonding at at runway/subbase (7.6"-8.1" deep), verified by coring. Possible further debonding in deeper layers (26.9" and 37.7" deep).	Area tested because of surface cracking, hammer sounding revealing possible delaminations.	Top layer of pavement approximately 7.6"-8.1" below surface, second layer 26.9" below surface, third layer 37.7" below surface.	None	Houston, TX IAH IAH 6.9-1 Sta 83+00 T/W W A E TAMU/TTI 6/2011

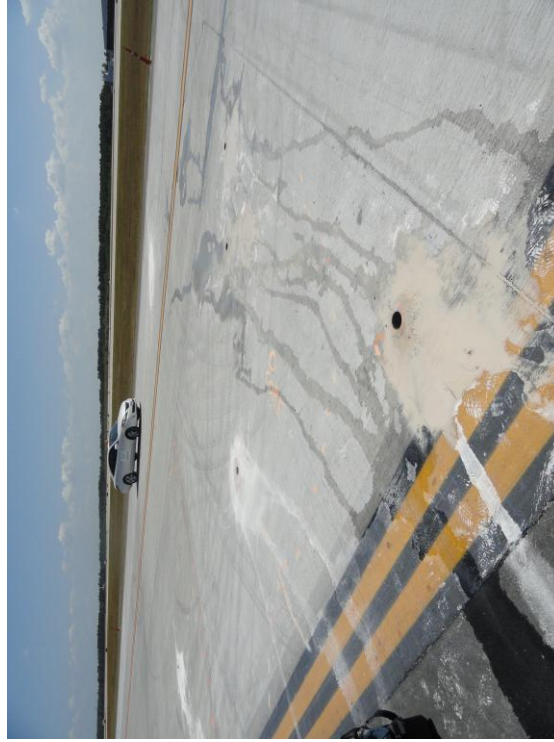
Defects	Notes	Backsurface	Reinf. Detail	V <sub>shear</sub> = 2885 m/s X-step: 200 mm Y-step: 100 mm Max Depth: 1000 mm Frequency: 50 kHz Houston, TX IAH IAH 6.13-2 Sta 82+75 T/W W A E TAMU/TTI 6/2011
Significant debonding at at runway/subbase (7.1" deep), verified by coring. Possible further debonding in deeper layers (25.6" and 37.5" deep).	Area tested because of surface cracking, hammer sounding revealing possible delaminations. Image is of typical runway segment.	Top layer of pavement approximately 7.1" below surface, second layer 25.6" below surface, third layer 37.5" below surface.	None

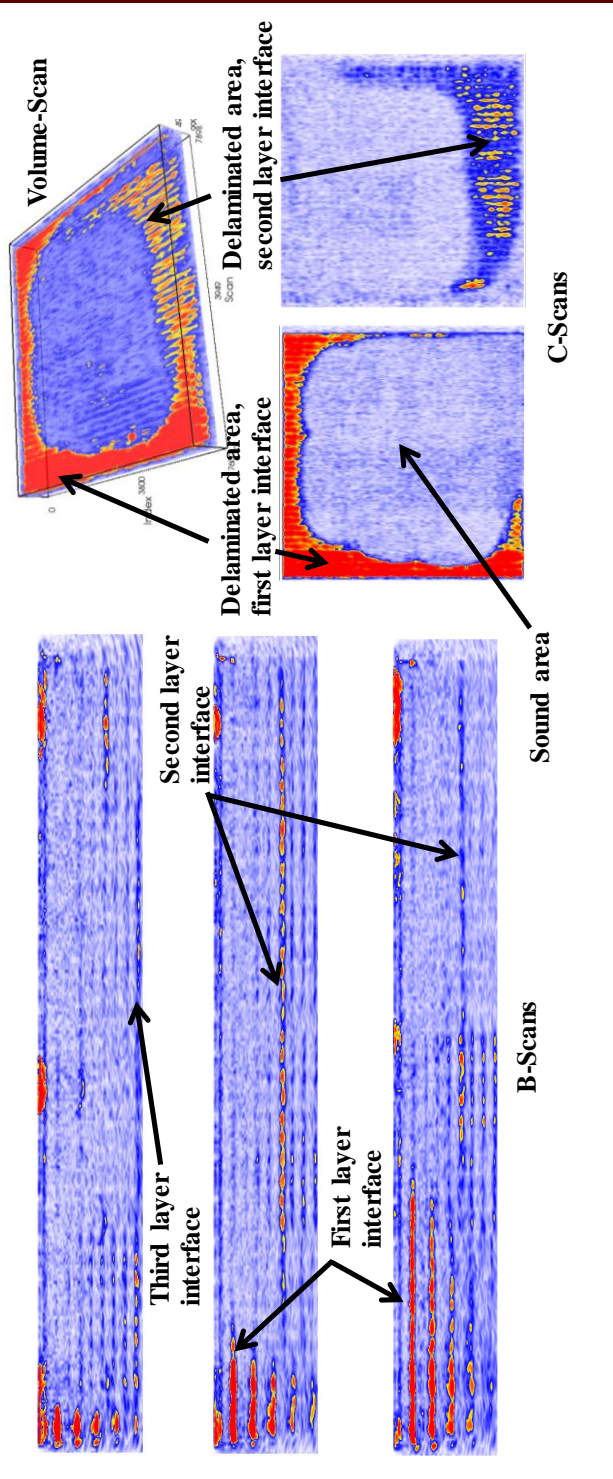
Defects	Notes	Backsurface	Reinf. Detail	V <sub>shear</sub> = 2885 m/s X-step: 200 mm Y-step: 100 mm Max Depth: 1000 mm Frequency: 50 kHz
Significant debonding at at runway/subbase (7.1" deep), verified by coring. Possible further debonding in deeper layers (25.6" and 37.5" deep).	Area tested because of surface cracking, hammer sounding revealing possible delaminations.	Top layer of pavement approximately 7.1" below surface, second layer 25.6" below surface, third layer 37.5" below surface.	None	Houston, TX IAH IAH 6.13-2 Sta 82+75 T/W W A E TAMU/TTI 6/2011
