**Assessing the quality of retrofits in solid wall dwellings**

Journal:	<i>International Journal of Building Pathology and Adaptation</i>
Manuscript ID	IJBPA-05-2017-0022.R1
Manuscript Type:	Original Article
Keywords:	Domestic energy efficiency, Moisture, Policy, Retrofit, Survey, Unintended consequences

The purpose of the paper is to provide a detailed appraisal of the quality of domestic retrofits.

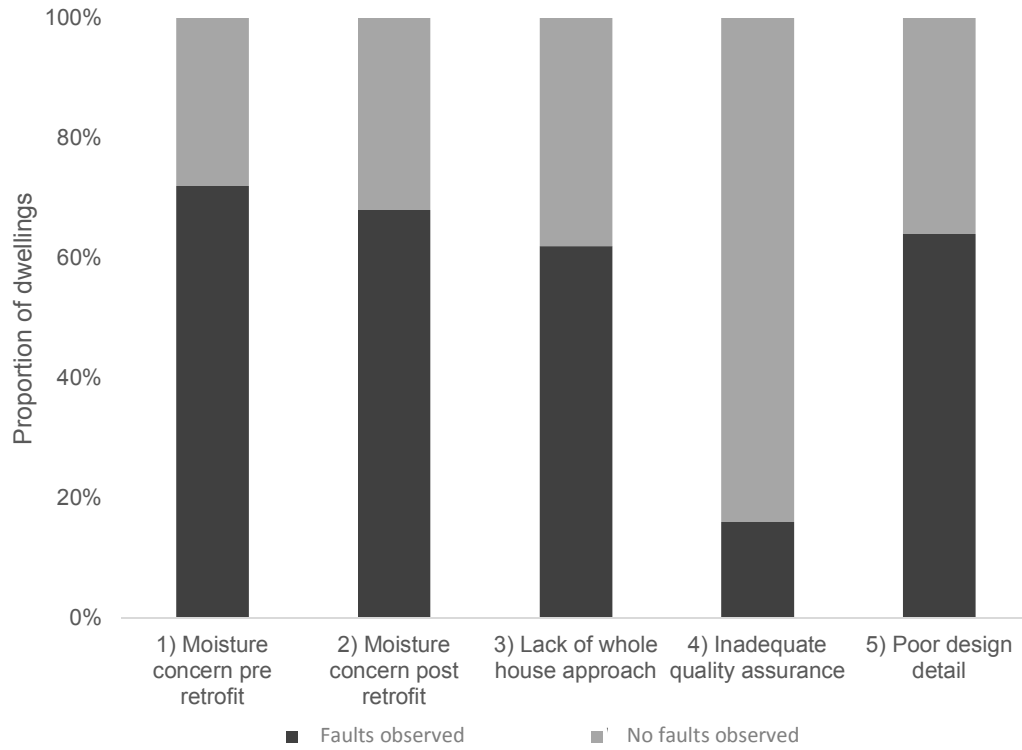
From this process five retrofit failure categories emerged which characterised the vast majority of all the observations; 1) Moisture issues pre retrofit, 2) Moisture risk post retrofit, 3) Lack of whole house approach, 4) Inadequate quality assurance, 5) Insufficient design detail. Figure 1 shows the proportion of homes exhibiting each of the 5 issues; the majority exhibited multiple failure types. The following sections describes each category in turn.

Figure 1 suggests 72% of the properties had damp issues prior to installation, an example of which is shown in Figure 2. Mould was observed to generally be removed prior to applying IWI, though not for EWI. Remedial action to address causes of damp was not seen to be systematic and only observed in the 'deep' retrofits. Table 3 describes the types of issues observed.

Figure 1 Proportion of dwellings with observed faults
