Integrated Approach for Post-fire Reinforced Concrete Structures Assessment

RESEARCH ARTICLE

Abstract

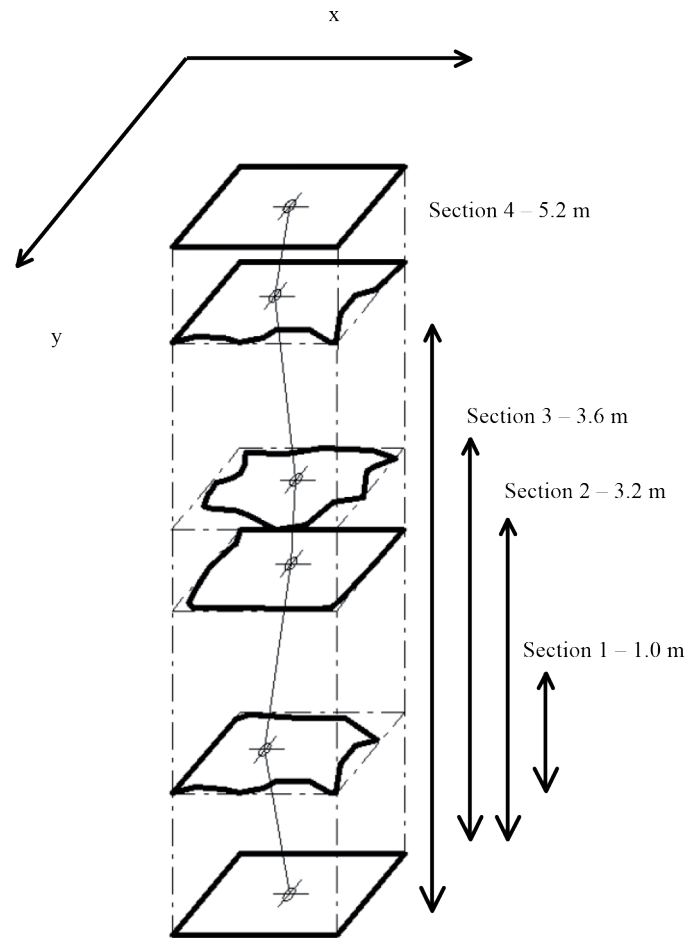
Fig. 11 Scheme of column cross-section center-of-gravity detection.

Concerning the central columns (8 and 5), it was possible to record the whole perimeter, while in the case of lateral columns (4,6,7,9), only one side was exposed to the fire and consequently recorded. In the latter case, the centre-of-gravity position was determined considering design characteristics for the other 3 sides. In this way, it was possible to study the variation of this position through column height, see Figure 12. In this Figure, the effect of the fire-induced deformation is clearly visible and tends to concentrate centre-of-gravity position variations in the central part of the column (Sections 2 and 3, see Figure 11), confirming the assumptions of constrained ends for each column. Column 6, characterized by a 90×50 cm cross-section, was dramatically hollowed-out during the fire and presents the most important variations, equal to 40 mm in x direction and 12 mm in y direction. It is important to mention that the position of the centre of gravity is influenced by section damage, and in particular for Column 6, these displacements do not necessarily involve deformation of the non-exposed sides. Columns 8 and 5, characterized by a 68×50 cm cross section, were exposed along their whole perimeter but present

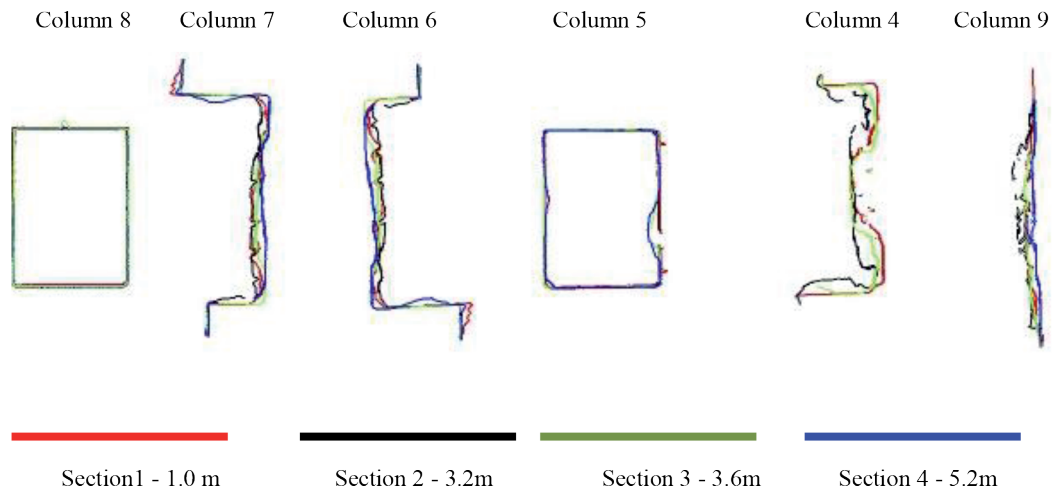
Fig. 13 Fire-exposed side of column cross-sections at different heights, recorded by means of a laser scanner.

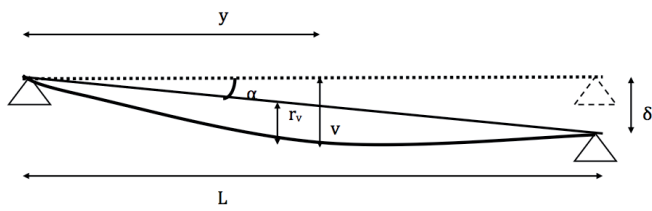
Fig. 14 Scheme of beam constraint displacement.

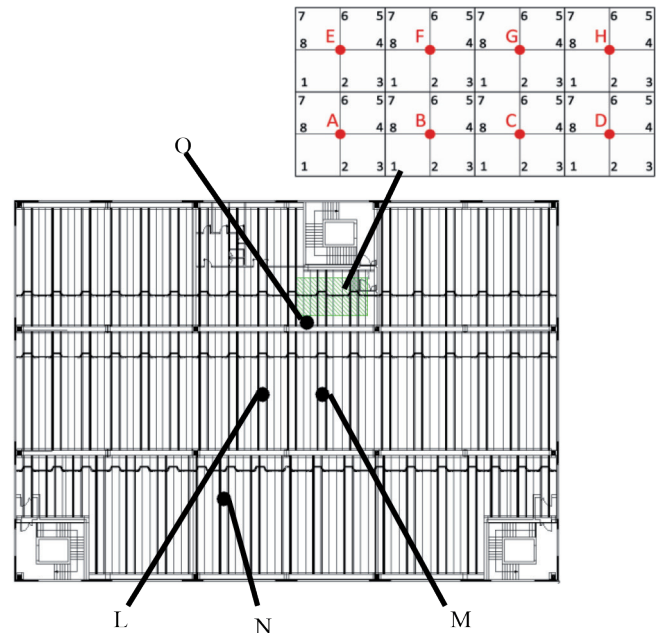
Fig. 16 First floor slab Sonic Tomography and ultrasound test positions.

From the data reported in Figure 17, it is clear that the most highly damaged area corresponds to left points A and E, which present the lowest speed (2000–2400 m/s). Indeed, it is well known (see [21]) that damage significantly reduces the speed of sonic pulses. On the other hand, points H and D present the highest speed value (3800 m/s) and are located in a corner of the slab, near the stairwell. The latter points were probably less exposed to the fire and consequently reached lower temperatures than the ones (points A and E) located in the centre of the slab.

Furthermore, four cylindrical core samples of 6 cm diameter were taken from the slab at points represented by the circular black spots in Figure 16 by means of an HILTI corer DD 130. An ultrasound direct test was performed on these cores, obtaining the results presented in Table 3. These results confirm degradation of the central part of the slab corresponding to the area around beam T4.

Slab core (points O,N,L,M, see Figure 16) compressive strength test results confirms the difference in mechanical concrete characteristics between the slab cast on site and precast

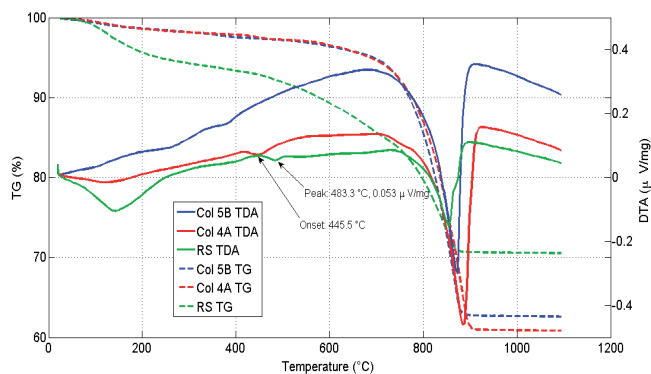
Fig. 24 Multi-plot of TG-DTA curves of selected samples (COL 5B, COL 4A (Sp a) and RS, see Table 9).

Table 10 reports some important diagnostic features of fire-affected concrete, determined by XRD and TG-DTA. This table also shows changes in mechanical strength at different temperature ranges. X-Ray diffraction patterns of the most highly-altered samples consist of calcite and dolomite. Calcite, dolomite, portlandite, ettringite and anhydrous calcium silicates and calcium aluminates were recognised in the RS sample.

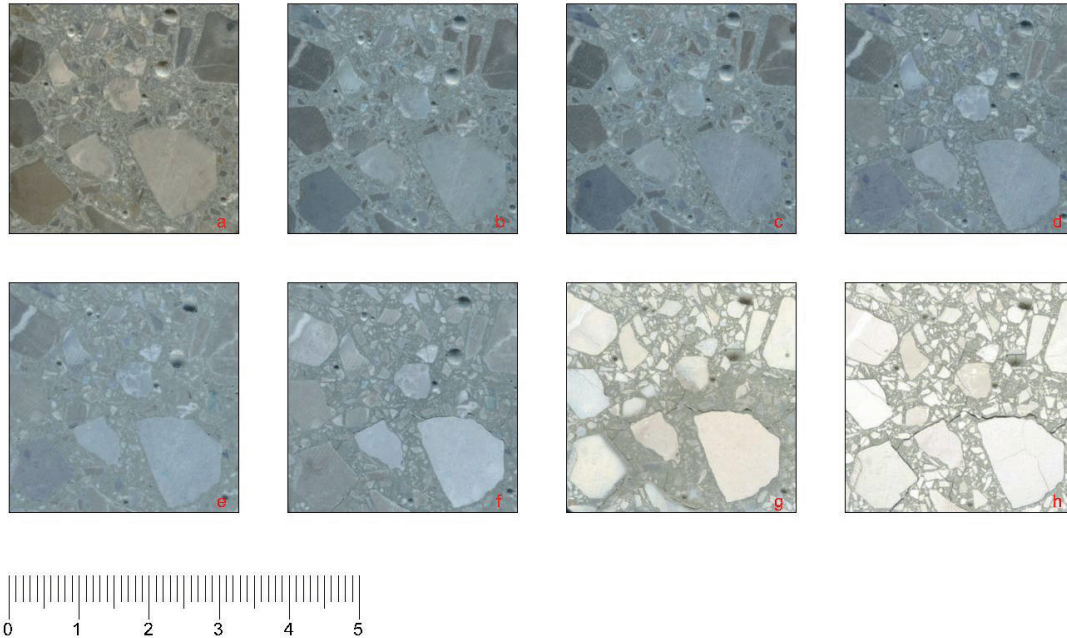
Fig. 25 Concrete slabs before and after thermal treatment; (a) untreated; (b) TT 200°C; (c) TT 300°C; (d) TT 400°C; (e) TT 500°C; (f) TT 600°C; (g) TT 700°C; (h) TT 800°C. The bottom-left scale is in cm.

In particular, the reddening of original pinkish-beige aggregates in the $300\text{--}400^\circ\text{C}$ range and the considerable lightening of concrete starting from approximately 700°C are the most relevant changes connected with temperatures.

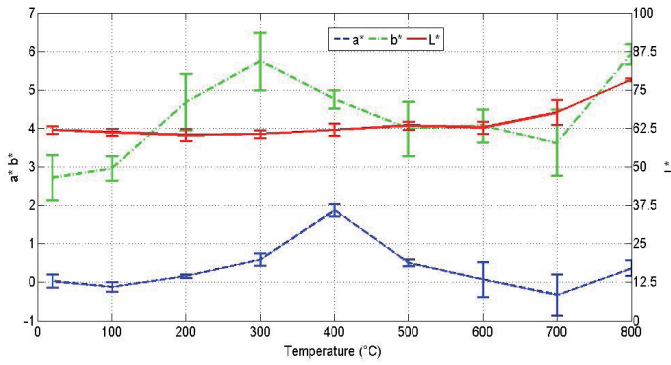
Fig. 26 Average values of L^* , a^* and b^* vs temperature (cement matrix of the RS sample). The error bars represent the standard deviation for each measure.

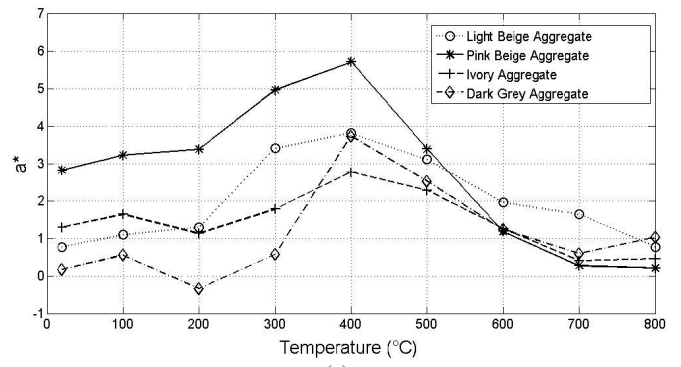
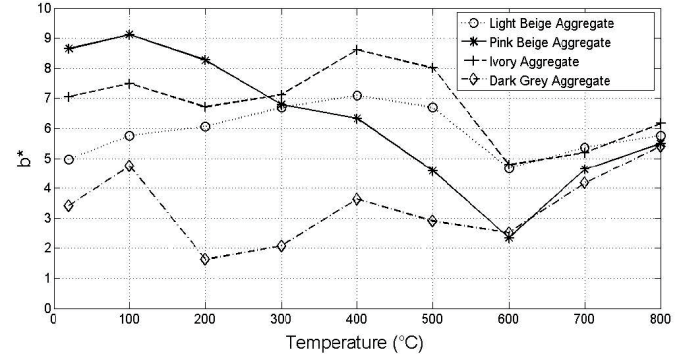
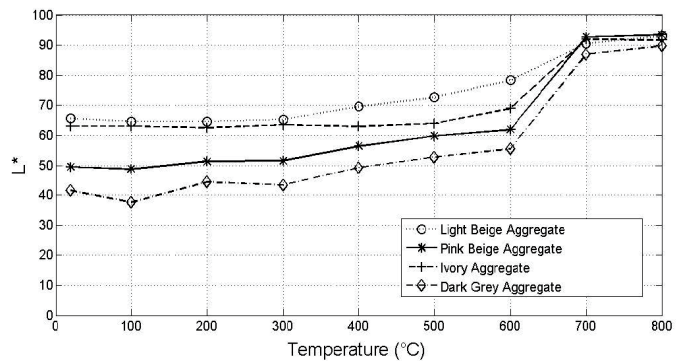
Fig. 27 Average values of L^* , a^* and b^* vs temperature (aggregates in the RS sample).
