Gonzalez-Longo, Cristina (2008) *Conserving, Reinstating and Converting Queensberry House*. In: Proceedings 8th International Seminar on Structural Masonry (ISSM 08). UNSPECIFIED. ISBN 978-975-561-342-0

# **Conserving, Reinstating and Converting Queensberry House**

## Cristina GONZÁLEZ-LONGO<sup>1</sup>

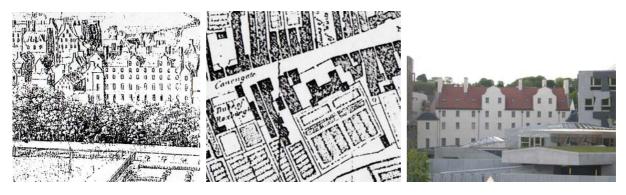
There is a drawing by Thomas Sandby from ca. 1740 showing Queensberry House in a Panorama of Canongate from Salisbury Crags as well as the plan of Edgar from 1742 showing the house in this period. These were considered in the conservation project as enough evidence to inform the reinstatement of the Dutch gables and ogee roofs to the pavilion towers of Queensberry House (Fig 4).

Figure 4. [a] View by Thomas Sandby [b] Plan of William Edgar, 1742 [c] South façade after the works
