APOLLO 15 MAIN-PARACHUTE FAILURE

By Donald D. Arabian and Joseph E. Mechelay*

ABSTRACT

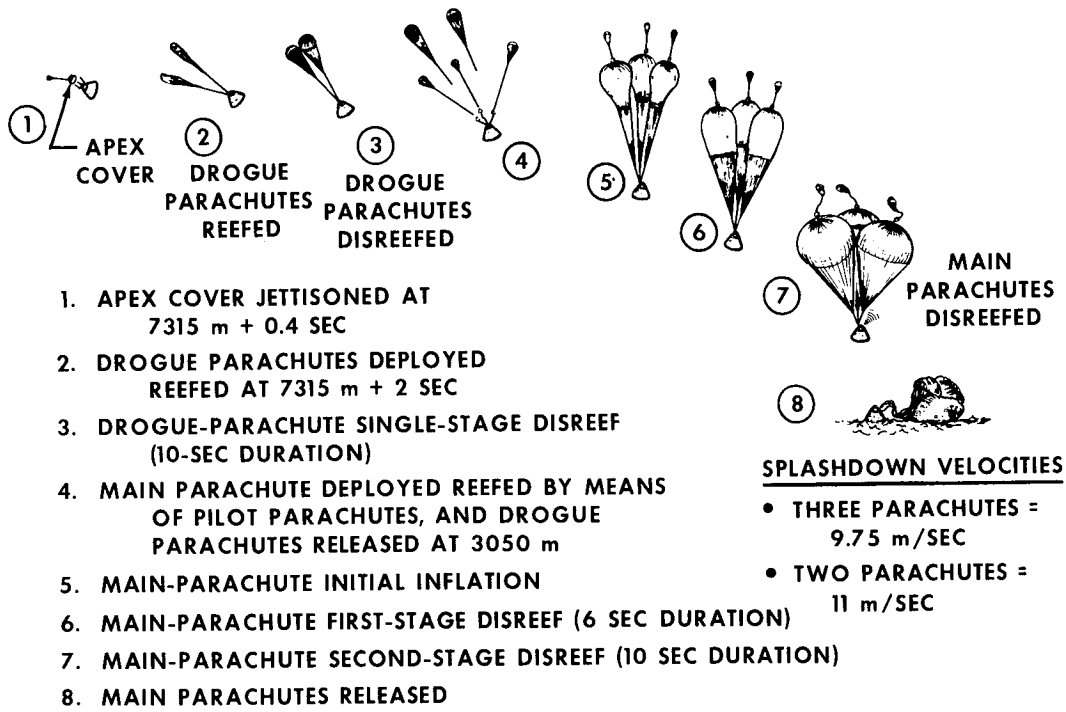
Trajectory analysis. - The landing sequence was initiated at a nominal altitude of 7315 meters with jettisoning of the forward heat shield (fig. 5), which is used to protect the parachute system. Immediately after separation of the heat shield from the command module, a 2.19-meter-diameter parachute was mortar deployed from the forward heat shield, an action that augments separation of the heat shield from the command module. Following a drogue- and pilot-parachute deployment sequence, the main parachutes are deployed and decelerate the command module to its final descent velocity of approximately 9 m/sec. The descent rate of the 172-kilogram forward heat shield is approximately 31 m/sec.

Figure 5. - Earth landing system normal sequence.
