THE HELIOS EXPERIMENT 5 ANTENNA MECHANISM

by E. J. W. Müller, Dipl.-Ing.

DFVLR-BPT, Germany

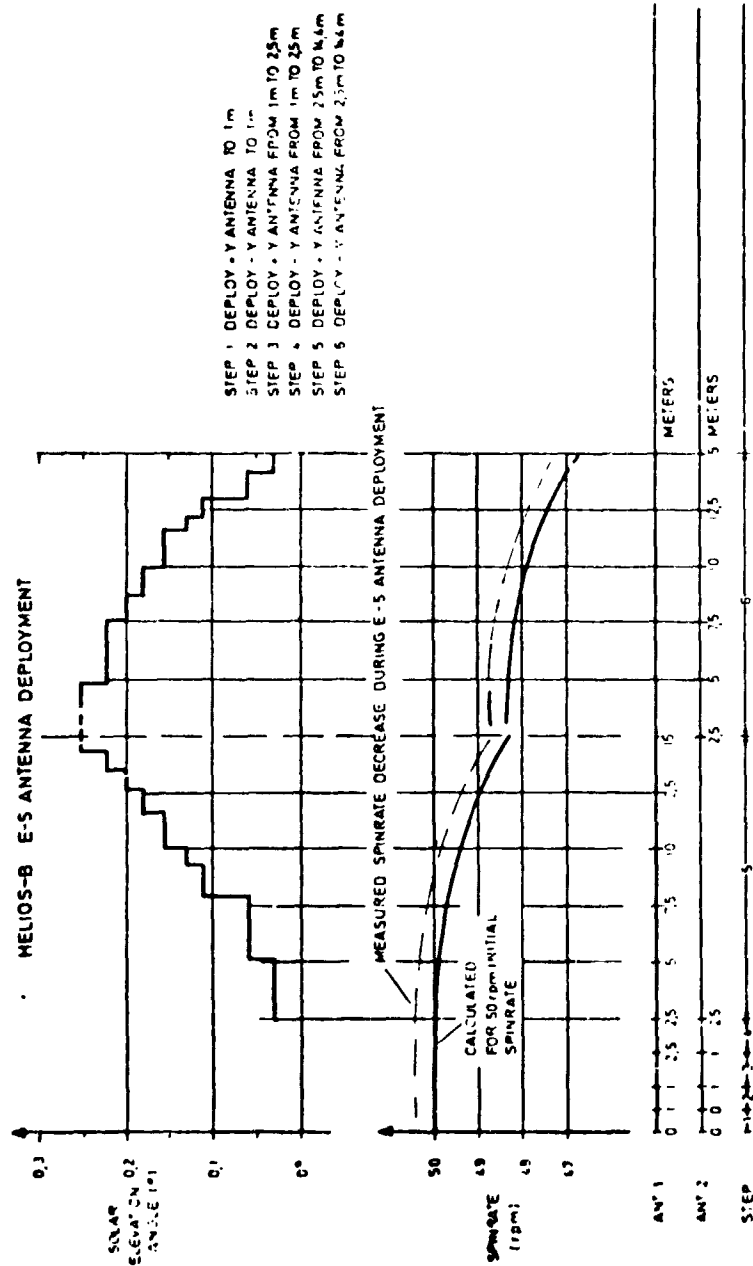
Fig. 4 HELIOS B Experiment 5 antenna deployment steps 1 to 6

Steps 1 to 6 of the deployment were performed successfully on the first day of the HELIOS B mission. All above-mentioned parameters were monitored and plotted and did not deviate from the predicted values. Figure 4 shows the plot of the spacecraft spin rate and solar deviation angle as function of deployed antenna length. Steps 7 and 8 were performed successfully during the third Goldstone pass on the third day of the mission.
