BLADE DESIGN AND OPERATING EXPERIENCE
ON THE MOD-OA 200 KW WIND TURBINE
AT CLAYTON, NEW MEXICO

Bradford S. Linscott and Richard K. Shaltens
NASA Lewis Research Center
Cleveland, Ohio

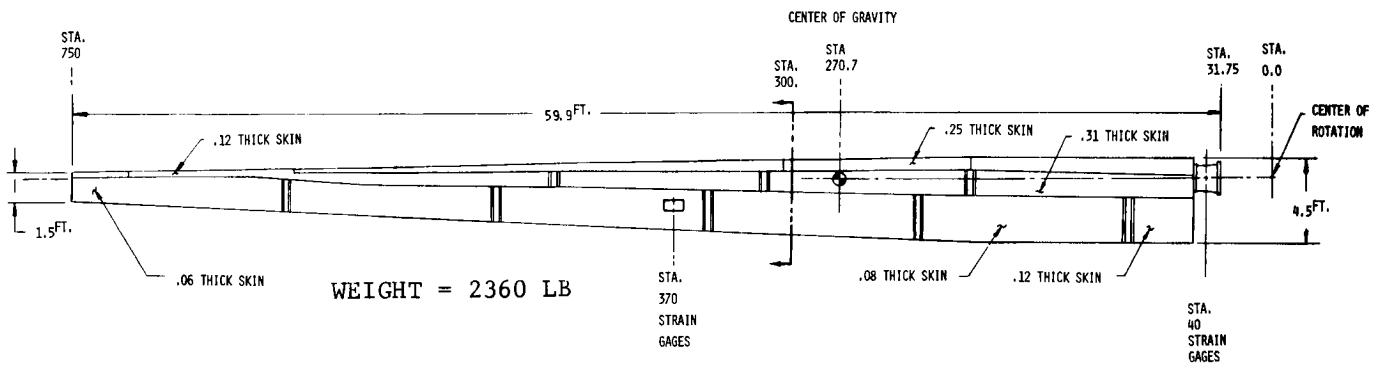
Figure 1. - MOD-0A blade configuration - planform.

The blade specifications are summarized in Table I. The specifications include the blade dimensions, materials, the airfoil type and the flapwise and chordwise cantilever natural frequencies. The planform of the blade is shown in figure 1. Strain gages are located at the root end and at blade midspan. The strain gages are used to measure the flapwise and chordwise bending moments and torsion. An ice detector is located at mid span. The ice detector provides a signal, during ice build up, that initiates the shutdown of the wind turbine. A twenty-four hole bolting flange at the root end of the blade provides the mechanical interface between the blade and hub of the wind turbine. A fifty-five pin standard electrical connector provides the electrical interface. The connector provides the electrical needs for the strain gages and the ice detector.

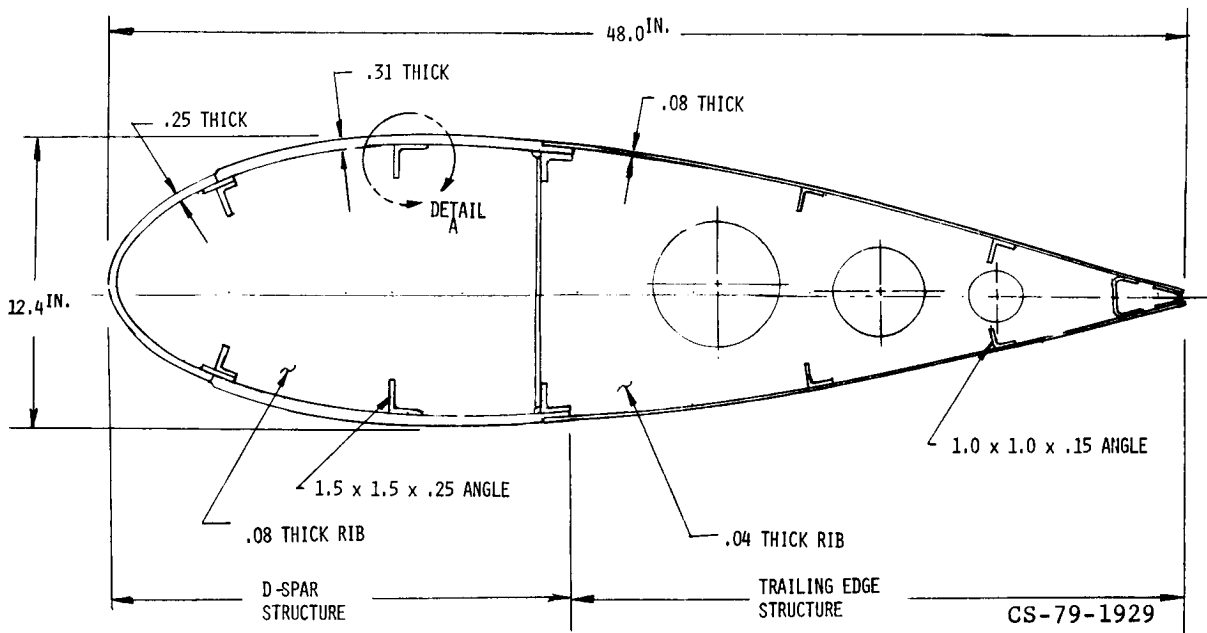
Figure 2. - MOD-0A blade typical cross section.

Figure 2 shows a cross section of the blade, taken at sta 300, also called out in figure 1. The forward portion of the cross section is called the D-spar. The aft portion of the cross section is called the trailing edge. The D-spar is a heavier and stronger portion of the blade and as a result it carries the majority of the applied loads. Angle stringers and ribs, shown in figure 2, are needed to prevent panel buckling, of the .08 inch and the .31 inch thick outer skins, due to compressive loads.

BLADE SECTION TAKEN AT STA. 300.

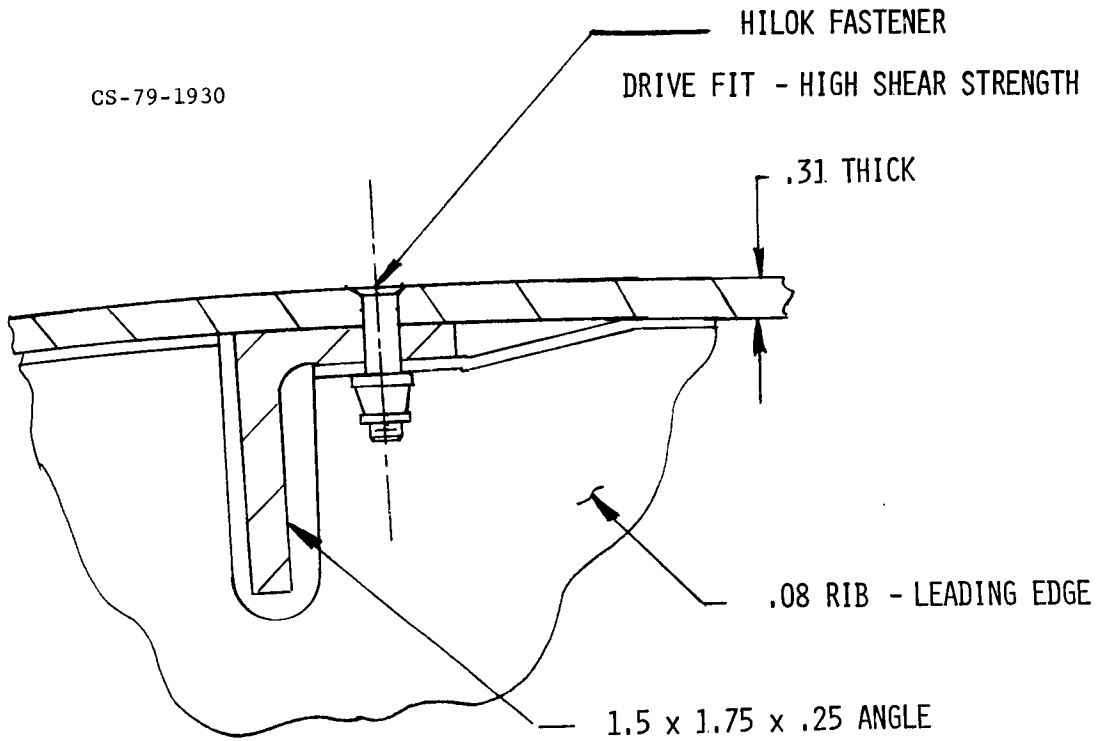
Figure 3. - MOD-0A blade fastener detail A.

Detail A, called out in figure 2, is shown in figure 3. A typical method of attaching the angle stringers to the D-spar skin and rib is shown in figure 3. The steel Hilok fastener is an aircraft type of high strength bolt. Close tolerance holes must be prepared so that there is an interference fit between each fastener and the hole. The interference fit allows the Hilok fastener to carry high shear loads. Aluminum rivets are typically used in the trailing edge portion of the blade.

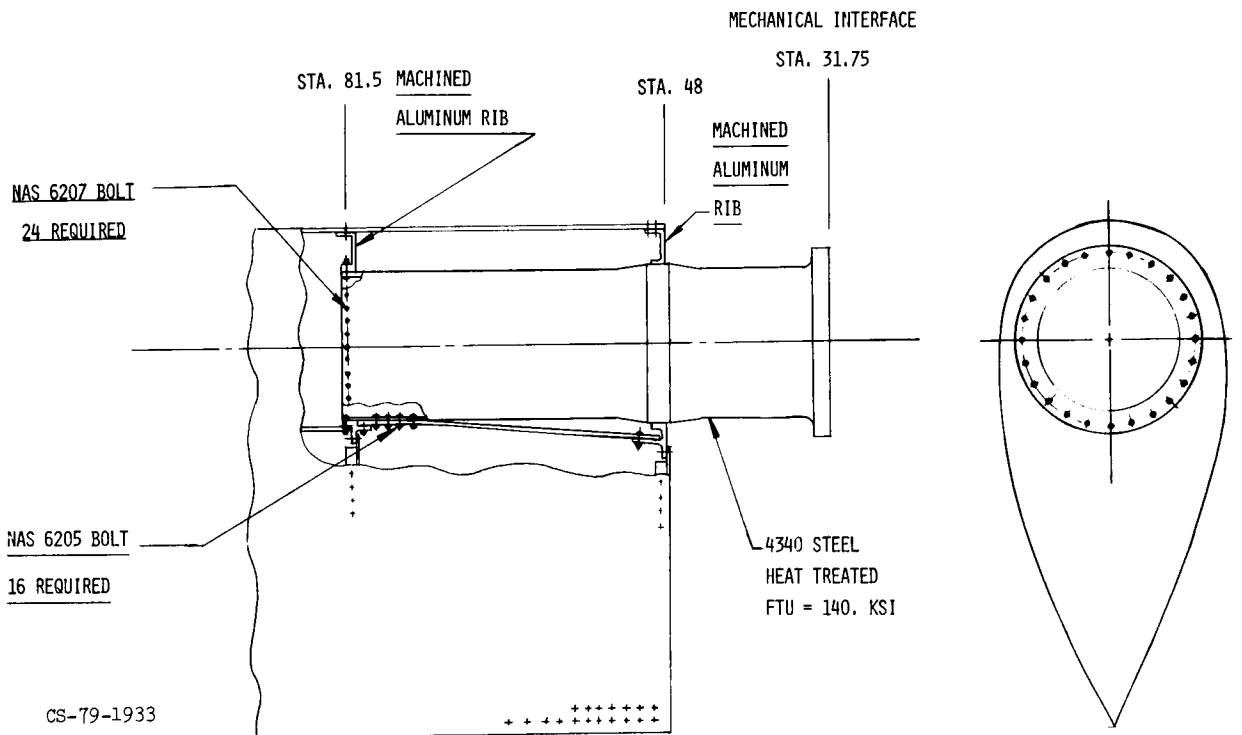
Figure 4. - MOD-0A blade root end details.

Figure 4 shows the design details of the root end of the blade. A steel cylindrical tube slides through the rib at station 48 and is bolted to the rib at station 81.5 and is bolted to the web near station 81.5. The flange at station 31.75 provides the mechanical interface to the hub of the wind turbine.
