99th Congress, 2d Session ----- House Report 99-1016

**INVESTIGATION OF THE CHALLENGER
ACCIDENT**

**COMMITTEE ON
SCIENCE AND TECHNOLOGY
HOUSE OF REPRESENTATIVES**

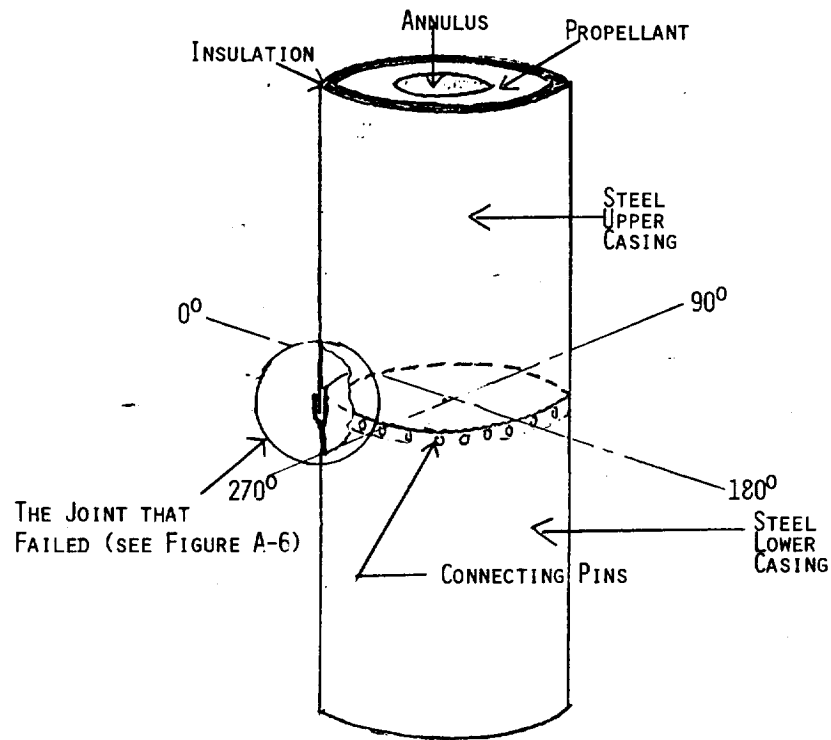
FIGURE V-5

Considerable reference will be made to the "joint design" throughout this section of the report. Consequently, the following description of the joint is provided. (See Figures V-5 thru V-7.)

A. JOINT IN NORMAL ALIGNMENT
(NO GAPS BETWEEN O-RINGS AND TANG)

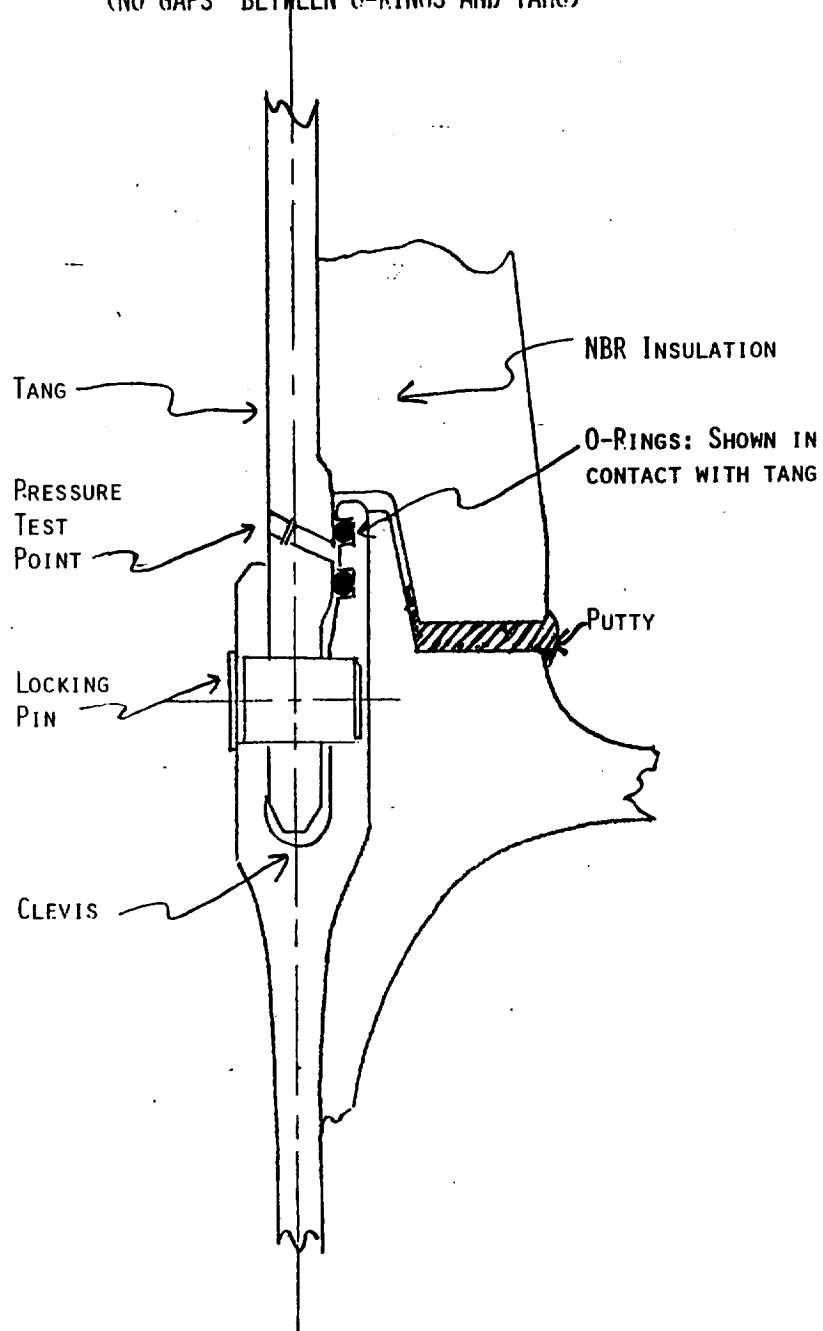
B. JOINT ROTATED
(OUT OF ALIGNMENT)

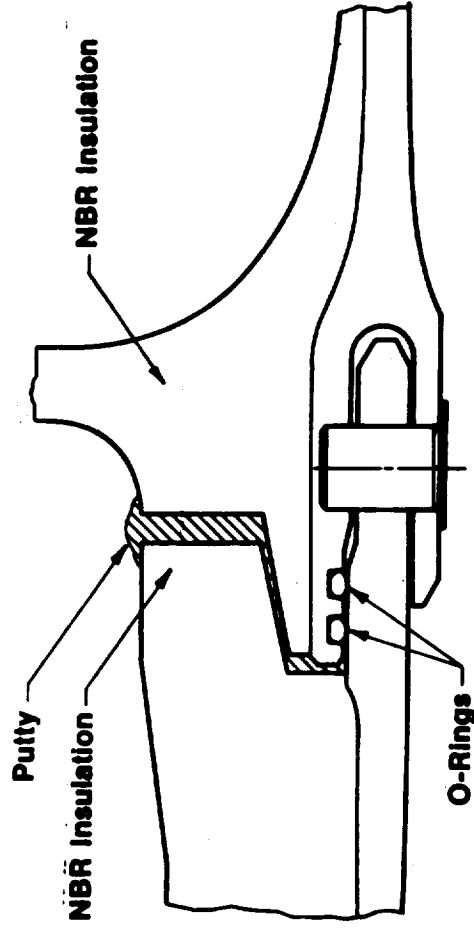
Figure 1

An analysis will be performed to assess the results of the FWC-SRM field joints as they compare to the HPM-SRM field joint. The field joints are shown in figures 1 and 2 for HPM-SRM and FWC-SRM, respectively.

SRM-HPM Field Joint

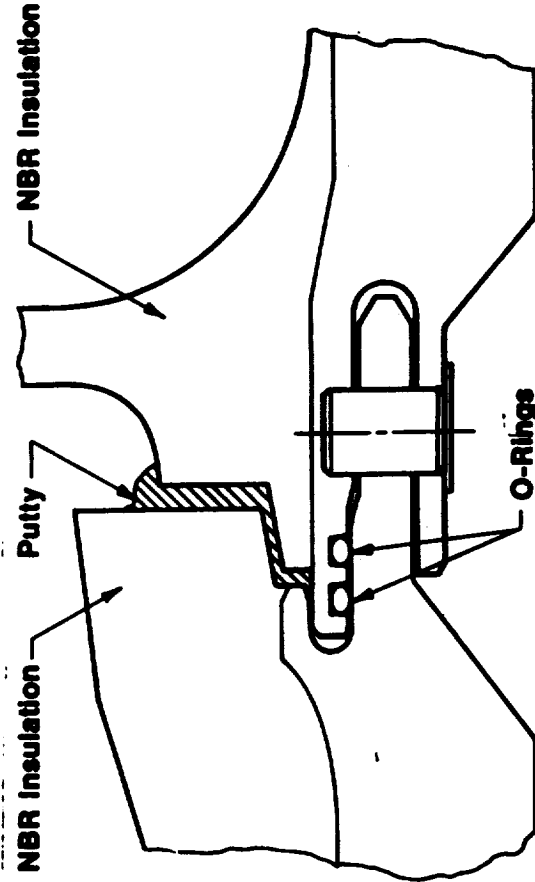
Figure 2

FWC-SRM Field Joint

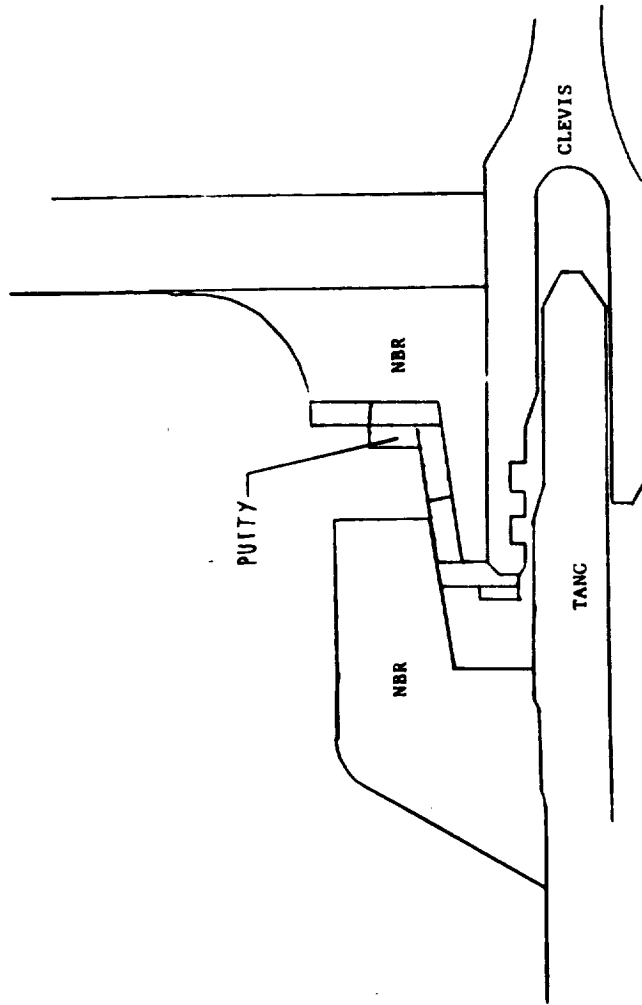
Figure 1

- a. Subscale and full scale tests to determine effects of asbestos filled, cotton and talc filled, and non-filled zinc chromate putty on O-ring sealing integrity.
- b. Full scale tests:
 - (1) Putty layup tests using current layup design.
 - (2) Putty layup tests using the attached figure 1 layup concept.
 - (3) Putty layup tests using the attached figure 2 layup concept.

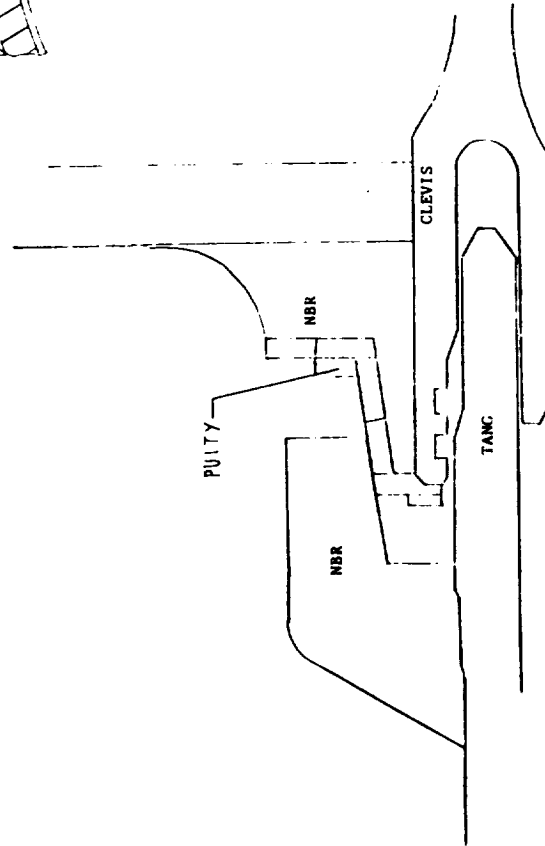
Figure 3

(4) Repeat tests (1) and (2) except with vent slots located at 120-degree interval around the circumference as shown by attached figures 3 and 4. The slots are designed to prevent air entrapment and resulting volcanoes. Evaluation of layup effectiveness should be performed with flow meters to determine cavity volumes.
