# DETECTION, LOCATION, AND CLASSIFICATION OF SPACE SHUTTLE MAIN ENGINE NOZZLE LEAKS BY TRANSIENT THERMOGRAPHIC INSPECTION

Samuel S. Russell  
Nondestructive Evaluation Team  
NASA Marshall Space Flight Center  
256-544-4411  
[sam.russell@msfc.nasa.gov](mailto:sam.russell@msfc.nasa.gov)

James L. Walker  
Center for Automation and Robotics  
University of Alabama in Huntsville  
256-890-6578 ext. 207  
[walkerj@email.uah.edu](mailto:walkerj@email.uah.edu)

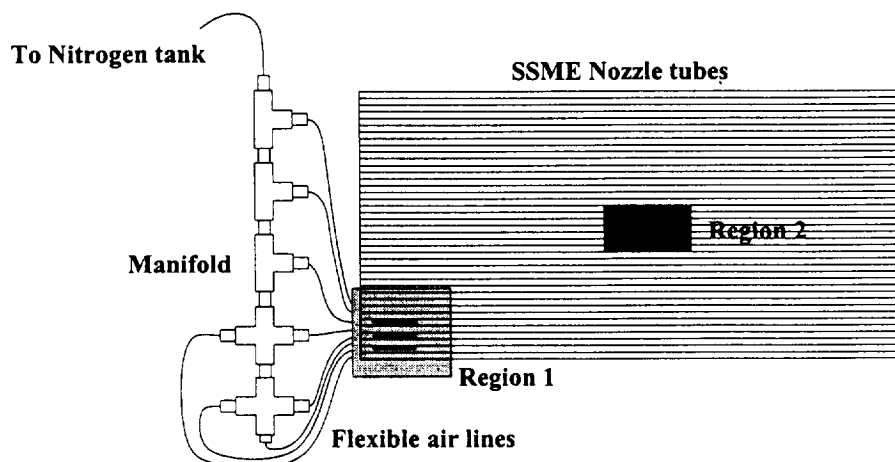
Figure 4. Configuration for panel from lower nozzle region with manufactured leaks.

Artificial defects were fabricated into a nozzle segment cut from the lower region of a scrap SSME nozzle including the eighth and ninth hat bands. By cutting open the tubing on the hot wall side of the nozzle, then puncturing the tube into the interstitial region and finally resealing the tube with a cover patch through a welding operation, phantom defects were fabricated, see Figure 4. The leak type and interstitial location were determined by individually pressurizing each tube and checking with leak solution.

In all cases no surface leaks were detected with leak check solution. For brevity only results for Region 1 are presented.

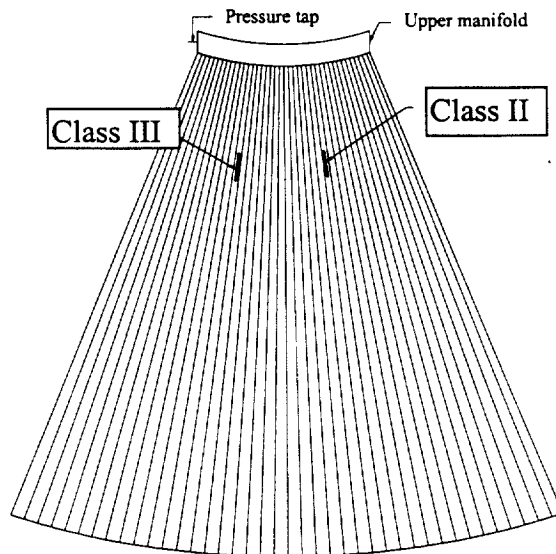
Figure 7. Location of defects in panel cut from the upper portion of a nozzle.

A second panel cut from the upper end of a nozzle was prepared with artificial weld defects that were classified as Class II and Class III as shown in Figure 7. The cooling tubes grow continuously from the top to the bottom of the nozzle creating a somewhat different problem at the top because of the much smaller tubes and interstitials. The Thermograms generated by rapidly (< 2 seconds) pressurizing the segment with 40 psig Nitrogen are shown in Figure 8. The difference between a Class II leak on the right and a Class III on the left is very apparent.
