HUBBLE SPACE TELESCOPE METALLIZED TEFLON® FEP THERMAL CONTROL MATERIALS: ON-ORBIT DEGRADATION AND POST-RETRIEVAL ANALYSIS

J.A. Townsend¹, P.A. Hansen¹, J.A. Dever², K.K. de Groh²,
B. Banks², L. Wang³ and C. He³

1. NASA Goddard Space Flight Center, Greenbelt, Maryland, 20771 USA
2. NASA Lewis Research Center, Cleveland, Ohio 44135 USA
3. Unysis Corporation, Lanham, Maryland 20705 USA

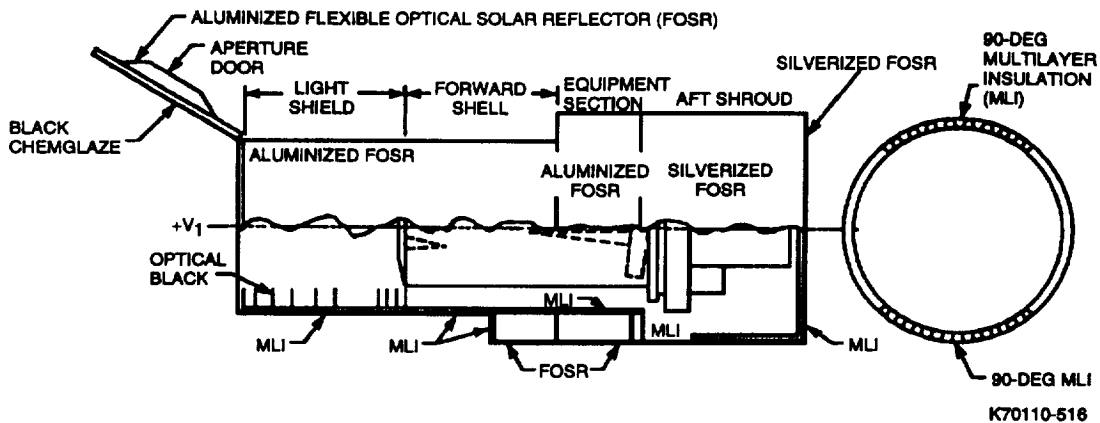
Figure 1. Location of Hubble Space Telescope Thermal Control Materials

FIGURE 1: LOCATION OF HUBBLE SPACE TELESCOPE THERMAL CONTROL MATERIALS
 In this image, Flexible Optical Solar Reflector (FOSR) is defined as metallized Teflon films used either as the top layer of MLI blankets or as tapes on radiator surfaces. MLI blankets were used on the entire Light Shield and most of the Forward Shell and Equipment Bays (Equipment Section). Tapes were used on the Aperture Door, a few locations on Equipment Bays, the entire Aft Shroud, and Aft Bulkhead (bottom of the telescope).
