ON-ORBIT TEFLON® FEP DEGRADATION

Jacqueline A. Townsend, Patricia A. Hansen
NASA/GSFC
Greenbelt, Maryland 20771
301-286-6685
jacqueline.a.townsend.1@gsfc.nasa.gov
patricia.a.hansen.2@gsfc.nasa.gov

Joyce A. Dever
NASA/LeRC
Cleveland, Ohio 44135
joyce.a.dever@lerc.nasa.gov

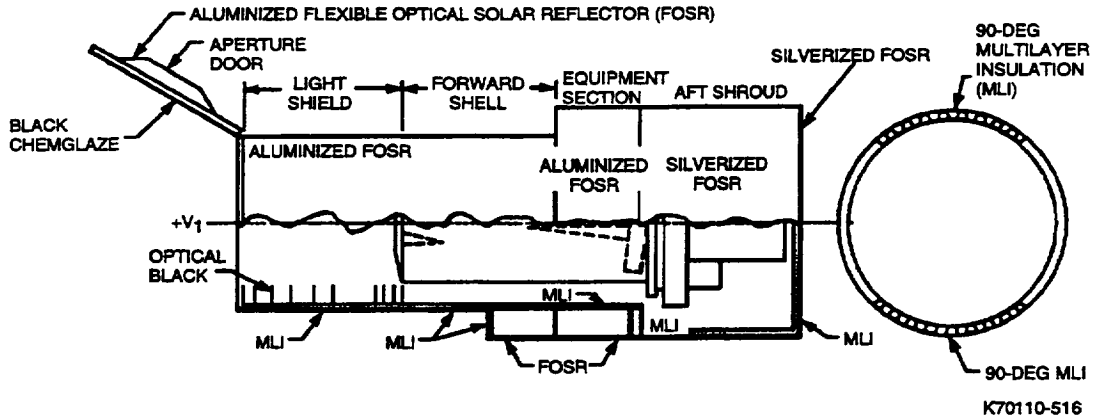
FIGURE 1: LOCATION OF HUBBLE SPACE TELESCOPE THERMAL CONTROL MATERIALS
 In this image, Flexible Optical Solar Reflector (FOSR) is defined as metallized Teflon films used either as the top layer of MLI blankets or as tapes on radiator surfaces. MLI blankets were used on the entire Light Shield and most of the Forward Shell and Equipment Bays (Equipment Section). Tapes were used on the Aperture Door, a few locations on Equipment Bays, the entire Aft Shroud, and Aft Bulkhead (bottom of the telescope).
