EVALUATION OF A COMPRESSION-LOADED-STITCHED-MULTI-BAY FUSELAGE PANEL WITH BARELY VISIBLE IMPACT DAMAGE*

Donald J. Baker
Vehicle Technology Directorate - ARL
NASA Langley Research Center
Hampton, Virginia 23681

Jian Li
Structural Integrity Department
The Boeing Company
Mesa, Arizona 85215

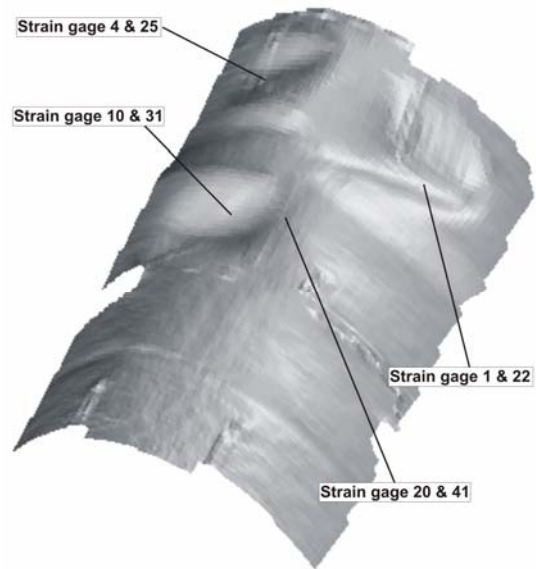
Figure 9a – Deformed shape of panel at $N_y = 1.63P_{cr}$.

The deformed shape of the panel at $N_y = 1.63P_{cr}$ (last image before failure) is shown in Figure 9a along with the strain gage locations where the results are given in Figures 9b through 9f. Strain results from gages 1 & 22 in the first bay to buckle are shown in Figure 9b. This figure and subsequent figures will include strain gage results from before impact, after impact, and strain results extracted from the VIC-3D images taken during the test to failure after impact. The critical buckling load, P_{cr} , used to normalize the data is the actual buckling load determined in the test. The critical buckling load for the post-impact test is approximately 97% of the buckling load for the before impact test. Results shown in Figure 9b indicate bending in the panel starts at approximately $N_y = 0.65P_{cr}$. The results for the gages from before and after impact are identical from initial loading to failure. The strain results extracted from VIC-3D, shown by the curve with a diamond symbol in Figure 9b, also match the strain, determined by strain gages to the buckling load. From the buckling load to failure the VIC-3D strain data deviates from the gage data by increasing at a higher rate than the strain gage results as load increases to failure. One possible explanation for this deviation is that as the buckle grows deeper the surface that is being photographed is approaching the limits of the depth of field for the particular camera/lens setup.

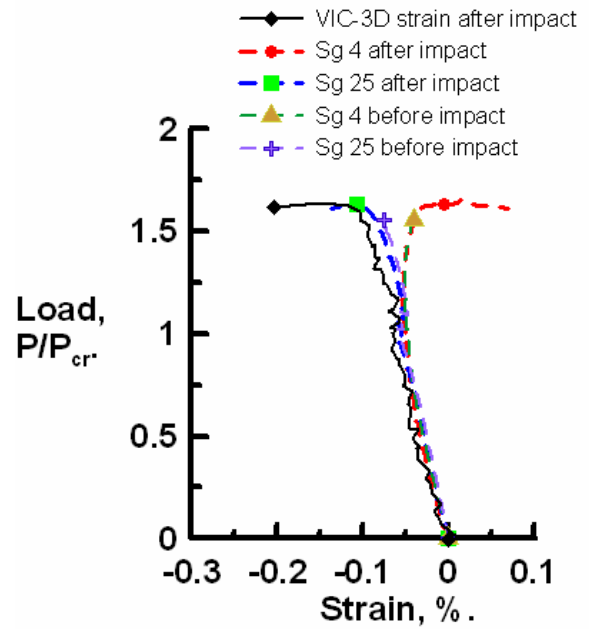
Figure 9c - Strain as a function load for strain gages 4 and 25.

Strain results for the upper L/H bay are shown in Figure 9c. The strain gage results for gages 4 and 25 from before and after impact appear to be identical. The bay started to bend at approximately $N_y = 1.2P_{cr}$ and continued to bend until failure. The strain results identified by a line with a diamond symbol was extracted from VIC-3D images compares well the strain gage data up to failure.

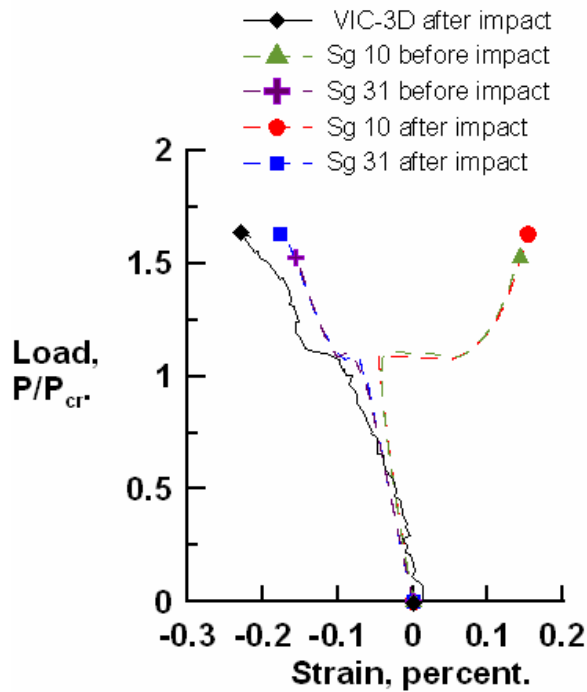
Figure 9d - Strain as a function load for strain gages 10 and 31.

Results at the point when the second bay buckles (middle L/H side) are shown in Figure 9d, for strain gages 10 and 31. The strain gage results from before impact test and after impact test match up to the failure point. The strain computed from the VIC-3D images compared well with the strain gage results up to the buckling point of the bay. The VIC-3D results indicated a step in the strain when the bay snapped into a single half wave of approximately twice the strain indicated from the strain gages and then maintained approximately the same slope as the strain gages.

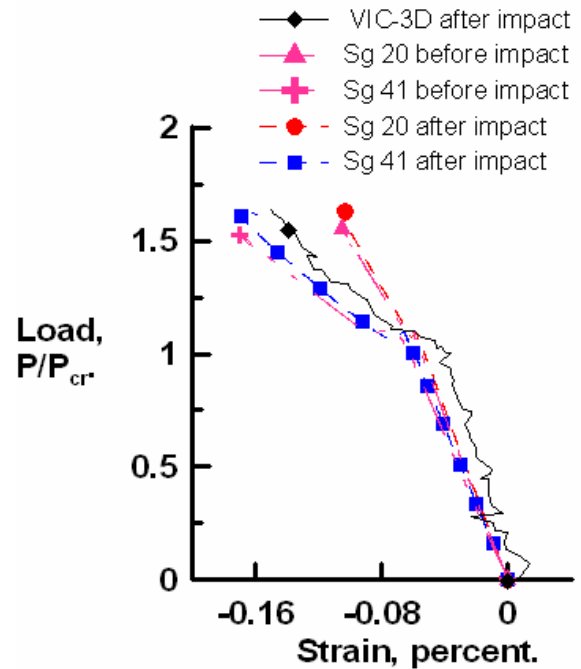
Figure 9e – Strain as a function of load for strain gages 20 and 41.

The result for strain gages 20 and 41, which are back-to-back gages located on the centerline stringer flange (gage 20) and OML (gage 41) at the panel center, are shown in Figure 9e. The strain gage (41) on the skin side indicates a step in the strain when the middle L\H bays buckle. The slope of the load-strain curve changes when the bay buckles and indicates an increasing strain on the OML side. Post-buckling stiffness of the skin is lower than the pre-buckling skin stiffness. The load strain curve extracted from the VIC-3D images is shown as a solid line with a diamond symbol and follows the same trend as strain gage on the OML side.

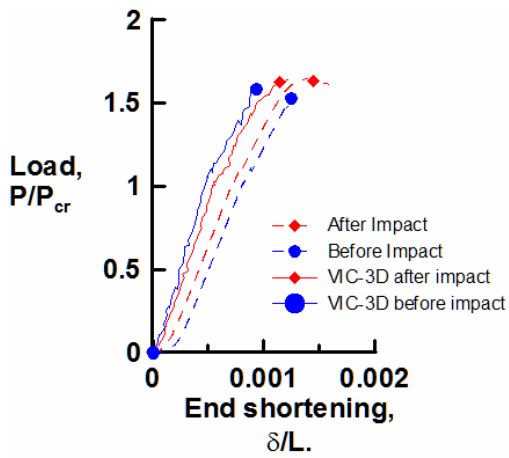
Figure 10 - Panel end shortening

The panel end shortening is shown in Figure 10. The dashed lines in Figure 10 are the results from LVDT data, while the solid line is for data extracted from the VIC-3D images. The end shortening per unit length for the LVDT data is determined by dividing the overall change in the distance between the platens by the panel unloaded length (28.4-inches). With the VIC-3D data the displacement and point location at two points is determined and the change in length is divided by the distance between the points.

A least squares fit has been calculated for each set of data from $P/P_{cr} = 0.1$ to 0.9 . There is a 2% difference between the slopes of the before impact and after impact curves as determined by LVDT's. As indicated in Figure 10, panel stiffness is higher as determined by the VIC-3D data than the stiffness determined from the LVDT data. The slope of the before impact VIC-3D curve is 135% of the slope of the curve for before impact with LVDT's. The slope of the VIC-3D curve for after impact is 87% of the slope for the before impact.
