## Ballistic Impact of Braided Composites with a Soft Projectile

### Abstract

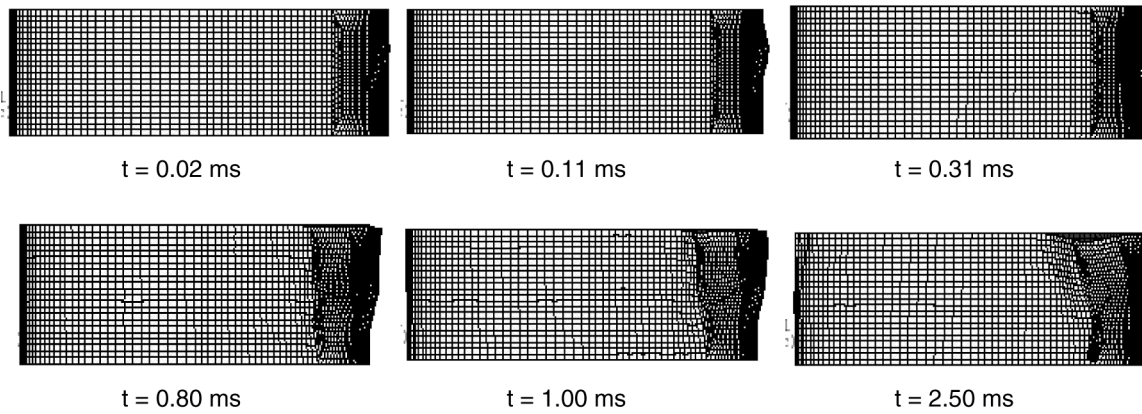
the ring represents the forward flange, which is connected to the inlet. Explicit finite element analysis (with no failure) was done to examine impact dynamics at an impact velocity of 183 m/s (600 ft/s). Projectile motion and ring deformation during and after impact are shown in Figure 2. Results of this preliminary analysis identified three time scales of interest. First, the initial contact of the disk with the ring and the subsequent rebound from this point (due mainly to rotation of the rigid projectile) occur at times less than 1 ms. Second, the continued motion of the projectile into the deforming ring and the rebound of the entire projectile from the ring occur over a time of about 1 ms. During this time interval the ring is subjected to the maximum strain energy density in a region near the impact site. Third, propagation of flexural waves around the ring occurs at times greater than 1 ms. Impact of quarter- and half-ring targets with free and fixed boundary conditions were also analyzed in the previous paper (Roberts 2002). Results indicated that the short time ( $< 1$  ms) initial impact dynamics was the same as that in the full-ring test for both free and fixed boundary conditions. The practical implication of this result is that it appears to be feasible to use simpler subsection tests (or flat plate tests) with a rigid projectile to study the local perforation response of the composite ring. This could lead to substantial savings in testing time and cost as long as the impulse provided by a smaller projectile impacting flat plates or ring sections can be shown by analysis to be comparable to the impulse in the full ring test. Although work in understanding this short time local impact problem is continuing, the subject of this paper is deformation and failure during the second time interval described above when the strain energy density is large enough to induce failures such as cracking and delamination even in the absence of perforation. In order to achieve this condition experimentally, a soft gelatin projectile is used instead of a rigid titanium projectile. If a rigid projectile were to be used, perforation of the composite by the projectile would limit the transfer of projectile kinetic energy into strain energy in the composite. It would therefore not be possible to identify failure modes that occur at very high levels of strain energy.

Fig. 2. Deformation of 91 cm (36 in.) composite ring after impact at 183 m/s (600 ft/s).

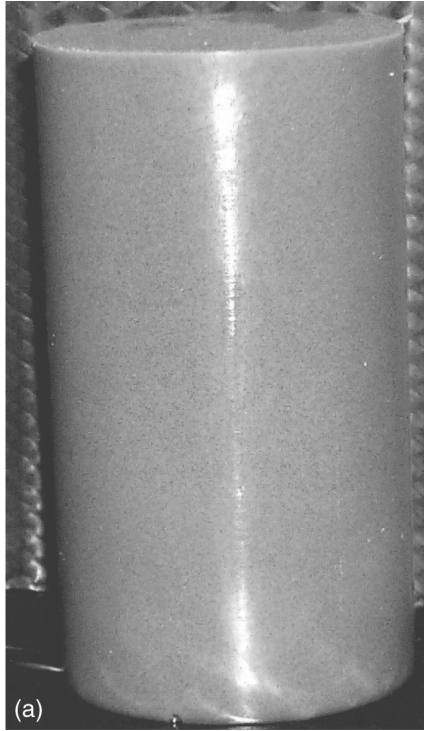
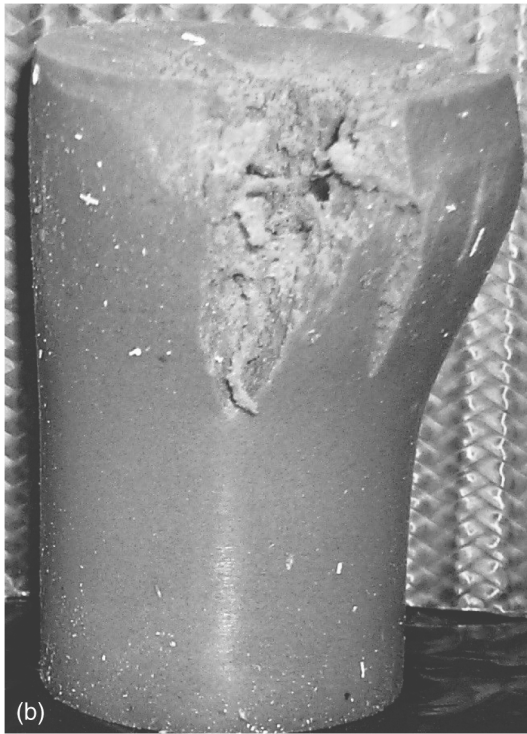
The soft projectiles used in the impact tests were made using a mixture of gelatin and microballoons with a density of  $960 \text{ kg/m}^3$ . The mixture is cast in the shape of a cylinder 12.7 cm (5 in.) long and 7.0 cm (2.75 in.) in diameter. Figure 3 shows an example of a projectile before and after impact. For impact testing a projectile is mounted in a sabot and shot into a target using a 20.3 cm (8 in.) diameter gas gun. The axis of the cylindrical projectile is aligned along the line of flight, so that the flat end of the cylinder makes first contact with the target. Impact velocity is measured digitally using a high speed video camera with a view perpendicular to the line of flight. During a test the projectile initially flattens into a disk approximately 25.4 cm (10 in.) in diameter before rebounding to the “after impact” shape shown in Figure 3(b). At low velocities the projectile can be recovered in the form shown in Figure 3(b), but at high velocities the projectile is disintegrated into small pieces.

Fig. 3. Gelatin projectile. (a) Before impact. (b) After impact.
