# Materials Examination of the Vertical Stabilizer from American Airlines Flight 587

Matthew R. Fox<sup>1</sup>, Carl R. Schultheisz<sup>1</sup>, James R. Reeder<sup>2</sup>, and Brian J. Jensen<sup>2</sup>

<sup>1</sup>National Transportation Safety Board, 490 L'Enfant Plaza, SW, Washington, DC 20594

## Abstract

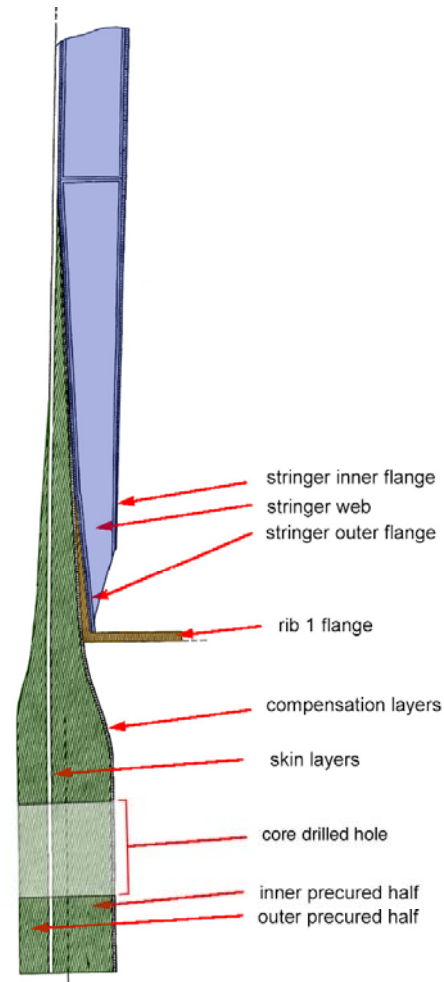
Figure 2: Drawing of main lug cross-section.

The main connections for attaching the vertical stabilizer to the fuselage are designed as six CFRP lugs (main lugs) on the lower end of the vertical stabilizer that connect by bolts approximately 2 inches in diameter to six metal clevis fittings on the fuselage. A schematic view of the typical assembly cross-section is shown in Figure 2 (drawing of lug cross-section). After the assembly is cured during manufacturing, the lug attachment bolt holes are core-drilled out. Three main lugs extend from the lower end of each of the two vertical stabilizer skin panels. At the thickest point, the main lugs are approximately 1.62 inches, 2.48 inches, and 2.17 inches thick for the forward, center, and aft lugs, respectively. The aft lugs alone each have more than 170 layers composed of approximately 50 percent  $\pm 45$ -degree fabric, 25 percent 0/90-degree fabric, and 25 percent 0-degree tape. The thickness of each lug decreases as plies are dropped in the lug-to-skin transition area. The skin layers are made of  $\pm 45$ -degree fabric. The I-shaped stringers have 0-degree tape at the caps and  $\pm 45$ -degree fabric in the web.
